Wizards Workshop

TEKTRONIX INTERNAL USE ONLY

August 8, 1980
Issue 10-16

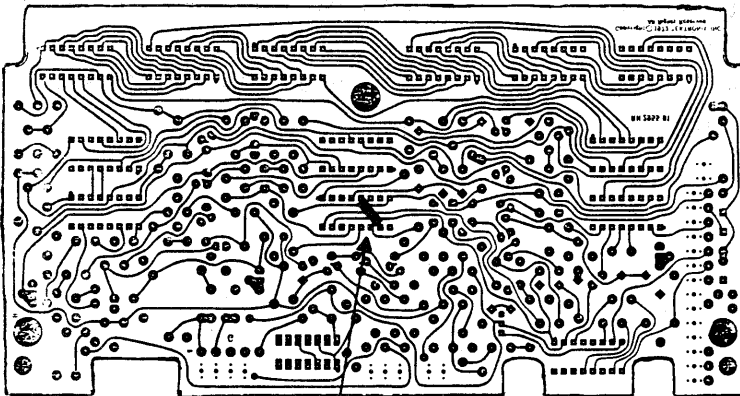
5440/R, 5441/R READOUT MALFUNCTION

To prevent possible readout malfunctions, such as decimal point placement or wrong numbers, a resistor is being added to the character skip line. The resistor, a 15K ohm 5% 1/8 watt, P/N 317-0153-00, is being added on the back of the readout board. It is installed between pin 4 of U1000 and ground.

ADD R1001 (317-0153-00)
TO BACK OF BOARD

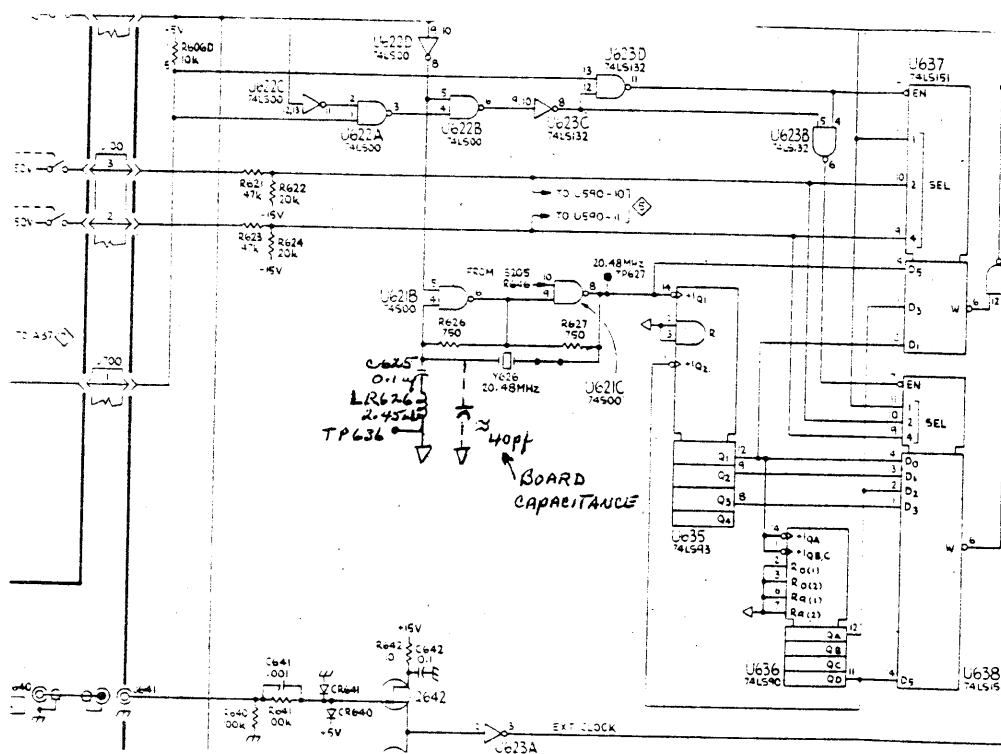
AFTER M40787

At serial #B010121 a mod was installed to insure that the clock generator would start at any sweep speed when the unit was powered up. The problem would only show up when the time per division was set to very fast sweep speeds. The mod consisted of changing C627 from 27pf, P/N 281-0762-00, to a 0 ohm resistor, or terminal link connector, P/N 131-0566-00. Also change C626 from a 10pf, P/N 281-0811-00, to LR626, a 2.45 μ h, P/N 108-0797-00. LR626 must be installed on the back side of the boards. Cut the run between LR626 and Y626 and add C625, .01 μ f cap P/N 281-0775-00, in series with LR626. Connect the other end of the capacitor to R626, 7.5 ohm resistor, on the end connected to pin 4 of U621B, as shown on the following schematics.

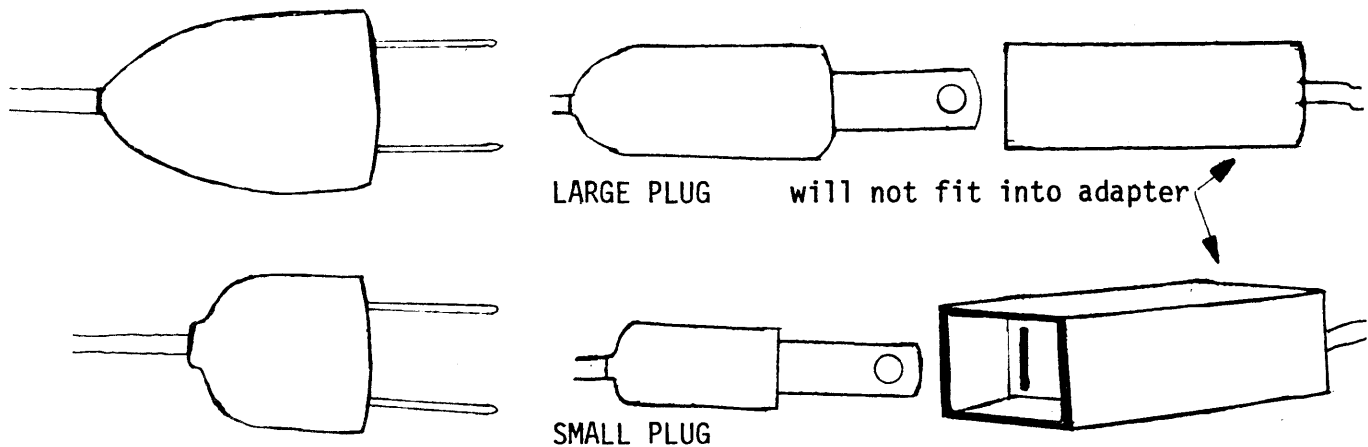
FIG. 1

Due to a change of vendors, a larger, two-terminal plug power cord for the 200 Series scopes was put into the stock system (see Fig. 1). This large plug will fit into the storage compartment for the AC plug on the 212 and 214 instruments, and will not fit the 211, 213, and 221 instruments.

However, some 212 and 214 instruments are shipped with a power plug adapter, P/N 161-0077-01, and the large plug will not fit into this adapter because the female receptical is recessed. (The adapter has one end to accept the smaller plug and one end which has just a power cord, so the user may adapt any type power plug he desires.)

All the large plug-type power cords have been removed from stock, and all service center stocks should be purged. Reorder the cords as necessary. Both styles of power cords have the same part number.

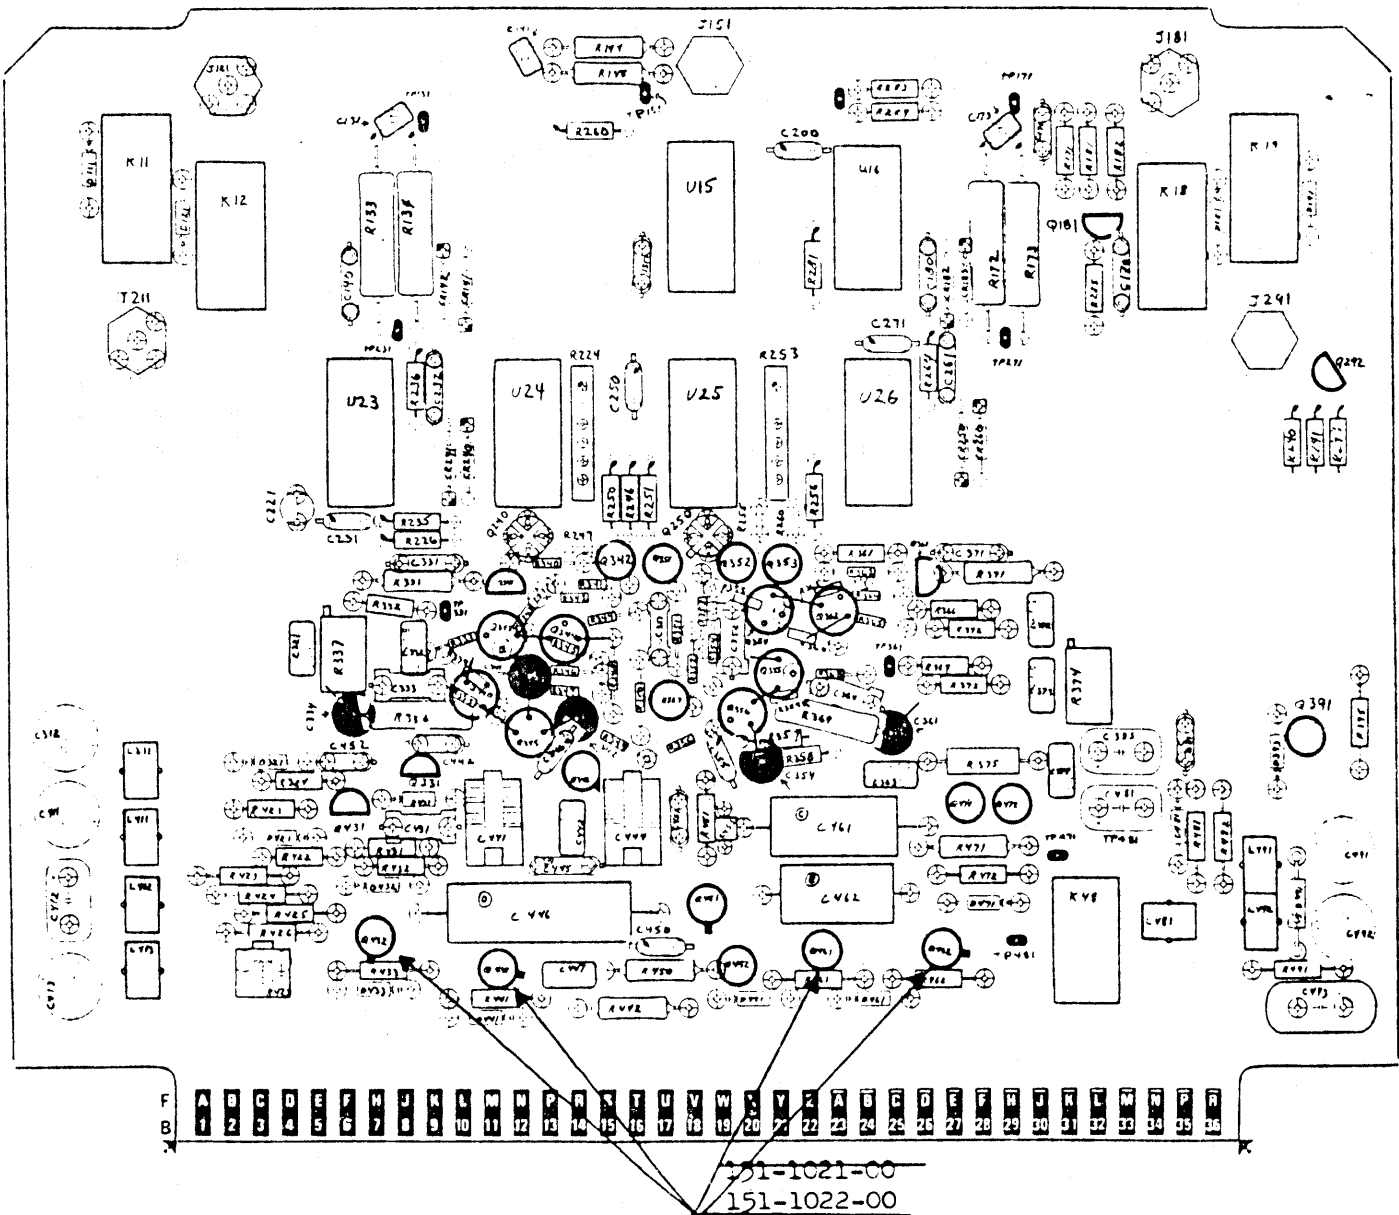
S-3200: SSTMS MAY GIVE ERRONEOUS READINGS AT THE BEGINNING OF RTADJ.EDT:VDT

The Delta T subsystem output card has been modified. Q432, 441, 461 and 462 have been replaced with FET's which have lower gate source cutoff voltage. The old part numbers were 151-1021-00. The new part numbers are 151-1022-00. The assembly number changes from 670-2409-02 to 670-2409-03.

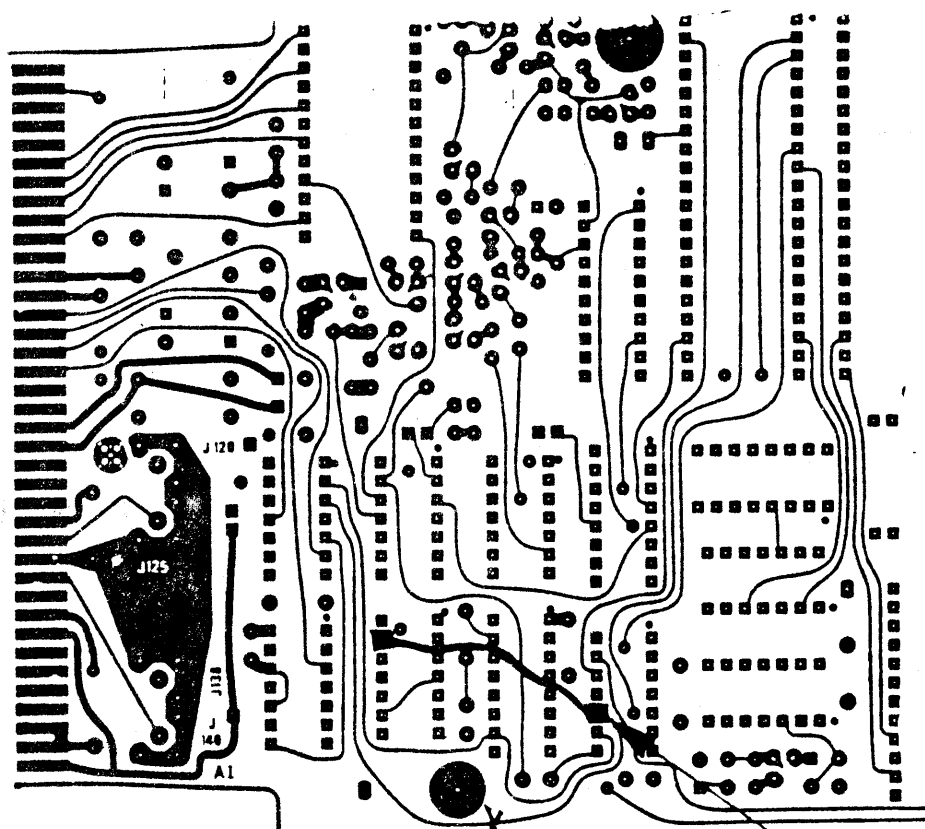
DIAGRAM A
BACKVIEW OF THE 670-4916-03 BOARD

SYMPTOMS: When the 7A16P is used with other than a programmable plug-in, you may lose the 'S' in the readout from the non-programmable plug-in. This has been seen in the 7912AD using a 7B53A or a 7B92A.

SOLUTION: On the backside of the A30 Programming Logic Board (670-4916-XX) cut the run between Pin 10 of U1330 and Pin 3 of U1620 as shown in Diagram 'A'. Strap Pin 10 of U1330 to Pin 13 of U1530 as shown in Diagram A.

CUT RUN BETWEEN PIN 10 OF U1330
AND PIN 3 OF U1620

STRAP FROM PIN 10 OF U1330
TO PIN 13 OF U1530

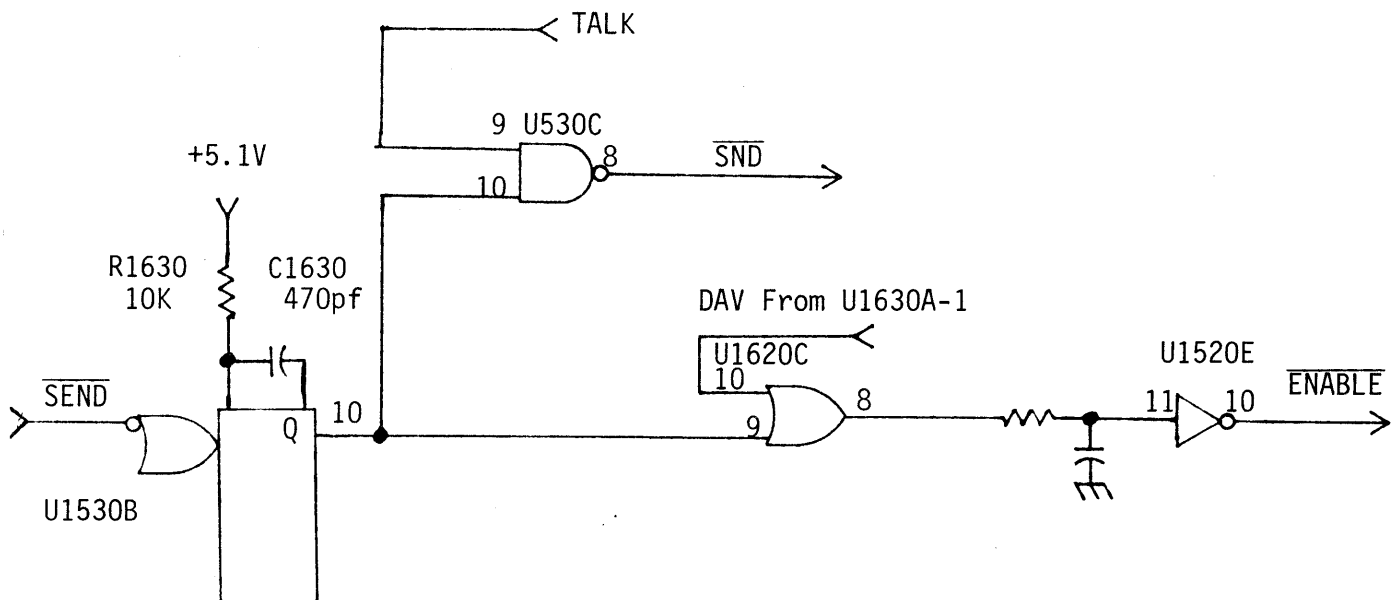
PARTIAL OF SCHEMATIC DIAGRAM 7

7B90P: READOUT ON OTHER PLUG-INS MAY LOSE OR CHANGE LETTERS IN DISPLAY

SOLUTION: Lift Pin 10 of U1620 of the A50 Programmer Board (670-5039-00). Then strap lifted Pin 10 of U1620 to Pin 1 of U1630. Remove C1630 and R1630. Replace C1630 with a 470 pf capacitor Part Number 283-0032-00 and replace R1630 with a 10 K Ω resistor Part Number 315-0103-00.

The schematic representation is shown in the following diagram.
