Wizards Workshop

TEKTRONIX INTERNAL USE ONLY

July 11, 1980
Issue 10-14

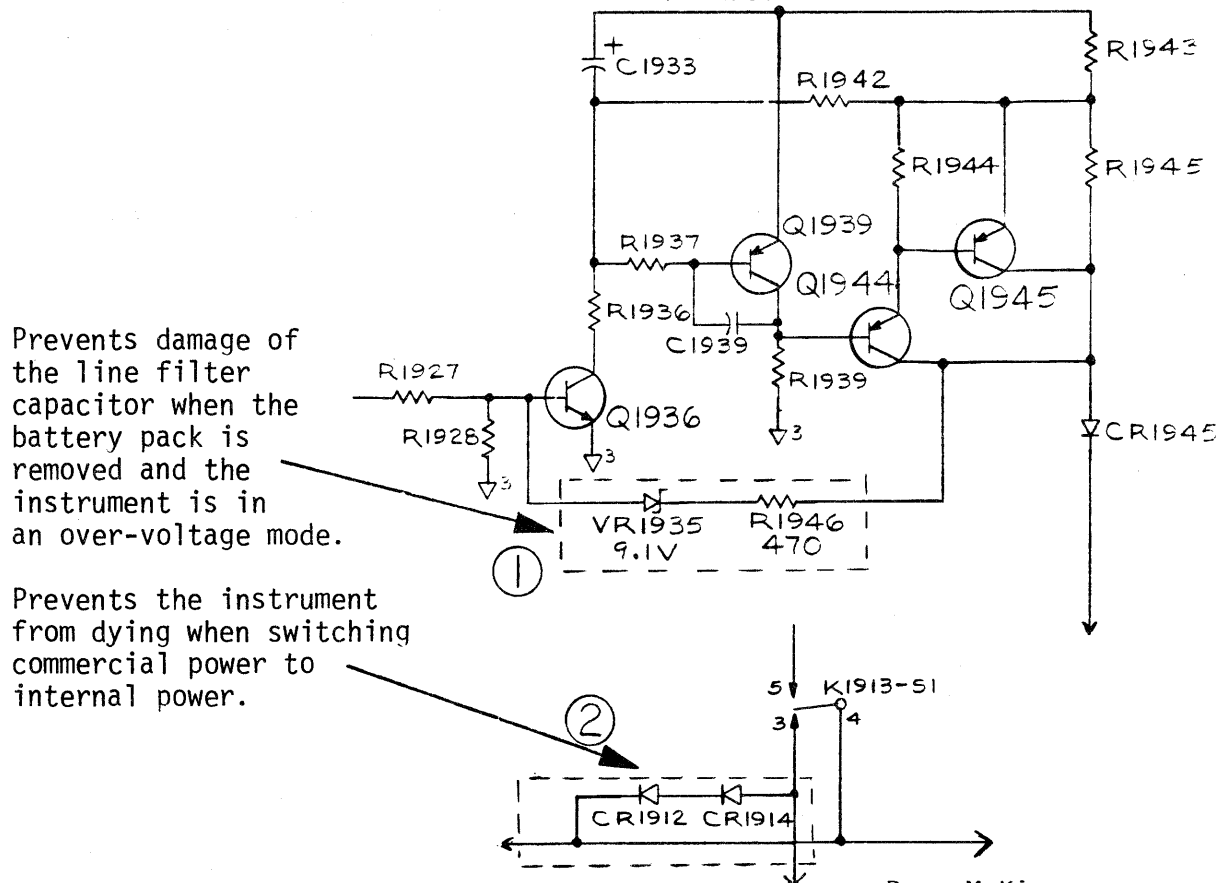
To incorporate the mods below on the 413 Medical Monitor, S/N B010100 - B049999, refer to the Kit P/N 040-0961-00. Manufacturing is implementing the change effective S/N B050000.

Refer to the picture for location of changes:

CIRCUIT NUMBER	PART NUMBER	DESCRIPTION
CR1912	152-0198-00	Semiconductor; Silicon, 200V, 3A, 1N4721
CR1914	152-0198-00	SAME AS ABOVE
R1946	315-0471-00	Res., FXD, CMPSN, 470 Ω , 5% 0.25W
VR1935	152-0306-00	Semiconductor Device Zener, .4W, 9.1V, 5% 1N960B

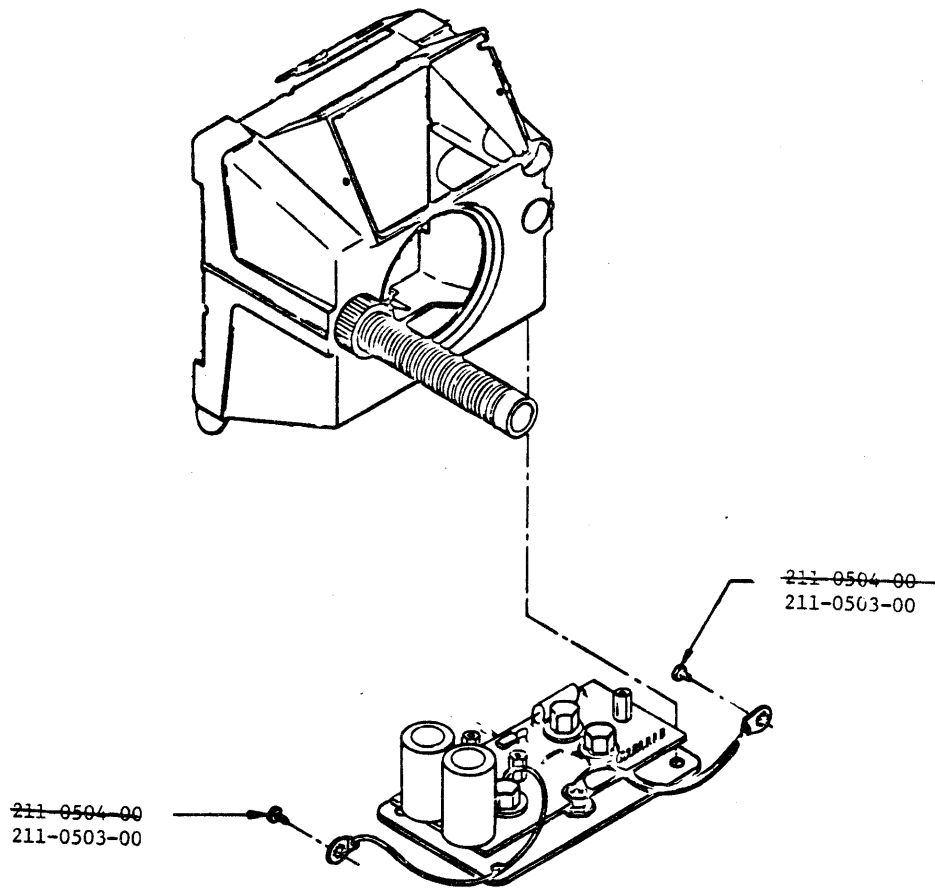
The present screw, P/N 211-0504-00, is bottoming out in the hole on the main frame assembly. (See sketch.) Replace the screw P/N 211-0504-00 with P/N 211-0503-00.

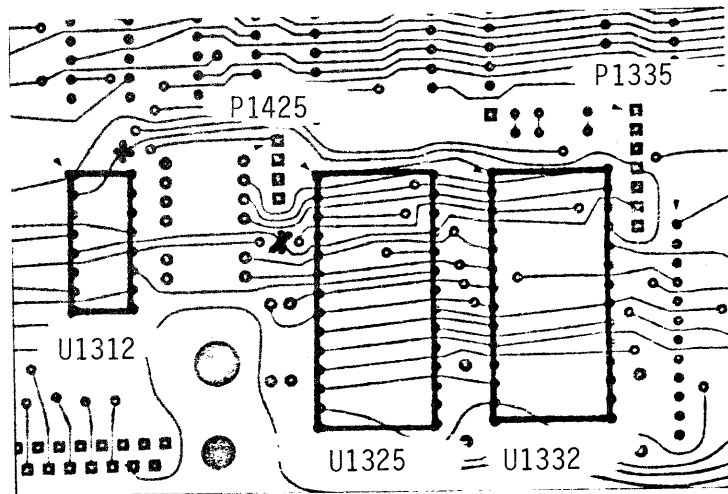
Figure 1 P/O A1 Processor Board
(Front View)

There still appears to be a need for additional information to clarify the steps which require the cutting of circuit board runs. Please refer to Figure 1. One step requires the cutting of a run between U1332-9 and U1325-25. This run is easily identified on the rear of the Processor (A1) board and is not illustrated. Another step requires the cutting of a run between U1312-2 and P1335-4. This is illustrated just above U1312 in Figure 1 or you can cut the run near P1335, Pin 4. The other step is to cut a run between U1312-5 and U1325-25. This can be accomplished by cutting the run just to the left of U1325, Pin 5 which is at a forty-five degree angle, see Figure 1.

A request is being made to include Figure 1 in the next version of the Current Loop (Option 2) Field Mod Kit, Part Number 040-0897-00.

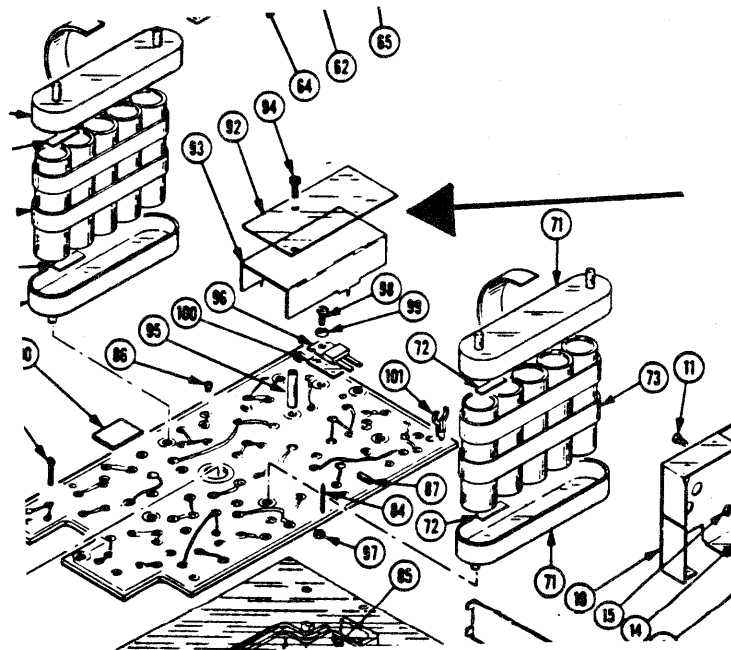
FIG. 1

The mechanical parts exploded view illustrates the assembly of the transformer shield with the screw going through a hole in the insulator film and through the shield into a spacer post. This assembly is not correct and is pictured incorrectly in the manual as shown in Fig. 1. The Mechanical Parts List calls for a nylon screw; however, the nylon screw has never been used in regular production due to stripping. A metal screw has been and is now being used.

If the shield is assembled wrong, the screw head--which is secured in the post which has A.C. line on it--will short to the CRT shield, which is at probe ground. It is then possible for A.C. line to be present on the ground clip of the probe. If for any reason the shield is removed, make sure upon reassembly the screw head is covered with the insulation film.

INCORRECT ASSEMBLY

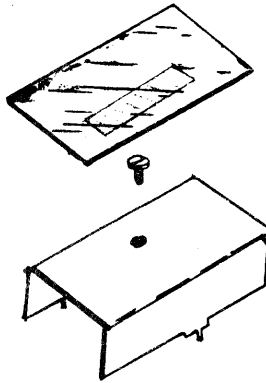
FIG. 1 B

The correct assembly has the screw going through the transformer shield only. The screw used is a metal screw, P/N 211-0087-01. The insulator film is placed over the shield and screw, and is held in place with double side tape, P/N 006-1342-00 as illustrated in Fig. 1B.

CORRECT ASSEMBLY

The insulator film has been modified by removing the hole so there will be no temptation to insert the screw through the film. The new number for the shield is P/N 342-0213-01. If the old film is used, make sure the hole in the insulator film is rotated so that it is not over the head of the screw.

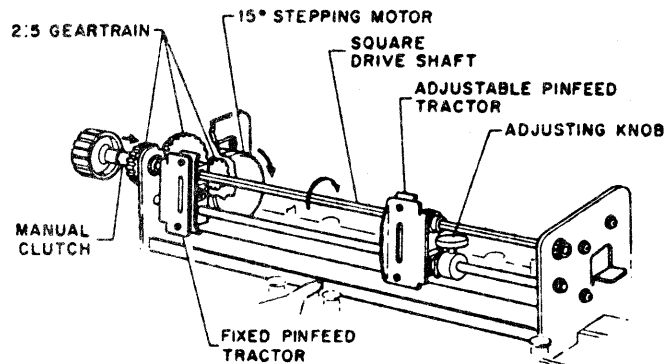
Uneven spacing between lines or line bunching as it's sometimes called is characteristic of excessive tractor tension. This condition can usually be corrected by moving the tractors closer together.

It has been brought to our attention that adjusting the tractor tension may not solve the problem of uneven spacing. If the line printer has received considerable use and the tractor tension will not correct the problem, check the free play between the square tractor drive shaft and the drive clutch gear. The drive clutch gear is part of the manual clutch assembly. There should be very little or no free play between the tractor drive shaft and the drive clutch gear. The presence of free play indicates excessive wear of the Clutch Hub that rotates the tractor drive shaft. To correct the problem, replace the Clutch Hub, Tektronix part number 118-0093-00. We would like to thank Charles Gelsinger for bringing this problem to our attention.

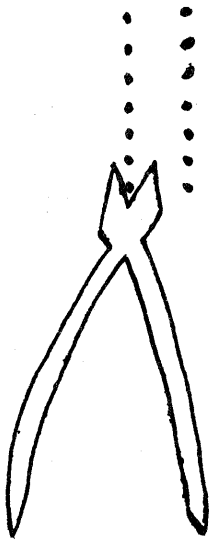
Right

13. In addition, the reeds indicated on the diagram IM,OM, 02, etc. are susceptible to poor solder joints on the signal path lead due to a contaminated surface before the connection is made or to insufficient heat being applied when the connection is made to the large pads. I suggest you pick at the reed signal path connections with a scribe. The poor connections will come loose without much difficulty leaving a dark tarnished surface on the pad. This is rosin, and should be cleaned off before the new connection is made using FOTOCAL or equivalent. Resolder these using plenty of heat and solder.
