PG 507
492/P
2215

SERVICETEKNOTES

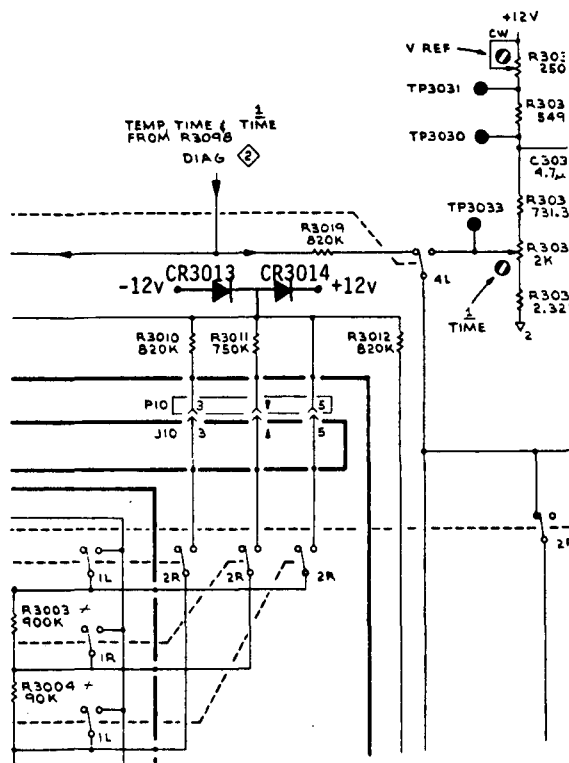
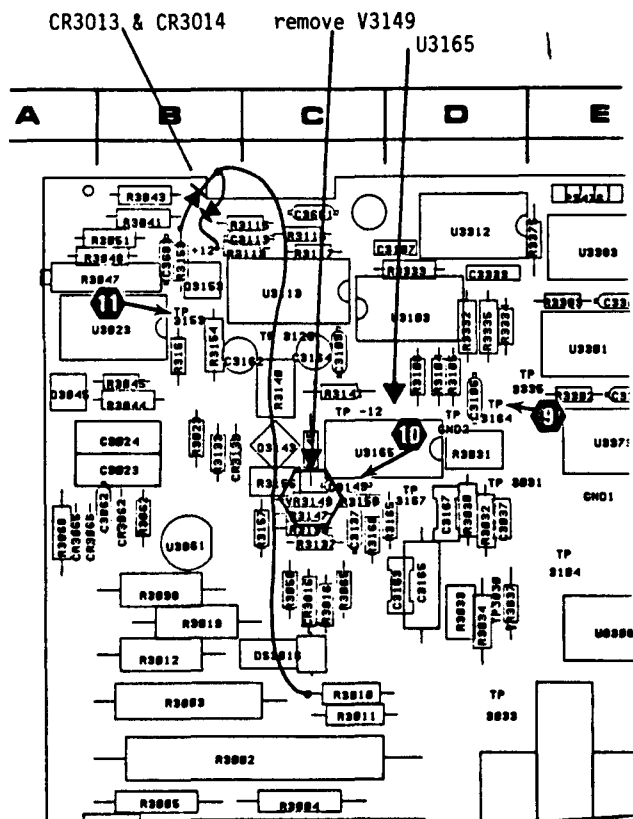
The old I.C., P/N 156-0477-00, used for the A/D processor, U3165, is no longer

DM44, U3165 A/D I.C. REPLACEMENT (cont.)

available. A new I.C., P/N 156-1268-00, is now used for a replacement. The I.C. is not a direct replacement and the circuit must be modified as follows:

1. Remove VR3149
2. Add CR3013 & CR3014, P/N 152-0323-00, at location shown in the diagram. (CR3013 anode to R3153 [-12 volt supply], CR3014 cathode to R3113 [+12 volt supply], the two diodes are joined together and wired to R3010.)
3. Replace U3165.

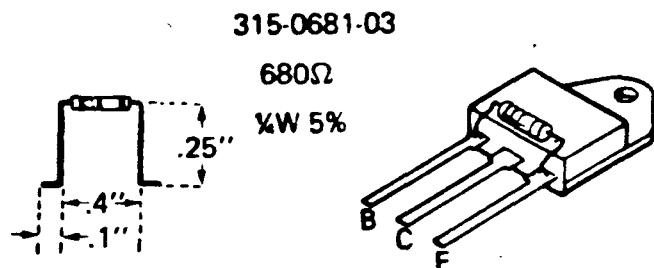
Transistor/Resistor combination

Early GMA102A Low Voltage Power Supplies (prior to serial number B060000) have shown a particular failure mode where R126, R127 and R129 overheat. Other components that typically fail as a result are CR681, Q101, R203, R210, R301, U221 and VR210. This failure occurs when the connector on the leads of Q5008 comes loose.

This type of failure is prevented by installing modification S42417 as follows:

- Remove R210 (680 Ω , 315-0681-03) and VR210 (120 v zener) from the 670-5105-04 power supply board. The board level changes to -07 as a result.
 - Add another 680 Ω , 315-0681-03 resistor to Q5008 across the base-emitter junction (see figure). The leads of
- (ARTICLE CONTINUED ON THE NEXT PAGE)

R210 will be too short to use; the resistor must not obstruct connecting Q5008's socket.

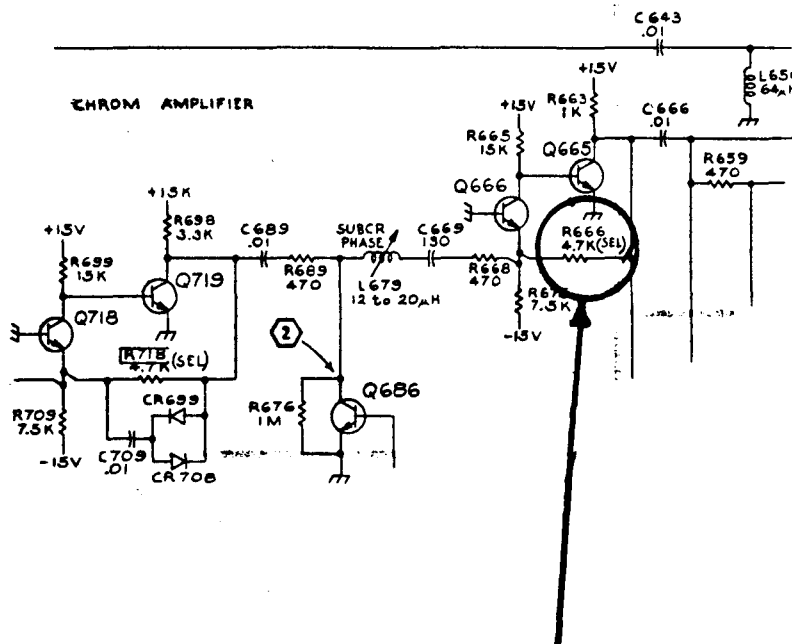
Transistors from different vendors are showing widely varying response characteristics (151-0190-00). This part is used in Q665, Q666, Q718, Q719 and Q715

In the past these transistors have had to be hand selected to keep phase shift with a change in burst gain within specifications.

Add C667

281-0670-00

(Nominal 1.8pf)

The addition of a test selectable capacitor (C667, 281-0670-00, nominally 1.8pf) will help avoid this selection routine.

Add C667 in parallel with R666 and select a value between 0 and 4.7pf to obtain minimum phase change with burst gain change, as necessary. See the illustration.

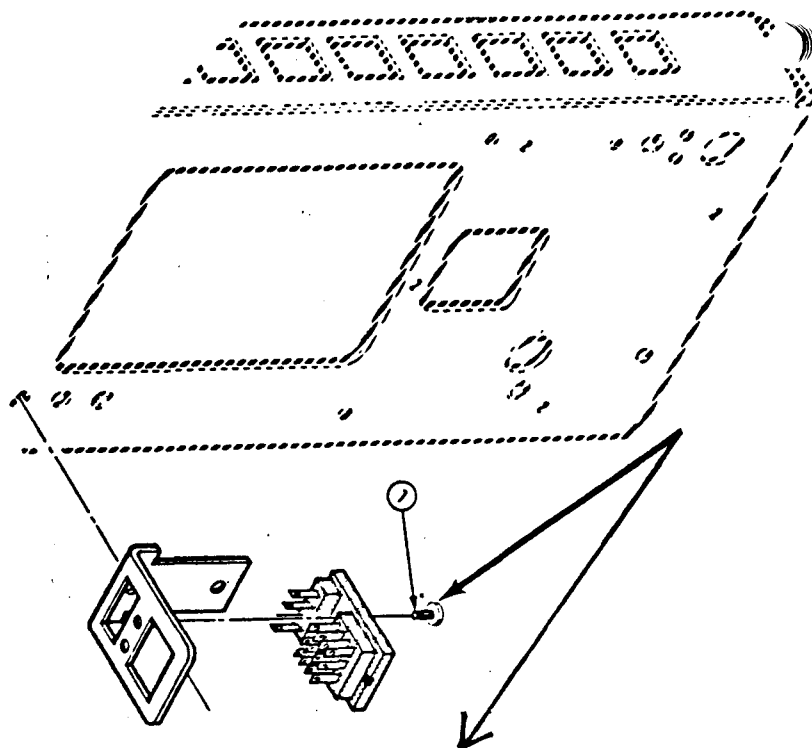
210-0586-00 Kep-Nut
211-0008-00 Screw

The screw on the Relay Assembly is not long enough, thereby allowing the parts to loosen.

Replace the self-taping screw on the relay assembly with a 210-0586-00 Kep-Nut and 211-0008-00 screw whenever a unit is in for service (see diagram).

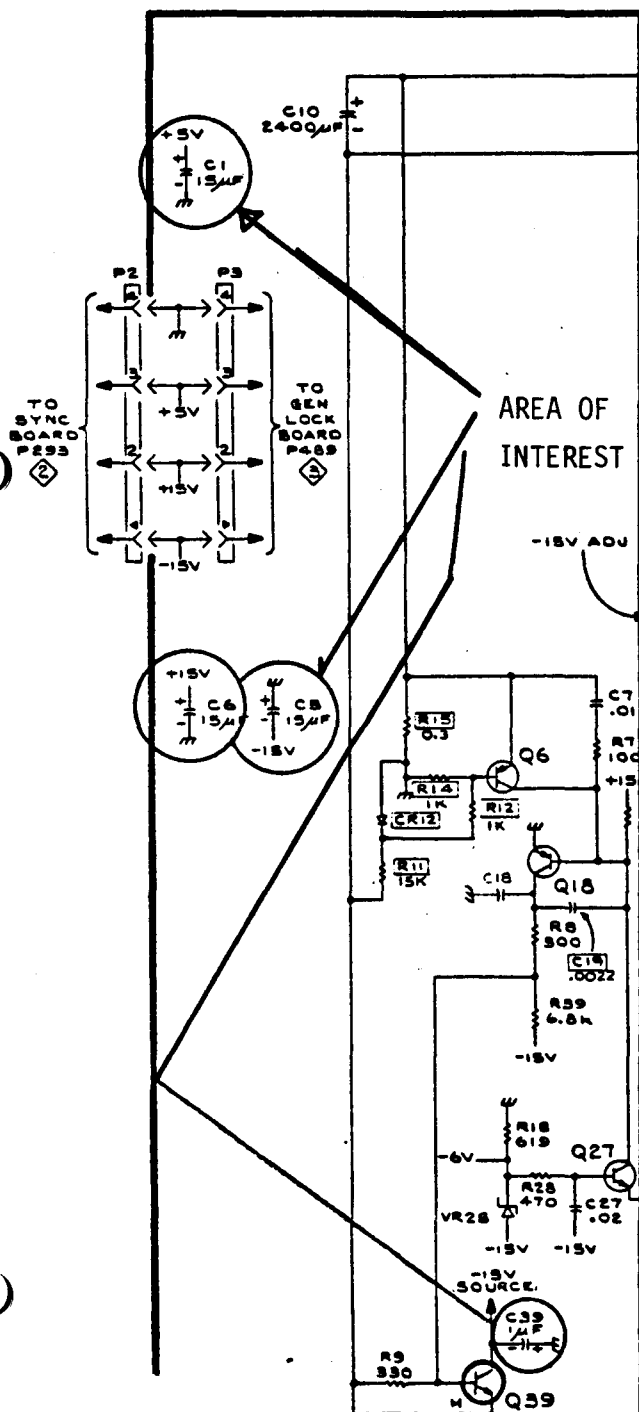
Under certain load conditions, the power supply tends to get unstable and oscillate. The following changes should eliminate this problem.

Change C1, C5 and C6 from 290-0135-00 to 290-0135-01 and remove C39. Install this change where necessary to correct faulty operation.

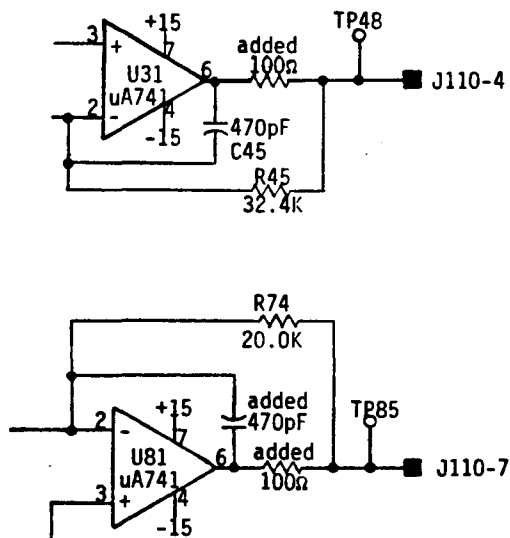
Hard copy image is noisy at the top, or weak at the bottom of the page. The "interrogate" scan line may be broken up (or a series of dots) at one end. The slow ramp may start one inch to the right of where it should start.

Load capacitance can cause the uA741 Op Amps--Slow and Fast Ramp Drivers--to oscillate. Usually this is due to long (ARTICLE CONTINUED ON THE NEXT PAGE)

Add 100 ohm resistors in series with the ramp outputs. Add a 470 pF capacitor from pin 6 (output) to pin 2 (inverting input) of U81. Note schematic corrections below.

1. Orient the board with edge connector toward you, component side up.
2. Lift pin 6 of U31. Lift the right end of C45 (on top of R45) and solder it to the lifted pin 6. Solder a 100 ohm, 1/4 w, 5% resistor, p.n. 315-0101-00, from the right end of R45 to the lifted pin 6, U31.
3. Lift pin 6 of U81. Solder a 470 pF capacitor, p.n. 281-0580-00 across

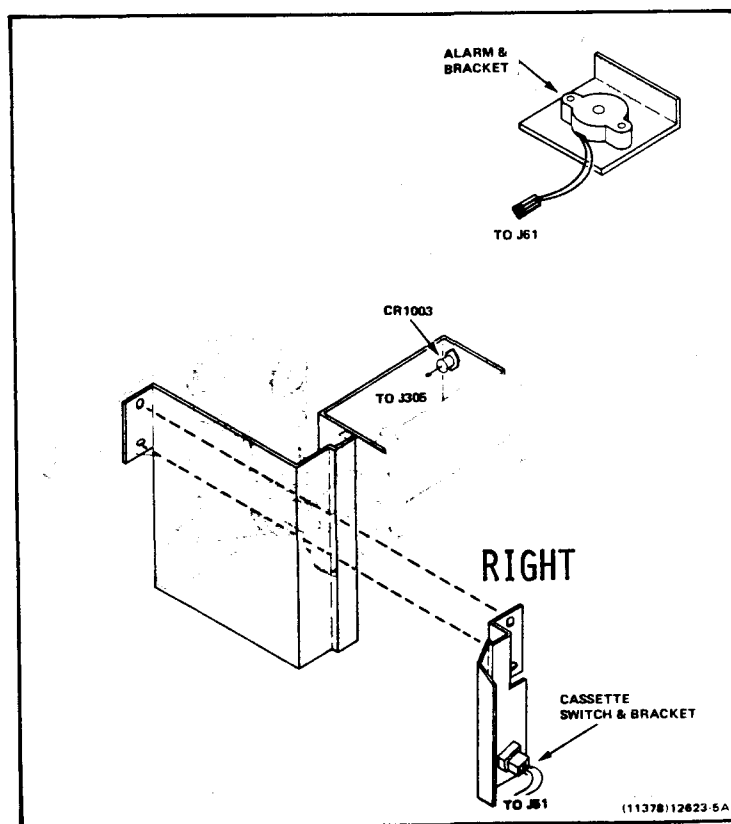
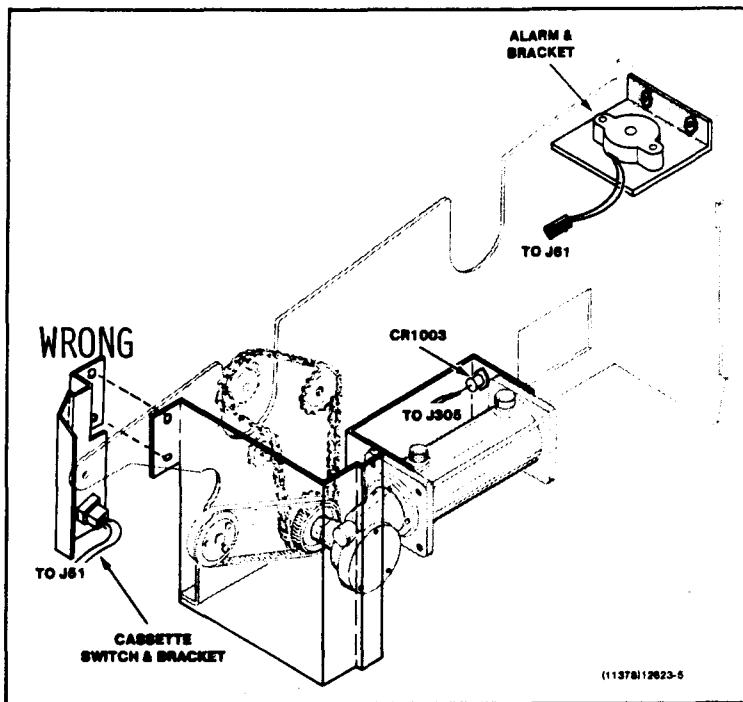
Figure 2-6. Attached Parts Location.

An error in the installation instructions for the (jam) Detector Board Kit, CM020-0814-00, may confuse both Tektronix and OEM customer service personnel. On page 2-9, Figure 2-6 shows the cassette switch bracket mounted to the left of a flange from the front subpanel. The correct mounting location is on the right side of the flange. The figures below should clarify.

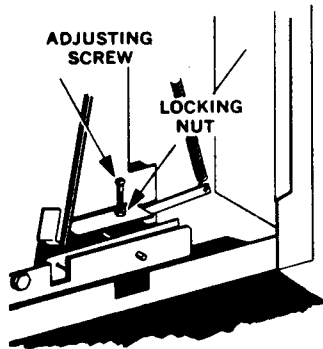
Elevation Brake Adjustment

If brake mechanism for tablet elevation does not release when brake pedal is depressed or if brake does not hold positively at desired elevation, it is possible that one or both brake mechanisms need adjustment. The brake mechanisms are located inside the end panels of the pedestal.

If the brake did not release when the foot pedal was activated, loosen the locking nut on the pre-determined side and tighten adjustment screw by turning clockwise. When the brake is adjusted properly, re-tighten the locking nut.

If the brake mechanism slipped when tested, loosen the locking nut on the pre-determined side and turn the adjusting screw counterclockwise to increase the brake tension. Re-tighten the locking nut after adjustment.
