# Wizards Workshop

Published by Service Admin Support  
56-037

June 5, 1981  
Issue 11-10

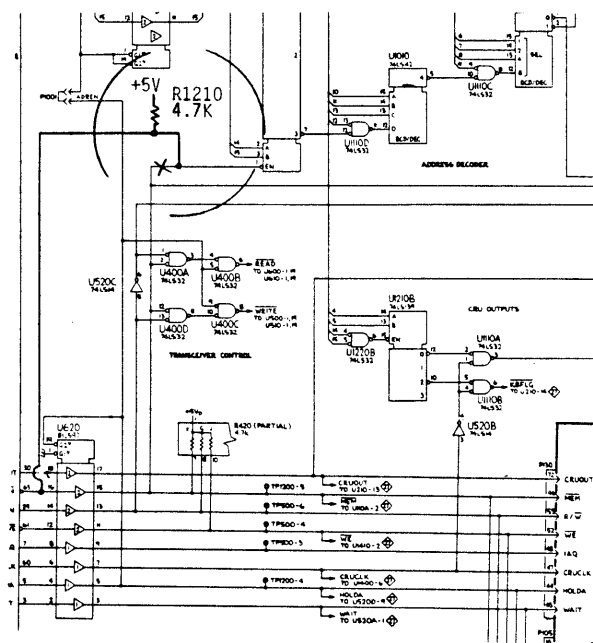
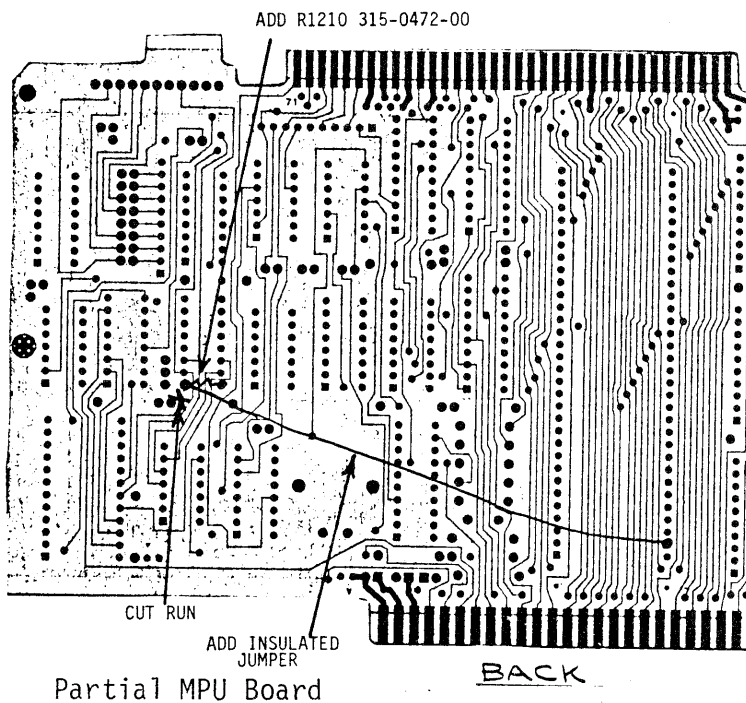
DIAGRAM 28 Microprocessor and Control - Partial

There is a possibility that when single or multiple acquires are requested, the instrument may not stop acquiring. To cure this cut the run going to the enable line of U1210A. Add R1210, a pull-up resistor, P/N 315-0472-00, as per the following drawings.
