Wizards Workshop

TEKTRONIX INTERNAL USE ONLY

May 30, 1980
Issue 10-11

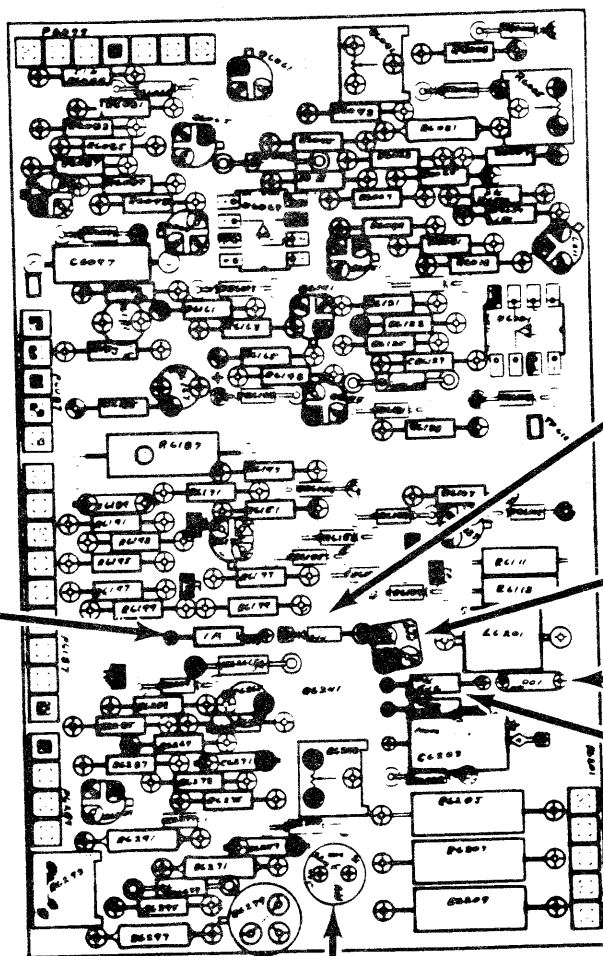
BLANKING CIRCUIT BOARD

650A/650HR SERIES, MODIFICATION TO PREVENT SPOT BURNING OF CRT PHOSPHOR

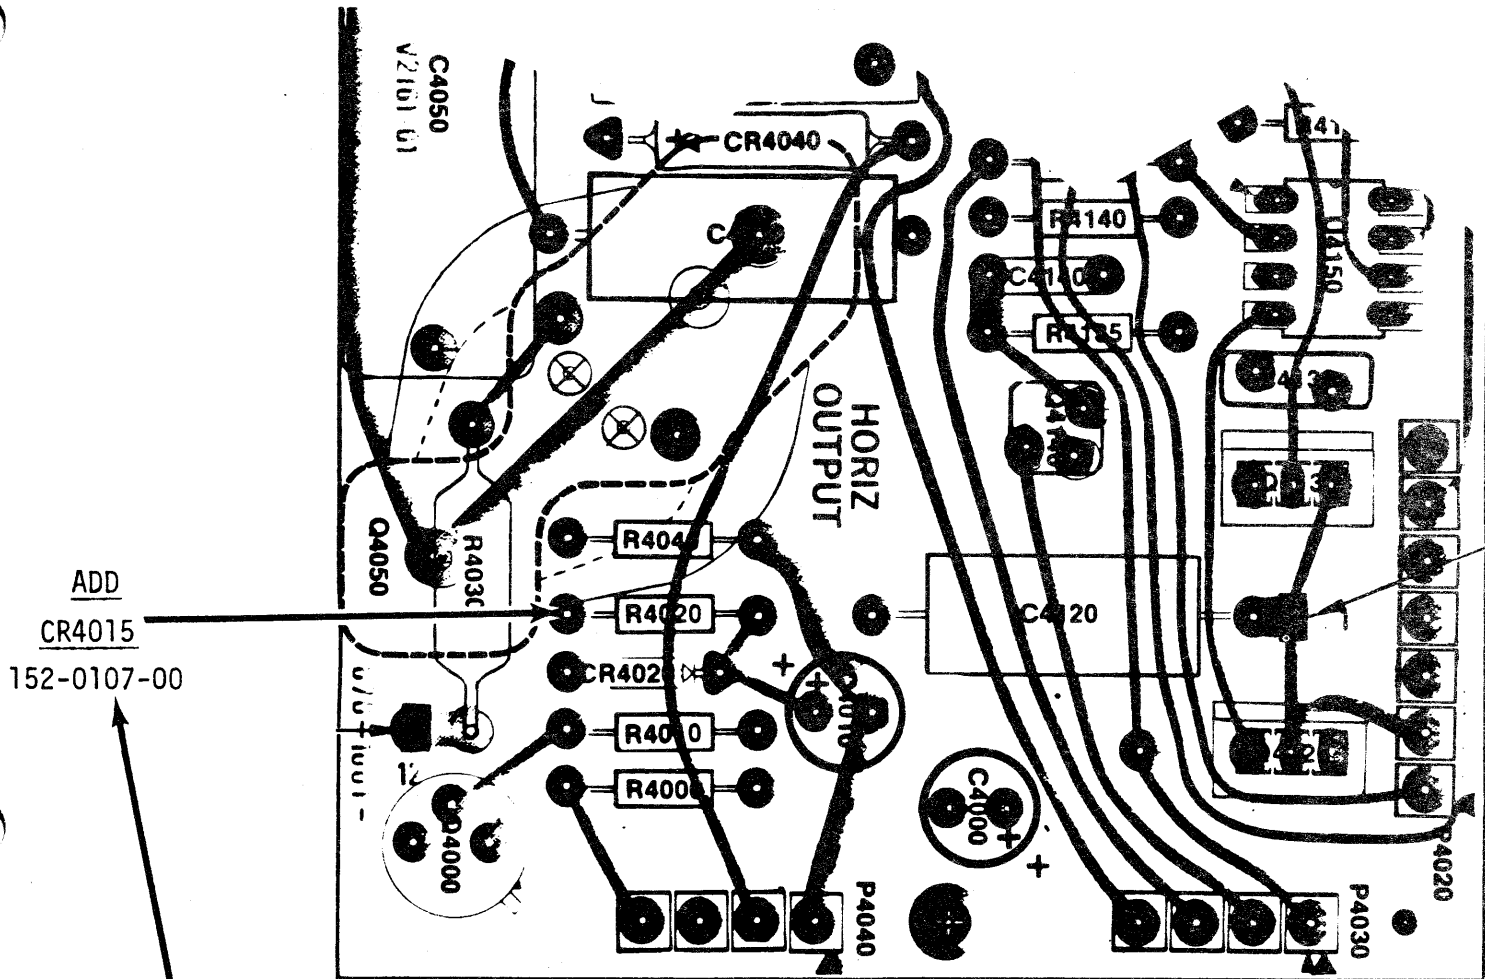
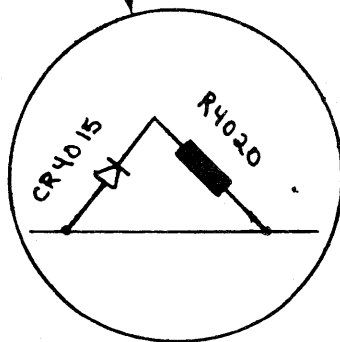
HORIZONTAL OUTPUT CIRCUIT BOARD

CR4015 AND R4020
ARE TEEPEED OVER
CIRCUIT BOARD

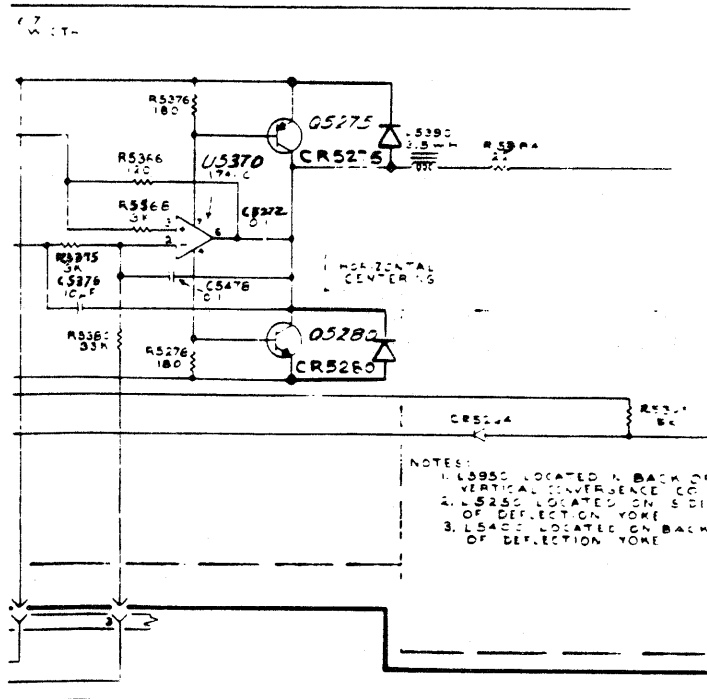
DIAGRAM 12 HORIZONTAL DEFLECTION (670A & 671A) DIAGRAM 5_b 670A-1 SERIES

Q5030, Q5275, Q5280 and F5042 are high failure rate components in the 670A Series monitors. Q5030 is failing because of timing problems which causes some transistors used in this location to turn on during flyback. This would open the fuse (F5042) and in most cases, destroy the transistor. Q5275 and Q5280 apparently fail due to a high induced voltage present during flyback.

To replace a failed Q5030 order P/N 050-1369-00. This kit contains Q5030, F5042, the new coil and the new resistor. To replace Q5275 and Q5280 after failure order P/N 050-1370-00. This kit contains transistors and diodes.

The modifications described here should be added to any 670A Series monitor as a preventative measure. Also, add these modifications when replacing any failures to Q5030, Q5275, Q5280 or F5042.

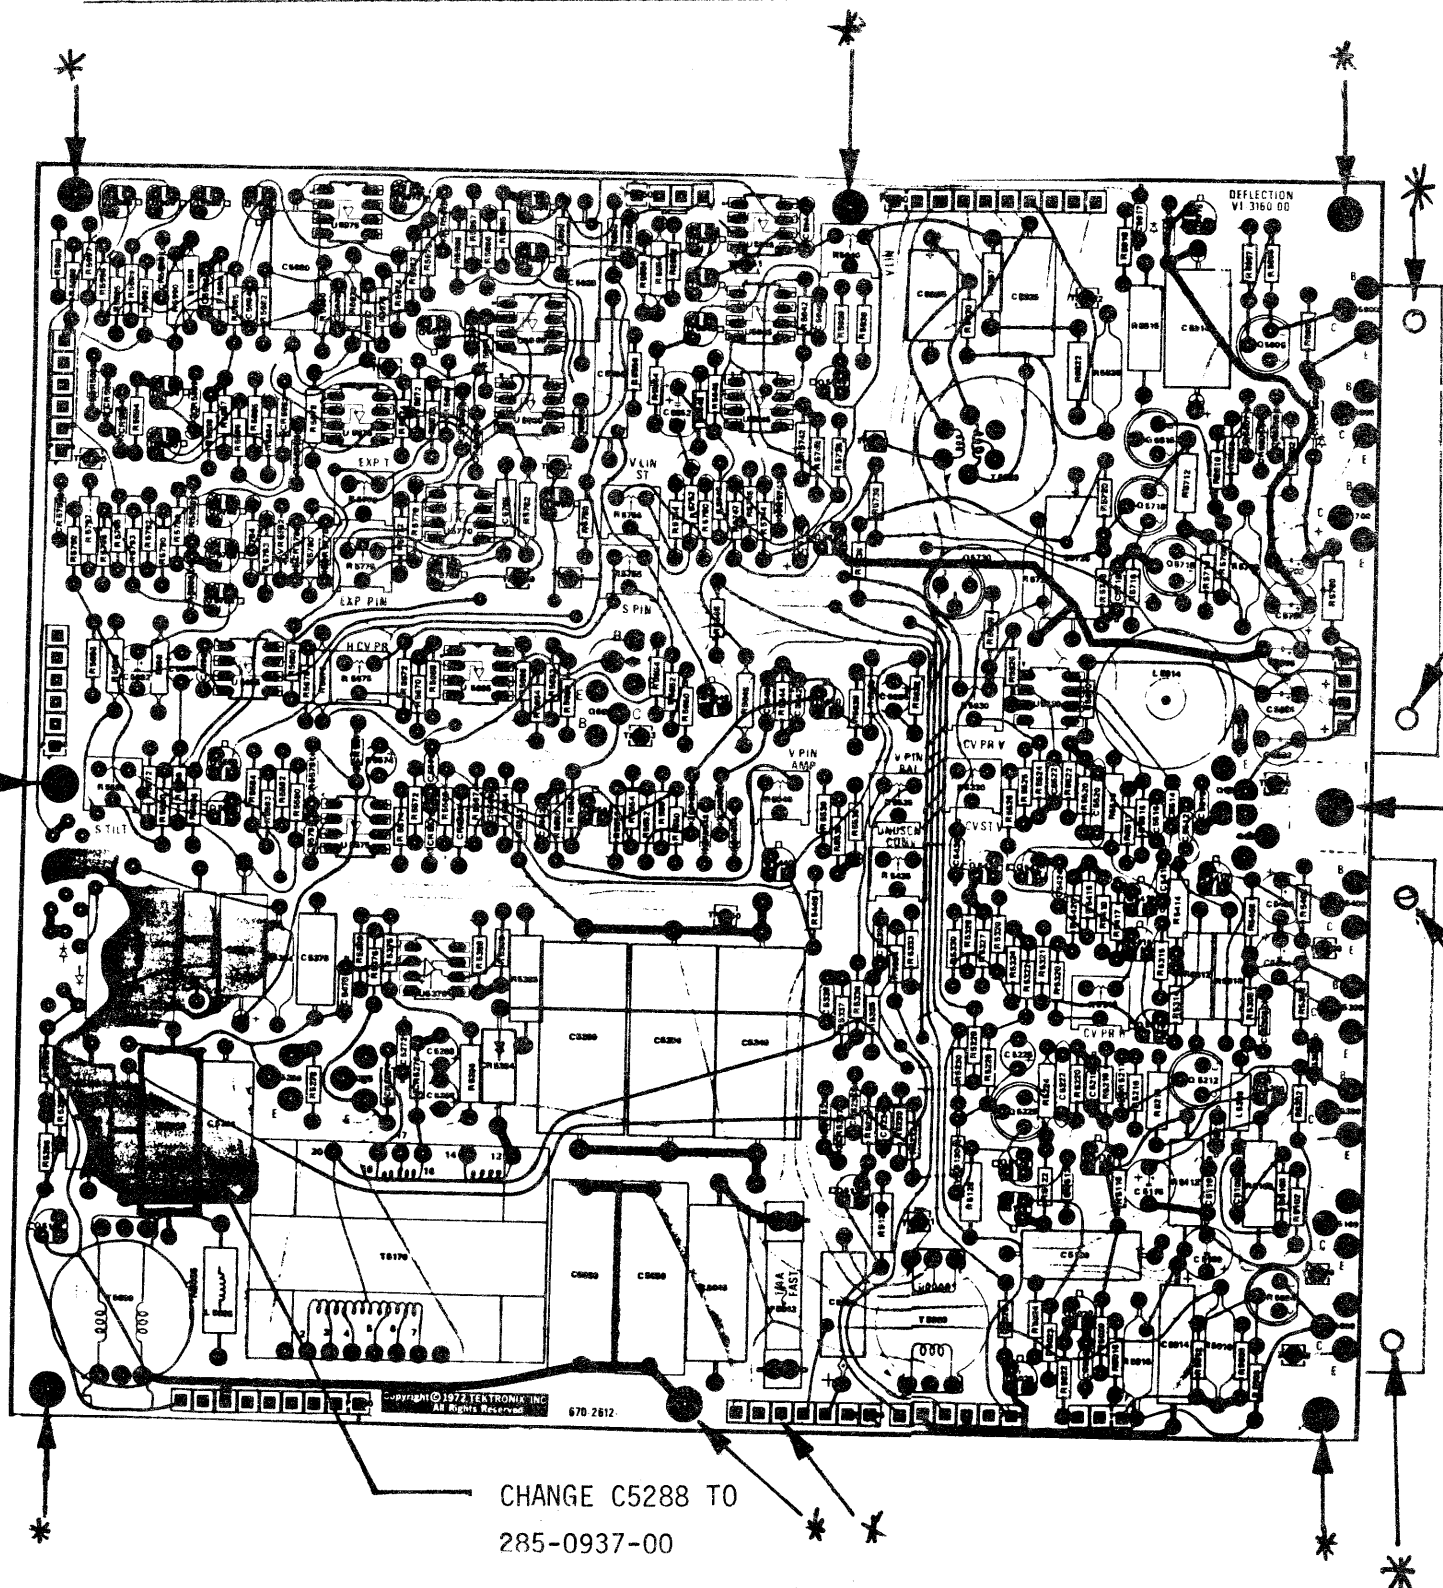
Some 670A/671A color monitors may exhibit a very faint light vertical line approximately 2.5 inches (6.35cm) from the left edge of the screen (in the yellow bar). The line is caused by a high ground current spike generated when Q5001 turns off. This line may become slightly more visible with the addition of the modification to the horizontal output circuits (see article in this issue).

* CHECK GROUND CONNECTION

Manufacturing is installing the new part number in current instruments. Serial numbers will be published when available.

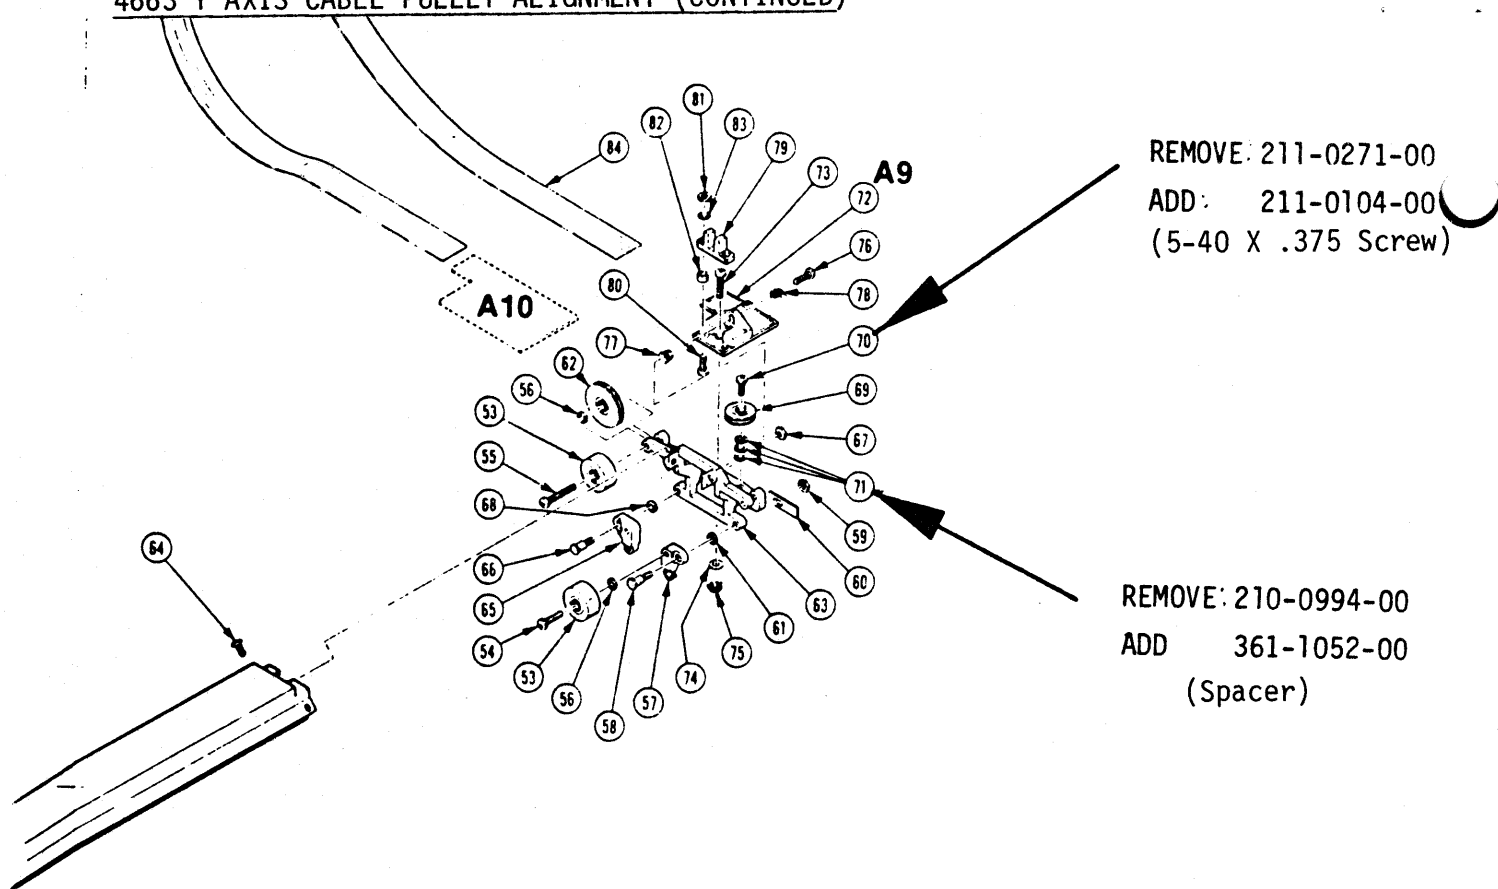
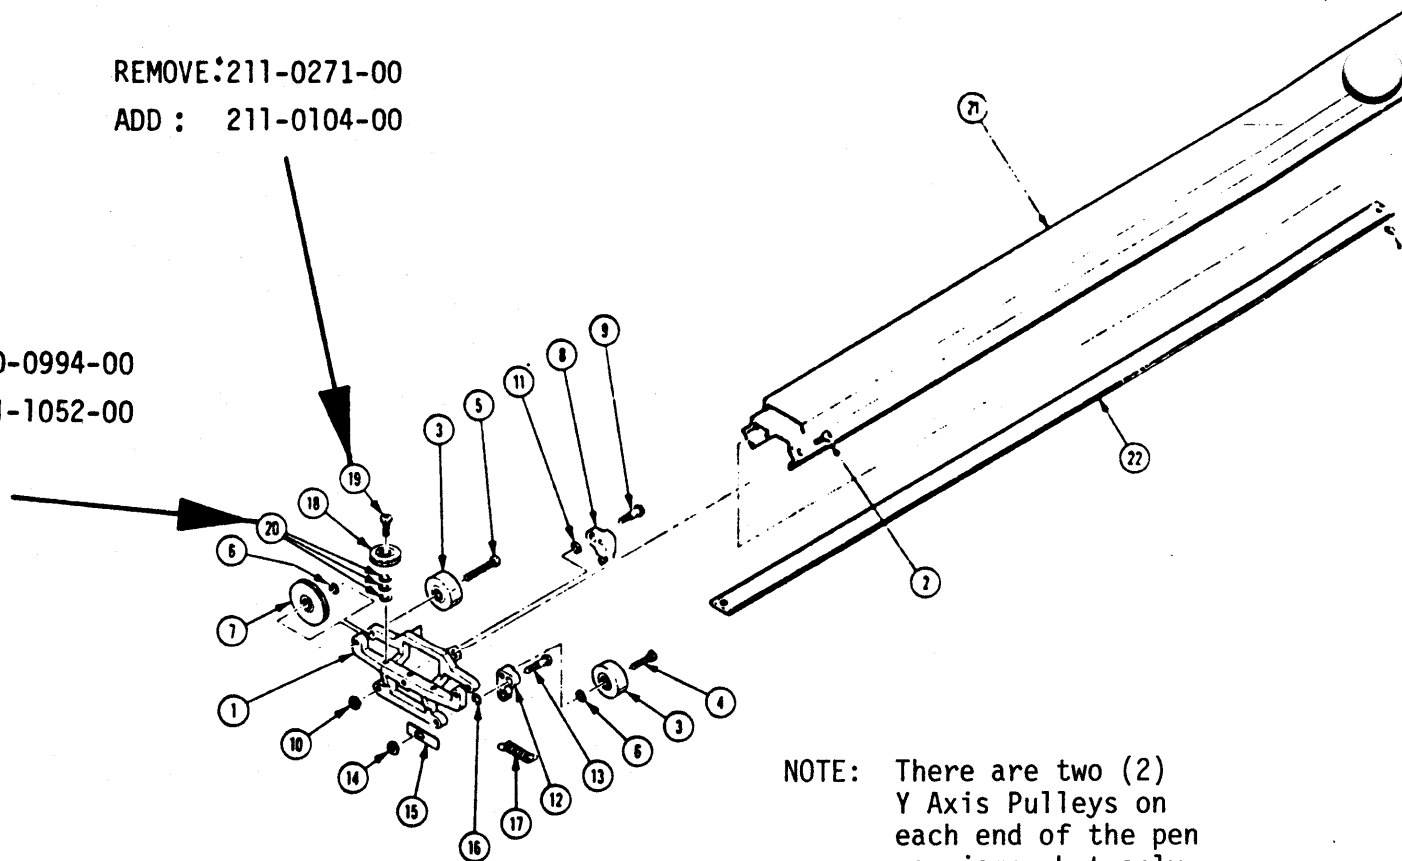
There is a 4663 modification that repositions the four (4) Y Axis Cable Pulleys located on the pen carriage to help prevent the cable from fraying. It replaces 4 screws and 12 washers with 4 longer screws (211-0104-00) and 2 plastic spacers (361-1052-00). Included with this article is a copy of the mechanical views with the affected hardware clearly identified. Install this modification only as required because NOT ALL 4663's experience fraying problems with their Y Axis Cable.

REMOVE: 211-0271-00

ADD : 211-0104-00

REMOVE: 210-0994-00

ADD: 361-1052-00
