Wizards Workshop

TEKTRONIX INTERNAL USE ONLY

Published by Service Admin Support

October 9, 1981
Issue 11-19

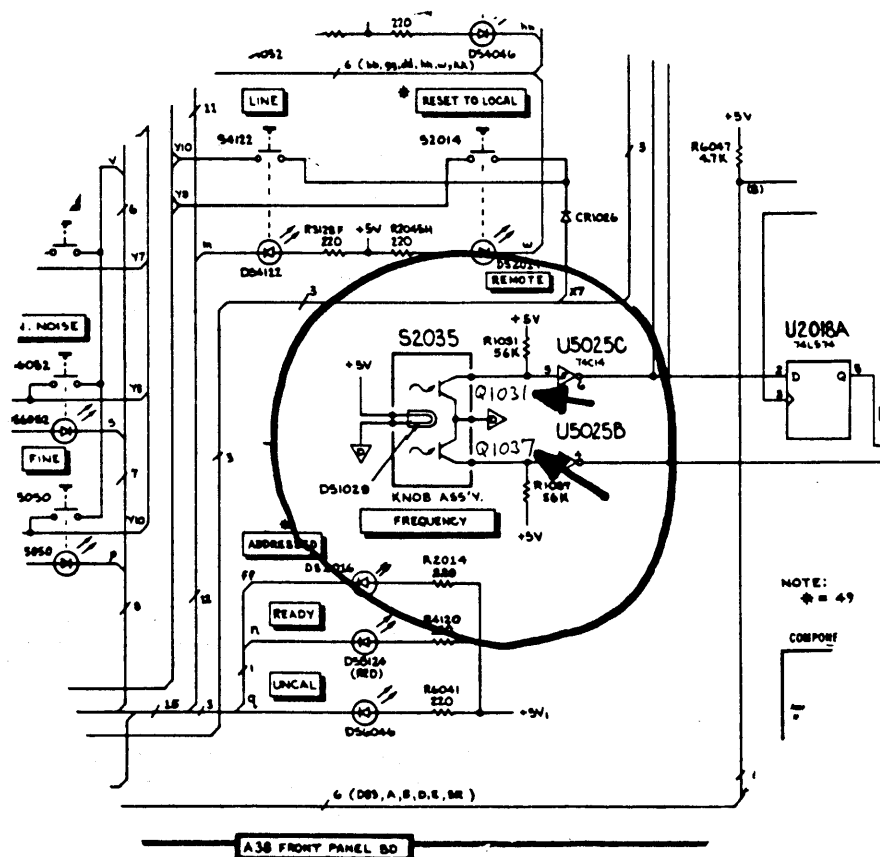
492/P CENTER FREQUENCY KNOB (A38 S2035) REPLACEMENT PARTS

Due to the high replacement cost of (A38 S2035) the Center Frequency Knob for the 492/P, some of the internal parts were made replaceable. Refer to the figure below for the parts list and schematic locations.

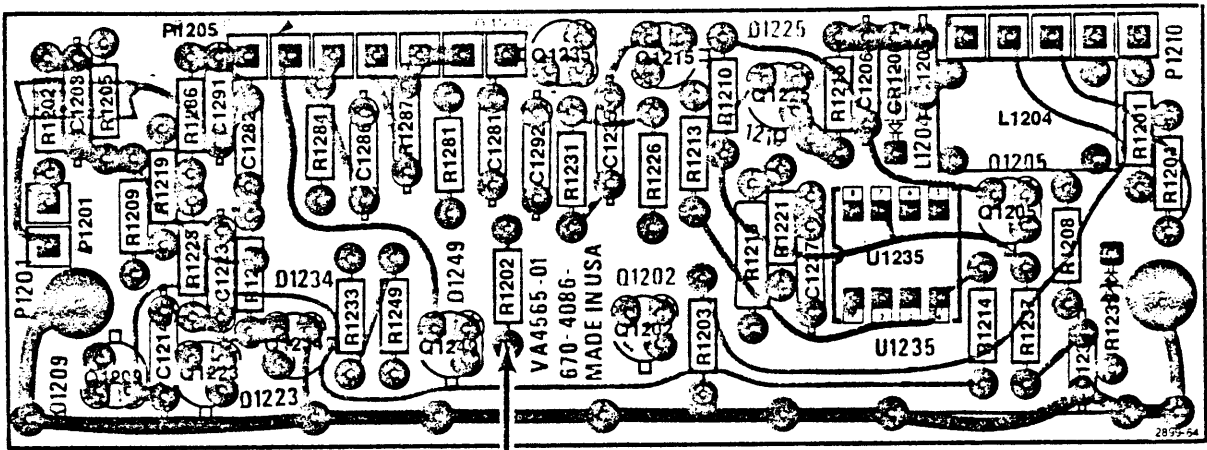
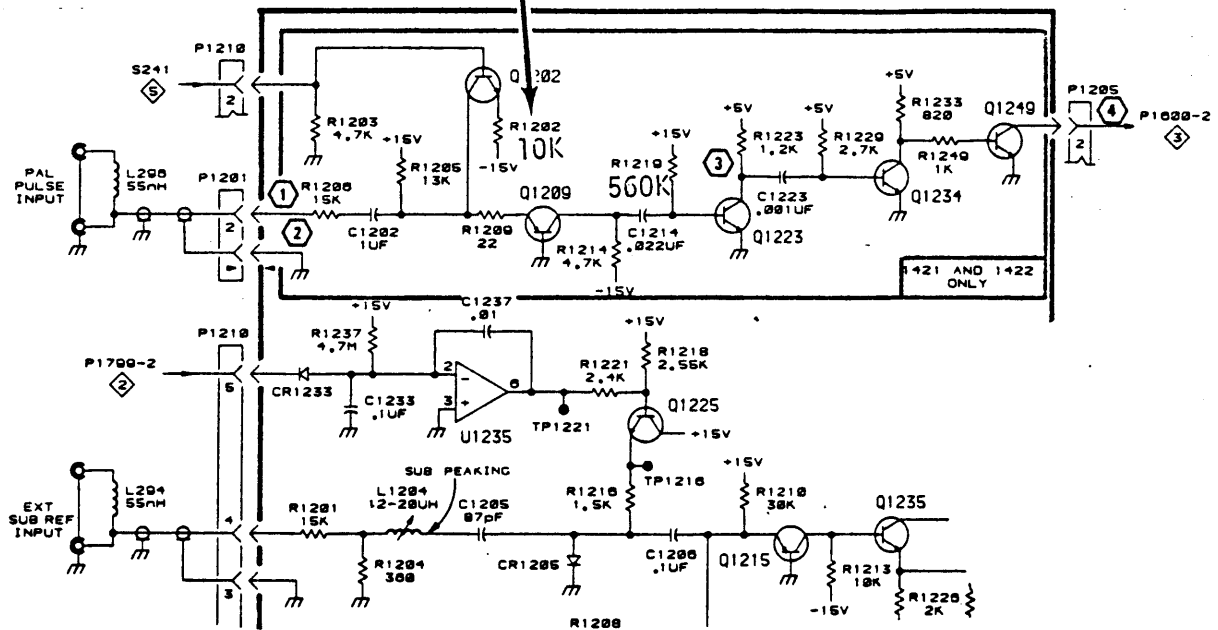
A5 EXT SUB REF BOARD

A few instances have been observed where the External Subcarrier light will not turn completely off when S241 is placed in either NTSC position and the INT/EXT SUB switch is set to the EXT position.

Correct Circuit Number to R1207 315-0622-00 6.2K
315-0103-00 10K

Reference Mod #M42515

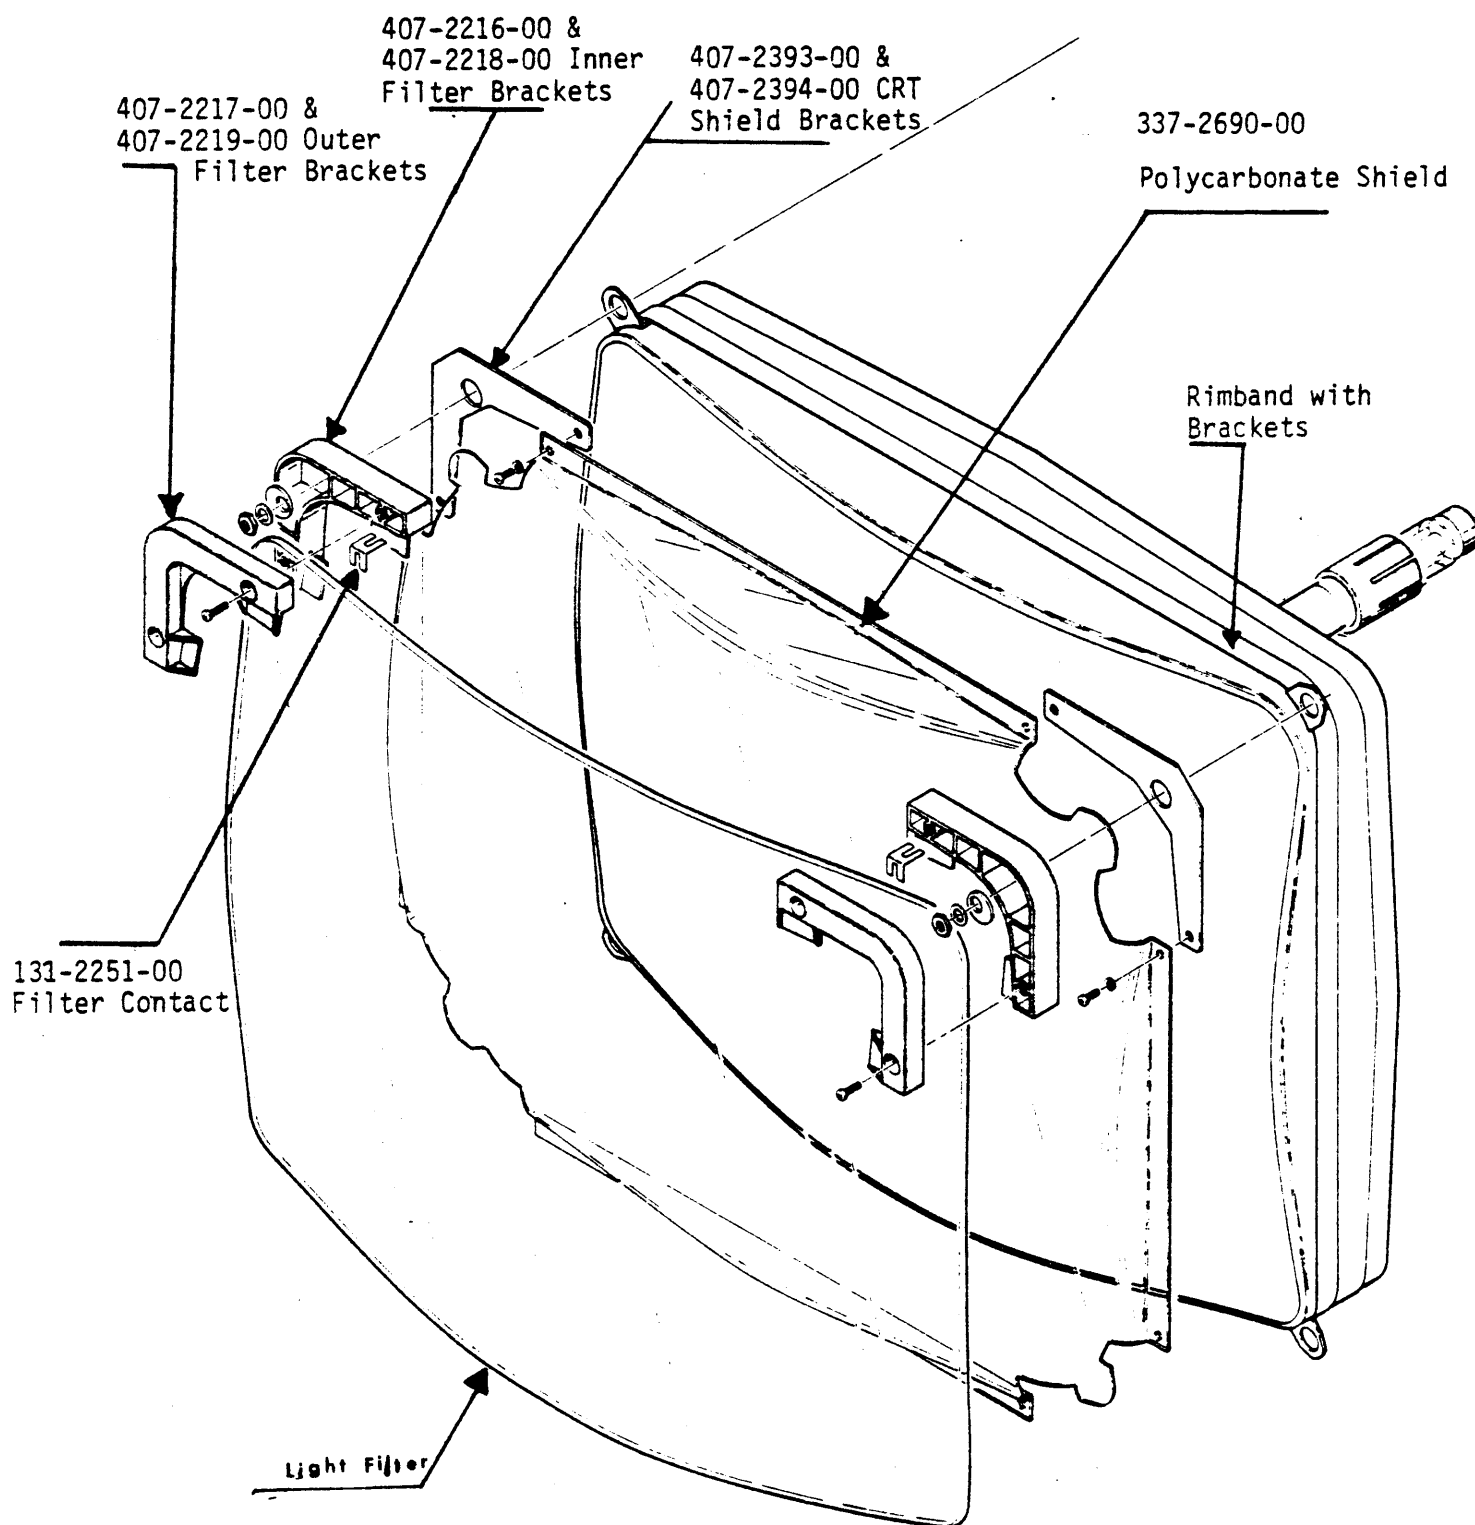
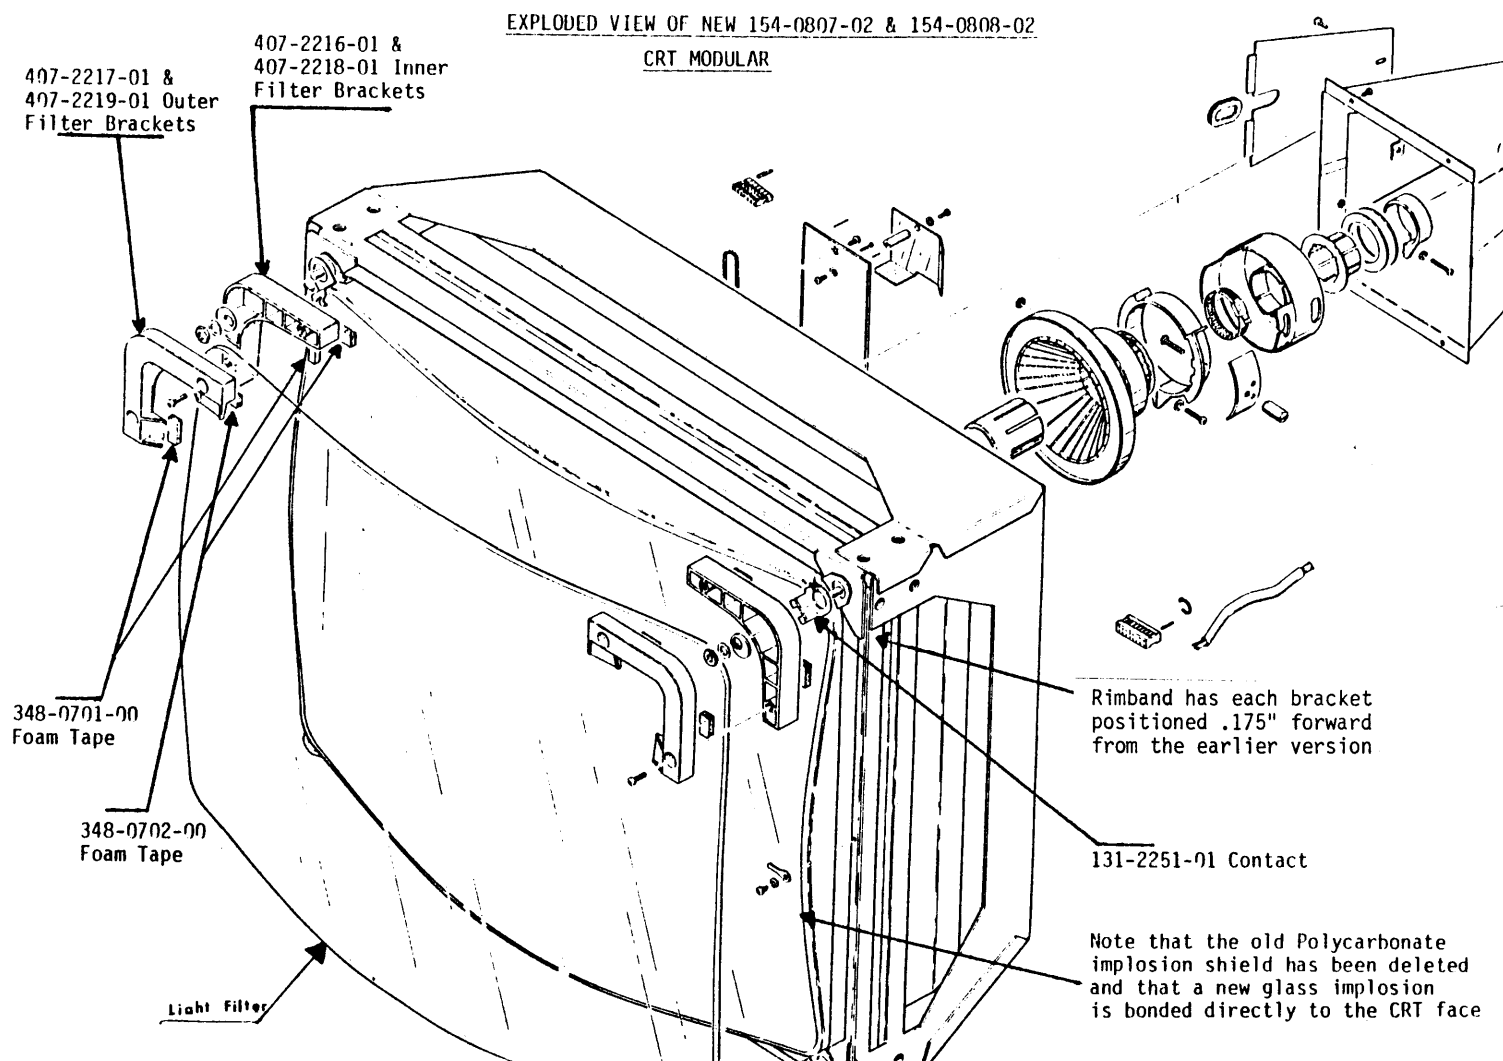
EXPLODED VIEW OF OLD 154-0807-01 & 154-0808-01

Recently all 25 inch CRT products have been modified to replace the polycarbonate implosion shield. The reason for this change is to eliminate distorted light reflections from the CRT face.

With the additional thickness of the bonded glass shield, the CRT had to be moved back $\frac{3}{8}$ of an inch to the rear causing the CRT JEDEC headers to be very close to the mu-metal shield wall. This could cause an electrical shorting problem unless additional space and insulation are provided. Therefore, the mu-metal shield was modified to add dimples to allow for new insulator heads that were designed to insulate the JEDEC headers.

Inner Filter Brackets previously had corner tabs which caused undue stress to crack the corners of the Light Filter. These brackets were redesigned to eliminate the tabs.

One exception to the above: If a product below the Starting Serial Number already has a CRT with the glass implosion shield then replace it with the appropriate 154 number.

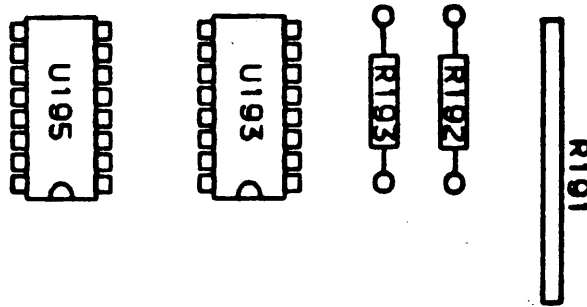
FIGURE 1
Component Locations

Reason: 8202 causes intermittent soft RAM errors.

1. Remove and replace U473 (8202) with an 8202A. See Note 1.
2. Remove U193 (74S74). See Note 1.
3. Insert R192 and R193 (131-0566-00, 0 ohm resistors) as in Figure 1.
4. Roll the 670 from -00 to -02 . Add 672-0950-02 sticker.

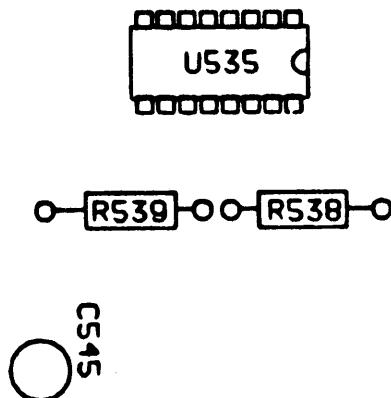
FIGURE 2
Component Locations

Reason: 8202 causes intermittent soft RAM errors.

- A. If U535 does not have a piggyback IC.
 1. Remove and replace U451 (8202) with an 8202A. See Note 1.
 2. Remove U535 (74S74). See Note 1.
 3. Insert R538 and R539 (131-0566-00, 0 ohm resistors) as shown in Figure 2.
 4. Roll 670-6669-00 to 670-6669-02 and skip step B.
- B. If U535 has a piggyback IC.
 1. Remove and replace U451 (8202) with an 8202A. See Note 1.
 2. Remove U535 (74S74) and piggyback (74S04).

3. Insert R538 and R539 (131-0566-00, 0 ohm resistors) as shown in Figure 2.
4. Roll 670-6669-01 to 670-6669-02.

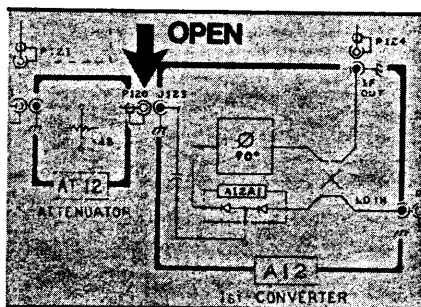
Figure 1. First step details.

Phil Snow, Spectrum Analyzer Engineering, has developed a simple procedure for testing the 492 Spectrum Analyzer input mixer with a Tektronix 576 Curve Tracer. This test is very useful when you suspect that the mixer has been damaged by excessive input power.

The first step in the procedure is to open the connection (P120/J123) between the AT12 attenuator and the A12 first converter (see figure 1). Second, open the connection (P150) between the 4.5 GHz low-

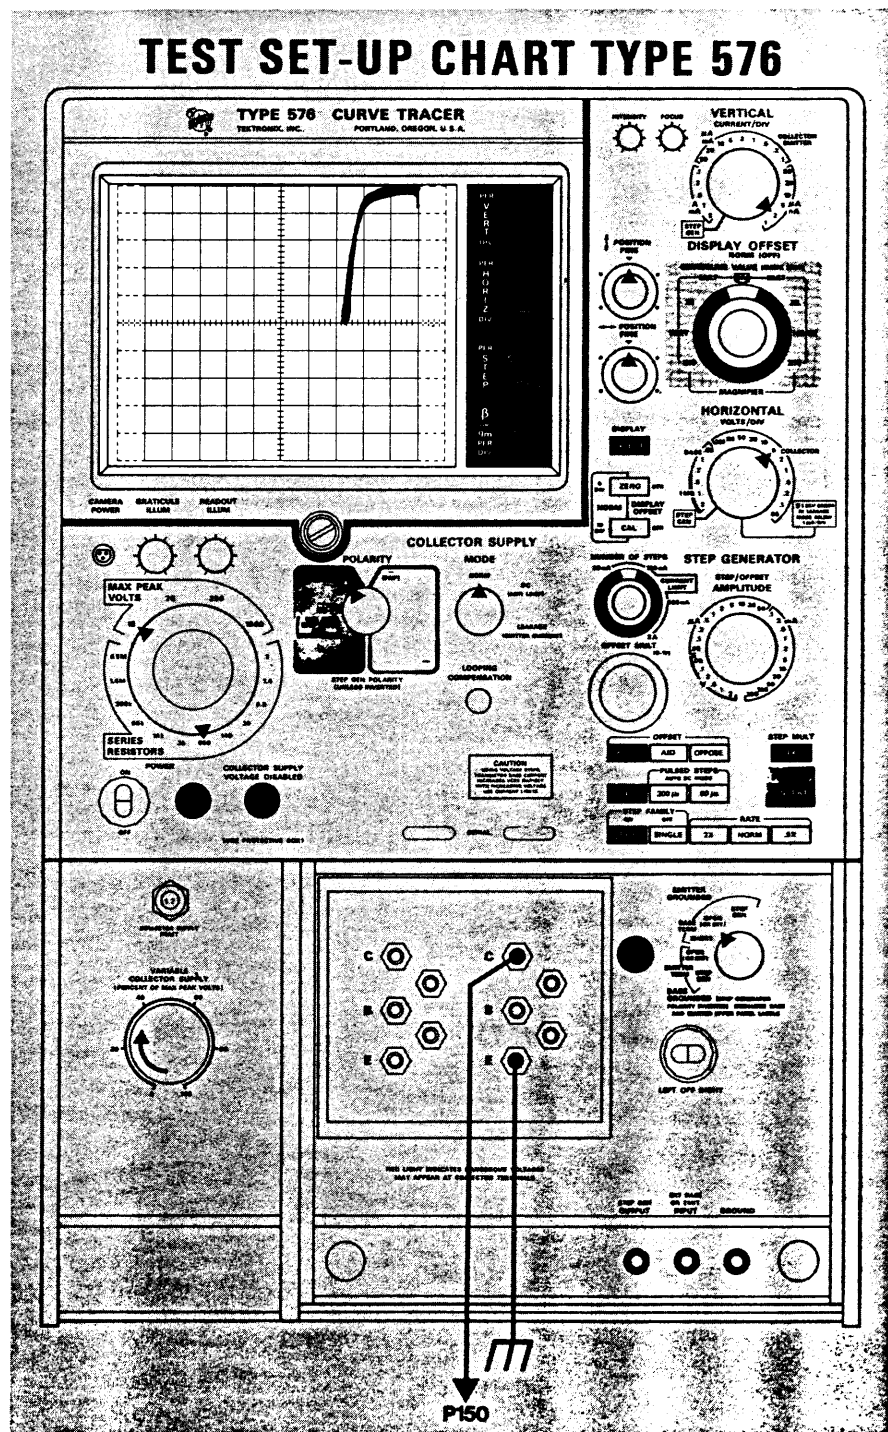
Figure 4. Reverse breakdown test and display.

The complete setup and a typical normal display waveform are shown in figure 4. Reverse breakdown (V_r) should occur at about 10 μ A, and should exceed 8 volts. A lower V_r indicates that at least one of the two diodes is faulty. ■
