COMBINATION EDITION
**Wizards
Workshop**

Published by Service Admin Support

September 11, 1981
Issue 11-17

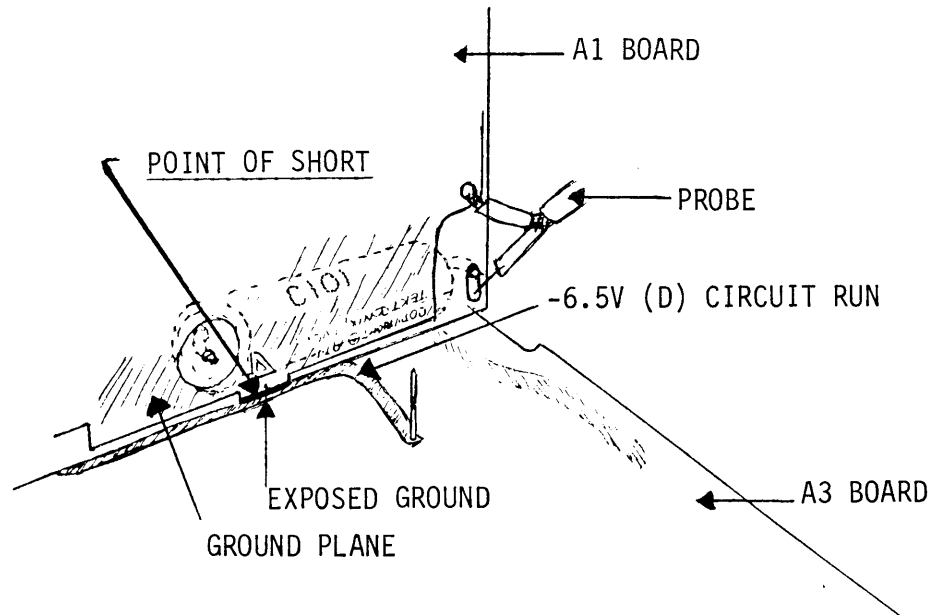
The picture below illustrates where a short can possibly develop in the -6.5v supply. Manufacturing has changed the position of the power supply run to prevent this short from happening at approximately the serial number listed above. On instruments below that number, to protect the run from shorting, use insulation film, P/N 342-0213-01, cut to cover the run and double-sided tape, P/N 006-1342-00, to hold it in place. Apply small pieces of tape so as not to cover runs.

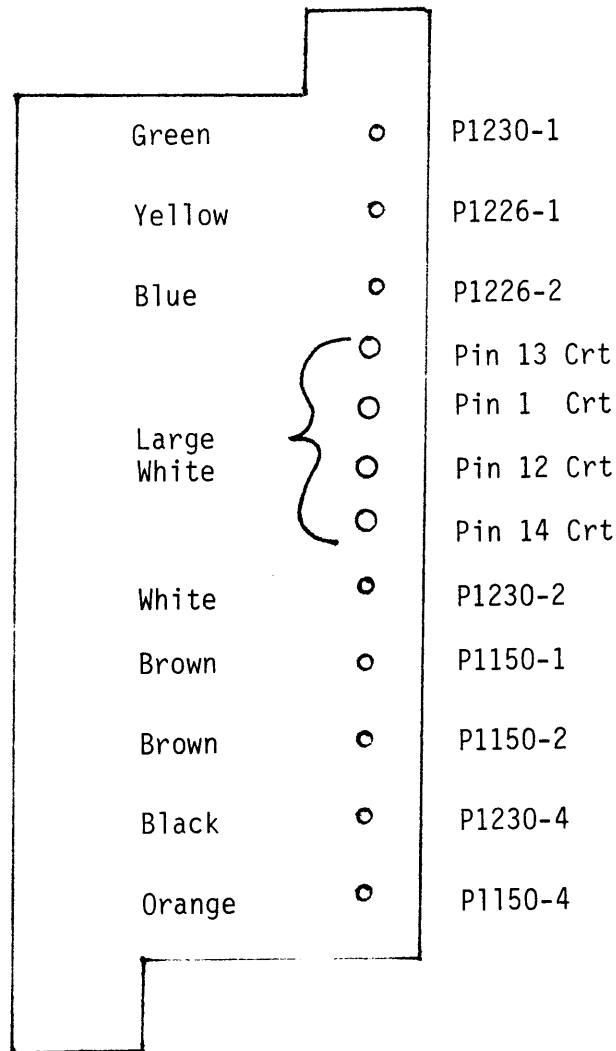
A new vendor for the H.V. module, Murata, does not number it's wires on the module as T.D.K. does. The drawing below shows the color and location of the wires.

The Murata module is black and red, whereas, the T.D.K. module is orange.

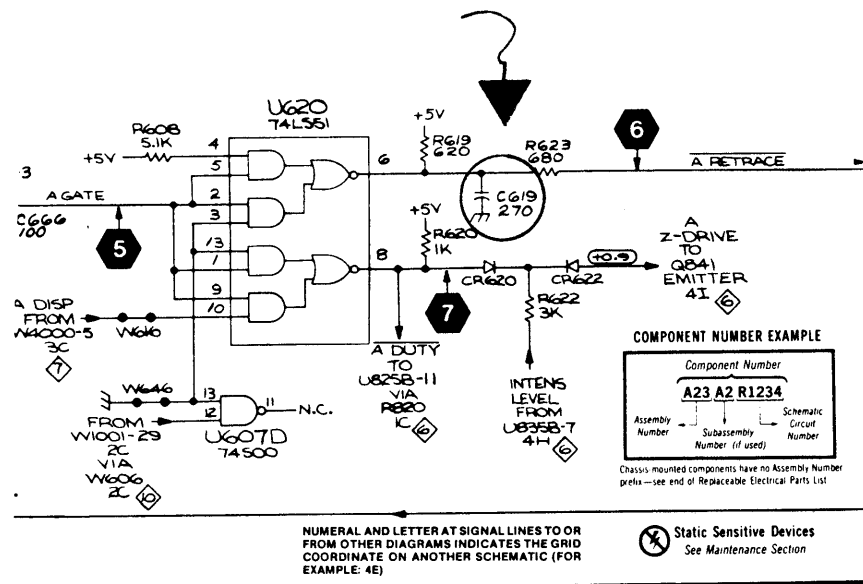
The start of the sweep at 5NS/DIV may be bunched up and nonlinear. By removing A10C619, the point at which the unblanking occurs changes and the nonlinear part of the sweep is no longer displayed.

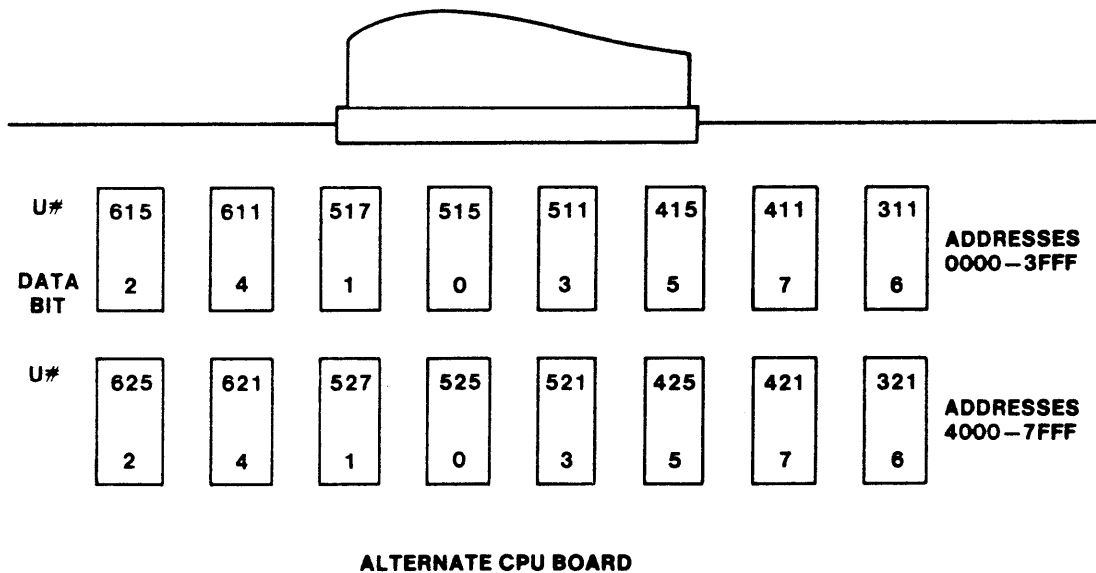
The RAMs that are being used will be 156-0968-02, which are 16Kx1 bit RAMs instead of the 156-0635-00 4Kx1 bit RAM. There will be only two RAM memory configurations for the new CPU boards. The two versions are the standard version which will be 16K bytes and the second will be the 32K bytes (Option 22). For use of the System Test Fixture the address breaks are in Figure 1.
