Wizards Workshop

January 30, 1981
Issue 11-2

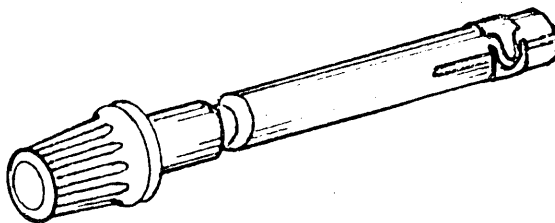
OLD TYPE

If you have instruments with knobs and shafts molded together, with binding problems here is good news.

The shafts have been slightly modified, to correct the binding problem, and are a direct replacement of the old type. Also, the cost is reduced by half.
