Wizards Workshop

TEKTRONIX INTERNAL USE ONLY

March 27, 1981
Issue 11-5

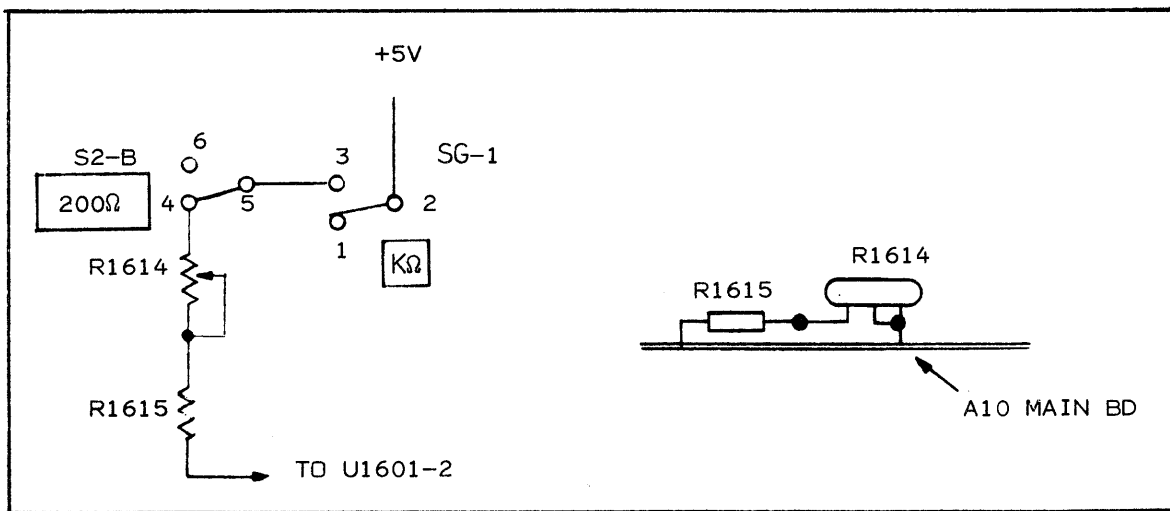
PARTIAL SCHEMATIC

The following modification will help eliminate the problem of zeroing the 200 Ω range in the DM501A.

Change A10R1615 from Part Number 321-0382-00, 93.1K Ω to Part Number 315-0753-00, 75K Ω .

Add A10R1614, Part Number 311-1555-00, a 100K Ω Pot in series with A10R1615 (see attached figure).

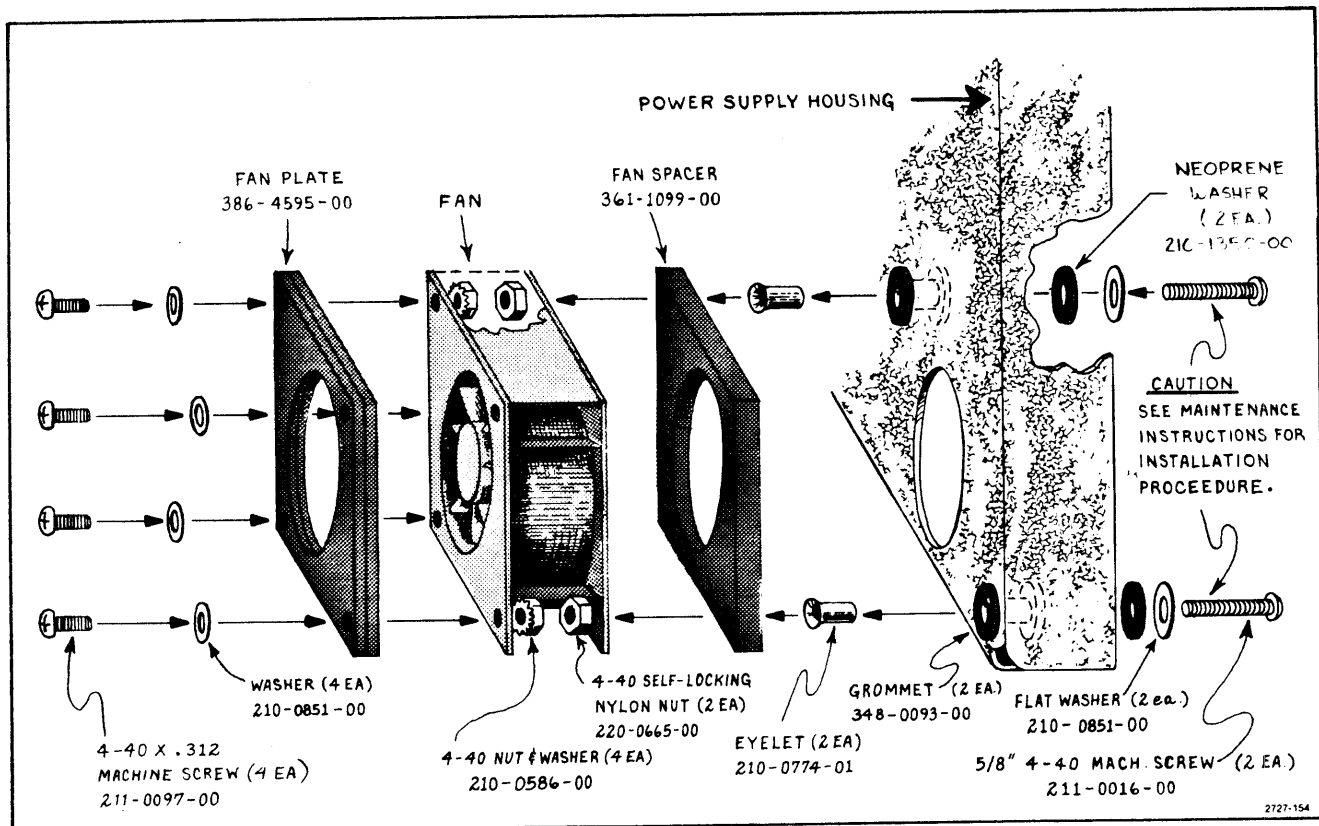
Fig. 4-9. Exploded drawing of fan assembly.

If the noted procedure is not followed and the fan mounting hardware is over-tightened, there is a good possibility that the instrument will experience 100HZ sidebands. This is due to the mechanical vibration caused by the fan on the RF deck.

Instruments SN B010322 and up may have a compliant mounted fan (see Fig. 4-9). It is important that the mounting screws for these fans are not over-tightened.

1. Refer to Fig. 4-9 and replace as follows:
 - a. Place the foam gasket between the fan housing and the power supply module cover.
 - b. Insert the two 5/8 inch machine screws, with washers mounted as shown in Fig. 4-9, through the two eyelets. Place the fan in position then while holding the nylon nut with needle-nose pliers, screw the mounting screws into the nut until the end of the screw is just flush with the nut. The nylon nuts are self locking.

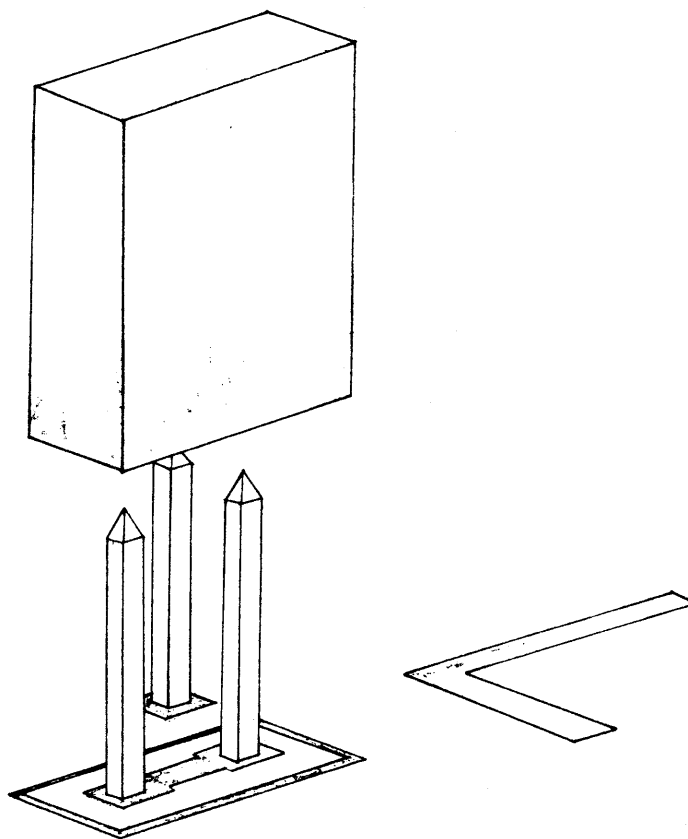
Figure 2 Location of strap L for "out" position.

Table 1 gives the strap configuration of both old and new boards for 4907 operation. Note that the strap L option is not on the new board. On the old board a strap with a covered top should be used on the L pins to prevent them from shorting to the cabinet rails. The two pins that should be strapped are enclosed in a white square painted on the board. Do not connect the strap to the third pin which has the run connecting to C12 on the component side of the board. See figure 2.

Do not strap to the **IN** position on any instrument. Note: Trace between two strapped pins. A strap with a covered top should be used to prevent any possible shorting to the chassis.
