COMBINATION EDITION

Wizards Workshop

June 19, 1981 Issue 11-11

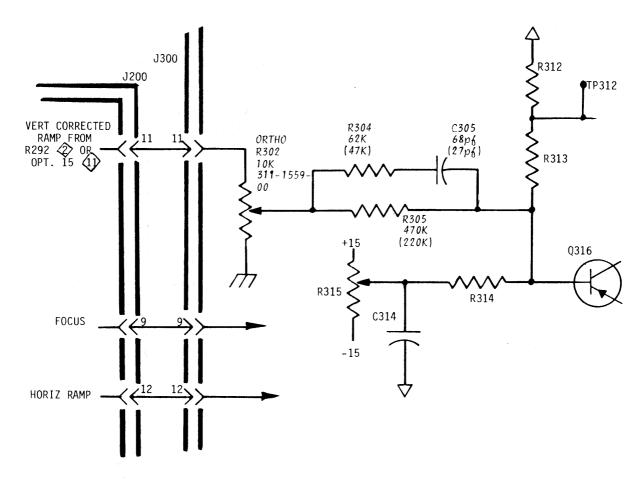
FIGURE 1

A number of changes have been made to the 634 yoke driver boards to improve reliability and performance. The new part numbers of the boards are 670-5594-03 for the standard product and 670-6122-02 for the 634 Option 15.

To improve geometry, an ORTHOGONALITY adjustment is added to both boards. However, the values of the added components differ between the two boards. Refer to Figure 1 for the values of the new parts. Those values in parentheses are for the Option 15 board. The new ORTHO control is best adjusted after step D5.h of the manual calibration procedure; that is, after the horizontal linearity adjustment.

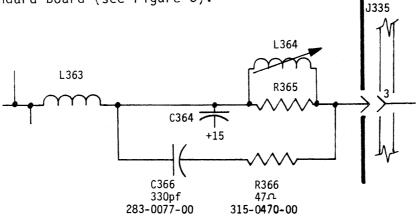
FIGURE 3

Several other changes are made to the standard yoke driver board. Resistor R380 is reduced in value and R386 is increased (see Table I). These values are changed to prevent an overcurrent condition. Resistor R352 is changed to an Allen-Bradley type component to prevent board damage in the event of an overcurrent failure. Capacitor C324 is changed from P.N. 283-0204-00 to 283-0003-00 to provide commonality between the standard and Option 15 boards. The damping network previously used on the Option 15 is now added to the standard board (see Figure 3).

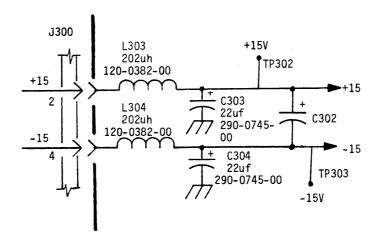
The 634 Option 20 was known to transmit noise and horizontal line rate interference down the customers' power supply lines. To correct this, filtering was necessary on the $\pm 15V$ and $\pm 15V$ supply inputs.

Modification 39769 solved the problem by establishing the 670-7004-00 yoke driver circuit board assembly. This board is identical to the standard 670-5594-02 except that line filtering is effected by the addition of two toroidal coils and two electrolytic capacitors.

This modification has been superseded by corporate modification #36631 (written up elsewhere in this issue). This article is for your information, only.

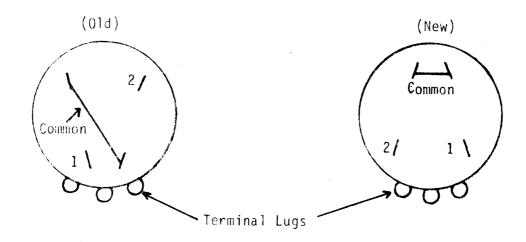
311-1941-00 Bottom View

The vendor for the threshold switch, Part Number 311-1941-00, found it necessary to invert the switch's body. All electrical functions remained the same, but there were some alterations made to the pin configuration which will affect the wiring. However, the part number remained the same for both versions.

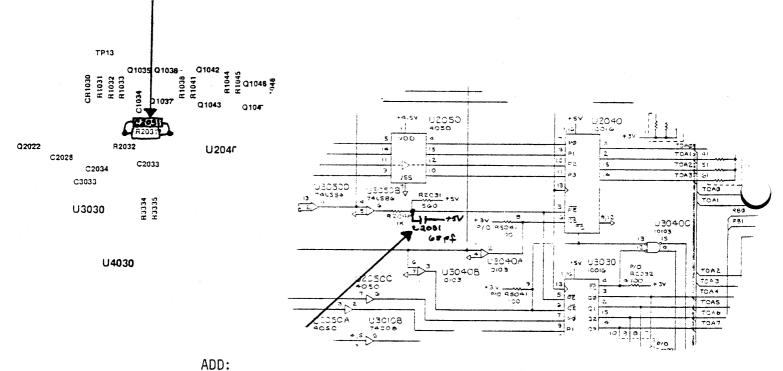
Some 7D02 Option 1s (Serial Number B021200 and below) will intermittently fail the timing option Test 3 during their power up diagnostics. This is due to bus noise and hardware race conditions.

C2031
281-0785-00 AS INDICATED BY ARROWS.

To remedy this problem, mod number M43199 was implemented which places a 68 pf capacitor (Part Number 281-0785-00) in parallel with R2031 on the A02 I.C. aquisition board.

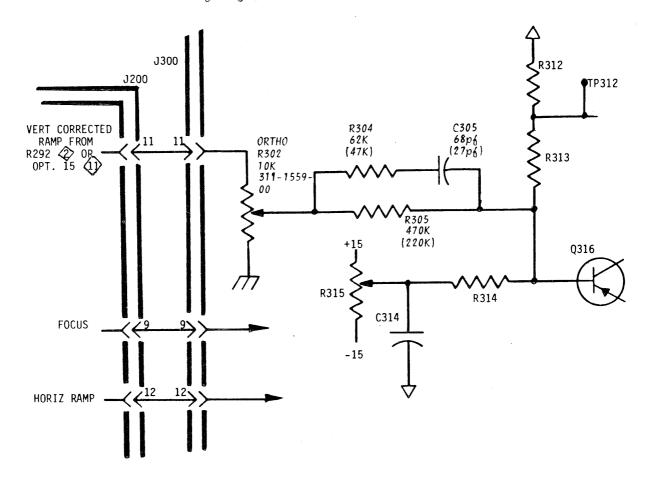
FIGURE 1'

A number of changes have been made to the 634 yoke driver boards to improve reliability and performance. The new part numbers of the boards are 670-5594-03 for the standard product and 670-6122-02 for the 634 Option 15.

To improve geometry, an ORTHOGONALITY adjustment is added to both boards. However, the values of the added components differ between the two boards. Refer to Figure 1 for the values of the new parts. Those values in parentheses are for the Option 15 board. The new ORTHO control is best adjusted after step D5.h of the manual calibration procedure; that is, after the horizontal linearity adjustment.

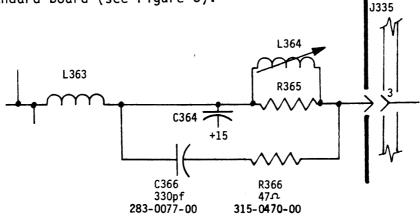
FIGURE 3

Several other changes are made to the standard yoke driver board. Resistor R380 is reduced in value and R386 is increased (see Table I). These values are changed to prevent an overcurrent condition. Resistor R352 is changed to an Allen-Bradley type component to prevent board damage in the event of an overcurrent failure. Capacitor C324 is changed from P.N. 283-0204-00 to 283-0003-00 to provide commonality between the standard and Option 15 boards. The damping network previously used on the Option 15 is now added to the standard board (see Figure 3).

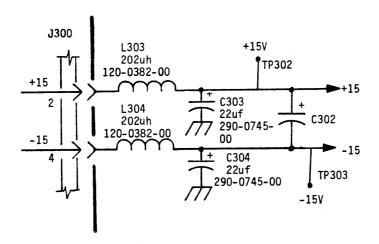
The 634 Option 20 was known to transmit noise and horizontal line rate interference down the customers' power supply lines. To correct this, filtering was necessary on the +15V and -15V supply inputs.

Modification 39769 solved the problem by establishing the 670-7004-00 yoke driver circuit board assembly. This board is identical to the standard 670-5594-02 except that line filtering is effected by the addition of two toroidal coils and two electrolytic capacitors.

This modification has been superseded by corporate modification #36631 (written up elsewhere in this issue). This article is for your information, only.

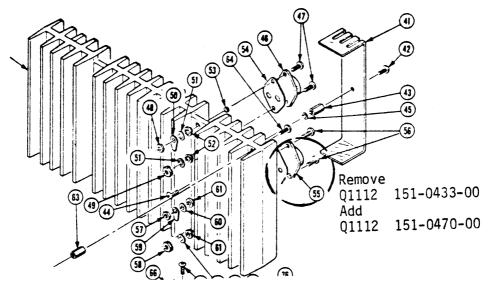
Service records have indicated excessive failures of Q1112 in the 4023 Power Supply. The Mod to the 4023 Power Supply changes Q1112 to a more reliable part.

Replace Q1112 on the chassi, P/N 151-0433-00, with transistor, P/N 151-0470-00.

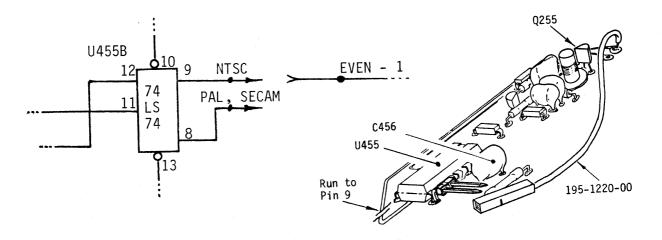
To accomodate either set of standards, the following modification may be made to the video interface board:

- Cut the run leading to U455 pin 9 close to the body of the I.C.
- Solder two pins of a right-angle 36 square pin connector (P/N 131-1426-00) onto pins 8 and 9 of U455. If necessary, reposition C456 to accommodate the pins.
- Solder a one-connector jumper (P/N 195-1220-00) onto the severed run at the through hole above Q255.
- Position the jumper on pin 9 for an NTSC system or pin 8 for a PAL or SECAM system.

Installation of this modification rolls the level of the 670-6297-01 video interface board to -02. This mod should be installed whenever an early 4612 is interfaced with a PAL or SECAM source.

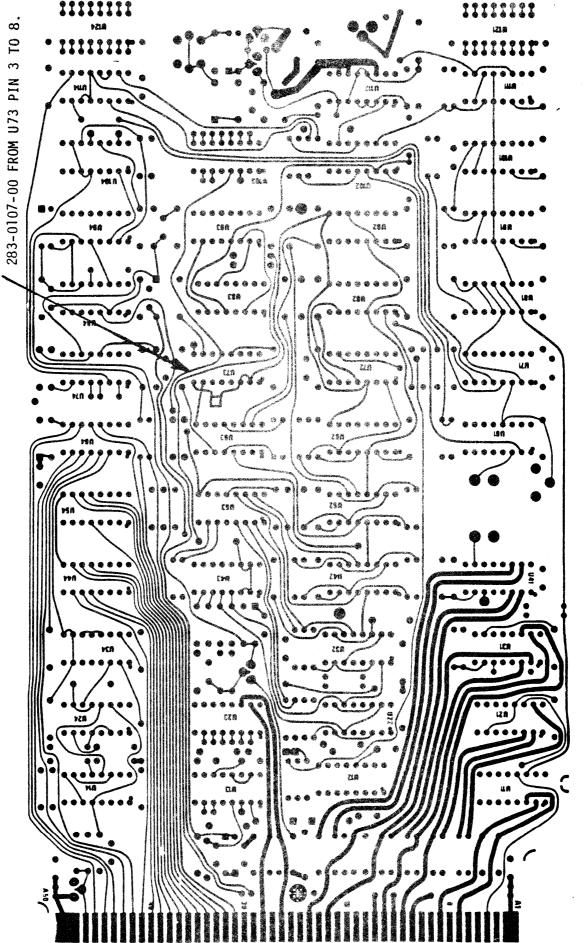
ASSEMBLY 670-5383-04 CYCLE LENGTH CIRCUIT BOARD

Cycle length counter bits may toggle prematurely due to a negative glitch in the "Inhibit" signal. This premature count may cause cycle length errors. The signal is enhanced by adding a 51pf, 5% 200V capacitor (283-0107-00). Component designation will be C173. Connect C173 from U73 pin 3 to pin 8. The leads of the capacitor should be insulated with sleeving (162-0581-00). Add the capacitor on the back of the board as shown in the diagram. The assembly number of the cycle length card will change from 670-5383-03 to 670-5383-04.

ADD C173 51PF 5% 200V
