WIZARDS WORKSHOP

TEKTRONIX INTERNAL USE ONLY

TABLE OF CONTENTS

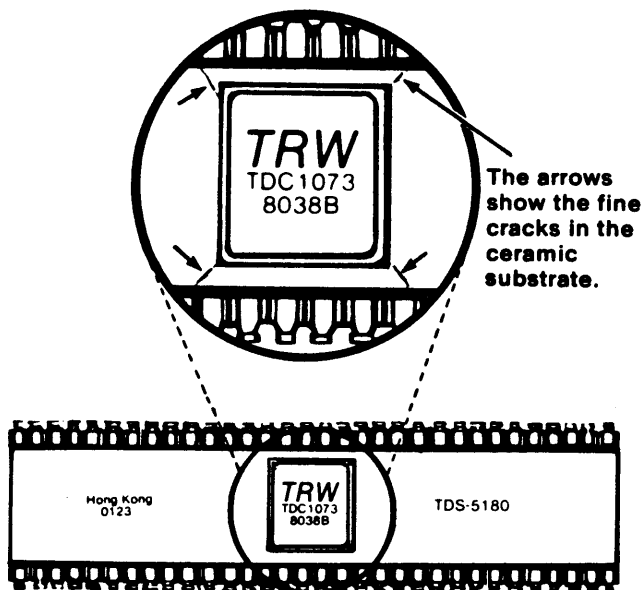
These parts are housed in 64-pin ceramic dual in-line packages. Analysis revealed that the failure mechanism was micro-cracks in the package which caused non-uniform stresses on the chip within the package (see illustration below). The cracks in the packages are undetectable without special equipment, such as a low-power microscope with side lighting, dye-penetrant detection or a method using Fluorinert FC77 in a vapor generator.

The cracks appear to be caused by an uneven stress (end-to-end) on the package while it is being inserted into or removed from a socket. The uneven pressure will cause the package to flex beyond

its structural limitations. This excessive flexing develops cracks which radiate from the cavity corner outwards.

This problem can be minimized (or eliminated) by using special care when inserting or removing large ceramic packages, and by following these instructions:

Inserting: Apply even pressure across the whole package (not one end first) during insertion. Pushing with the palm of your hand, or using a block of wood or plastic will provide the uniformity required to insert the package into the socket.

Removing: To remove these packages, avoid putting any leverage tool under one end and prying up. Instead, use a long letter opener which can be slipped between the part and socket. Do not use a screwdriver to accomplish this. Slide the letter opener to one side of the package pins, then rotate or twist the opener. This will cause one side of the package to be lifted, and the other side can then be lifted in the same way.

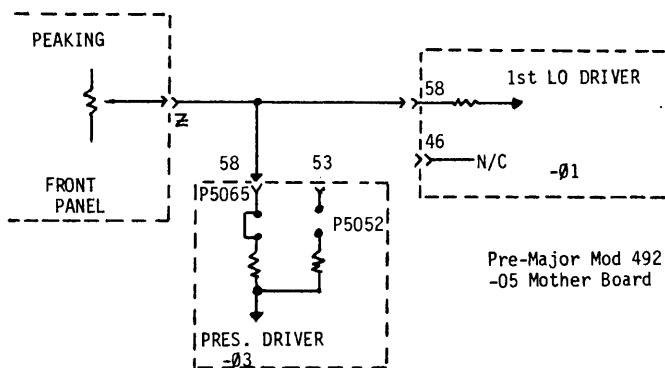
Pre-Major Mod 492
-05 Mother Board

with the jumper on either plug since there is an extra run in the -06 Mother Board between Pins 58 on the LO Driver, and Preselector Driver (see accompanying schematic). Connect the jumpers as in #1 above.

If the jumpers are incorrect on a 492/P, the Peaking control will be useable, but the Programmable Peaking will not work.

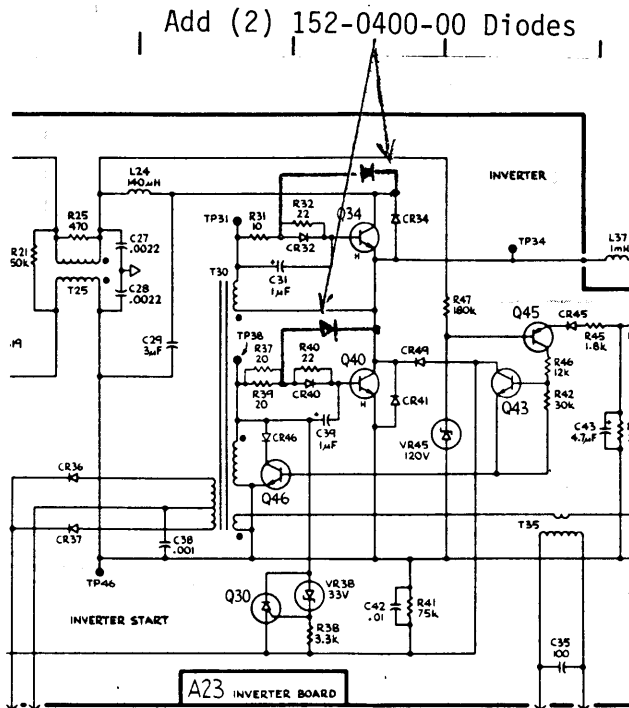
In the above mentioned issue the schematic shows CR33 connected to R47. It should be connected to the collector of Q34 as shown below.
