INTRODUCTION

SCAN EXPANSION

REJECT CODES

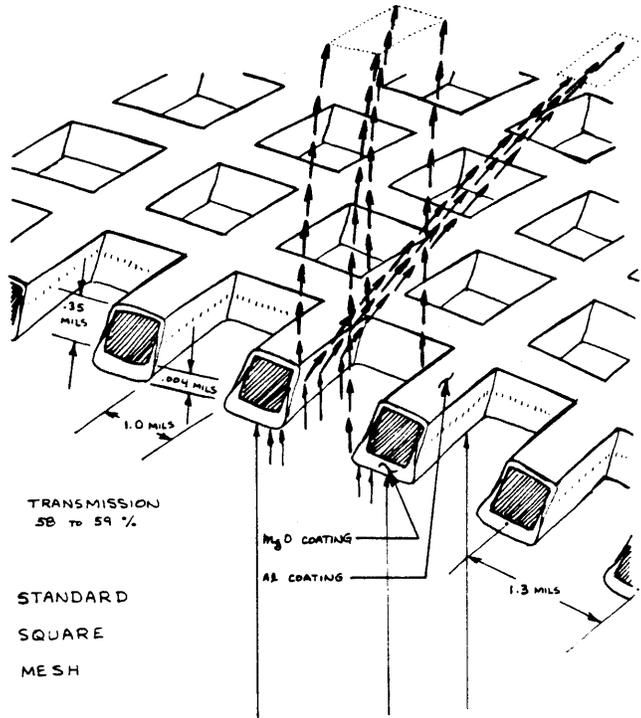
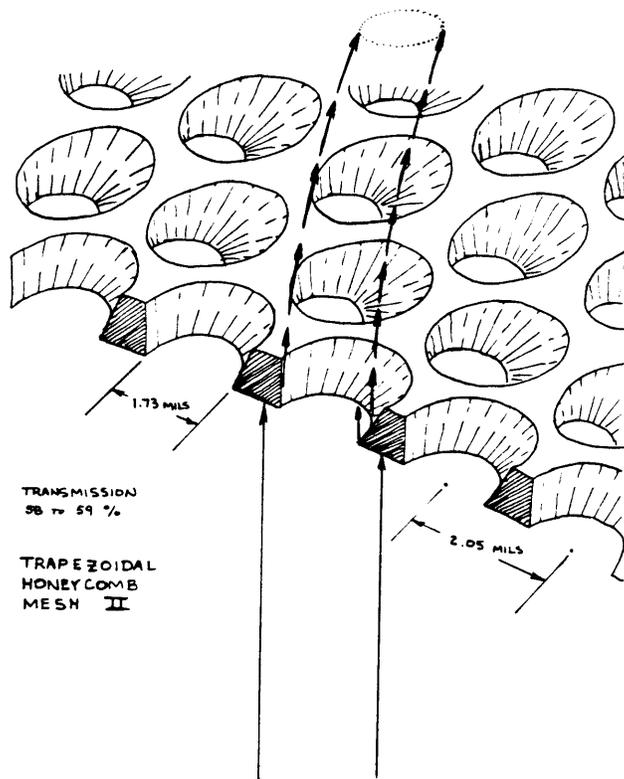
HALO SUPPRESSION

2. mild halo caused by mesh thicknesses being too thick. This produces increased area not protected by MgO. A cross-section of the mesh wire sometimes shows a "nailhead" where the nickel buildup exceed the photoresist. This increased exposed area allows more electrons to bounce off producing more halo.

3. mild halo caused by a thin coating of MgO. This does not give good coverage on the sides of the wires.
4. mild halo caused by a thick coating of aluminum. This covers more of the MgO coating on the sides of the wires.

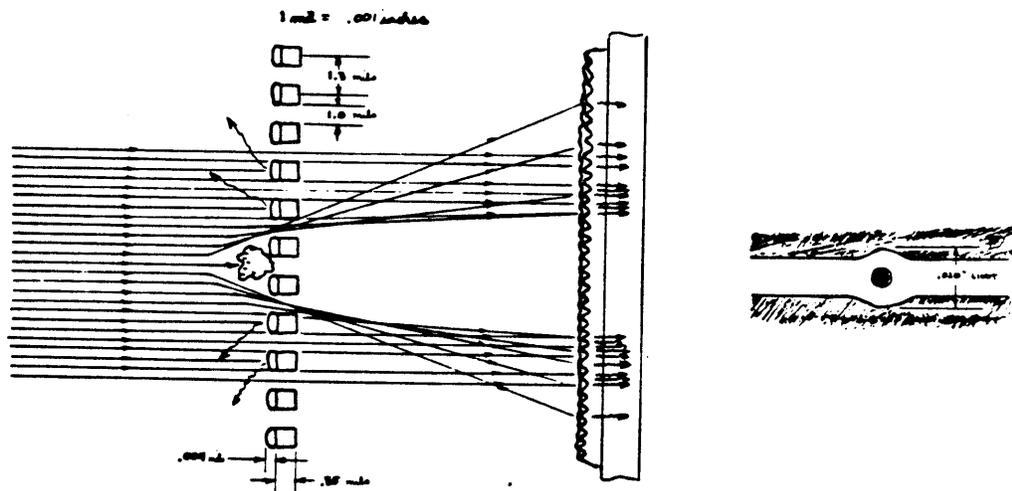
Mesh burr is defined as any type of foreign material causing out of specification reflections, defocus, or flaring of the trace. The effect of a mesh burr can best be described with the aid of the illustration below. The electron hits the contaminate and is adsorbed. These electrons cause the particle to charge. This charging then causes the electrons coming close to the particle to change their direction. These changes in direction of some electrons produce the effects seen on the screen. If the particle is on the MgO coating, the particle will charge more and have a greater effect on the screen. Some of the electrons hitting a particle will bounce off producing reflections.

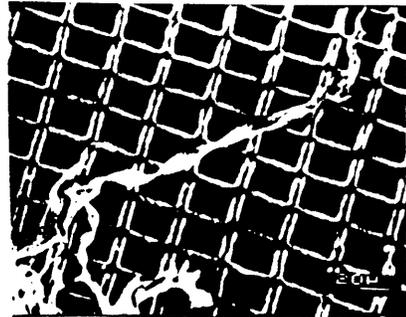
2. Clean room paper fiber was unknown for a long time. After identification, it was established that rework notes were being punched onto the snubber springs. This tearing released fibers.

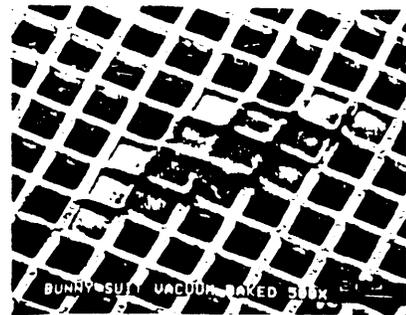
3. Polyester fiber typically melt down as shown but some will show part of a round fiber. This fiber has been traced to "greenies" and bunny suits.

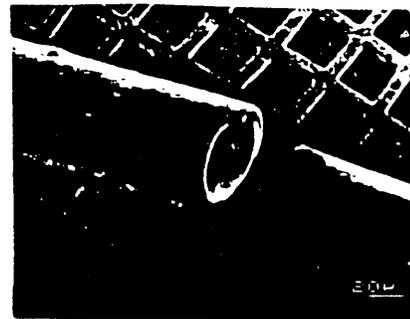
4. Hair is a fiber which was suspected but it has not been found in scrap tubes.

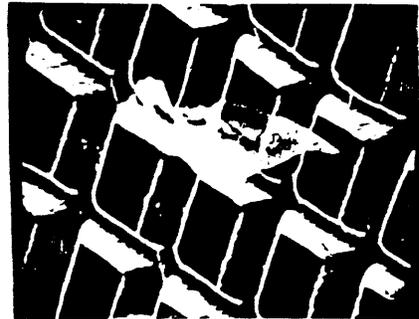
1. Aluminum flake from the screen. The final proof came when phosphor was also found on the flake. Much of the flaking is occurring around the edge of the screen.

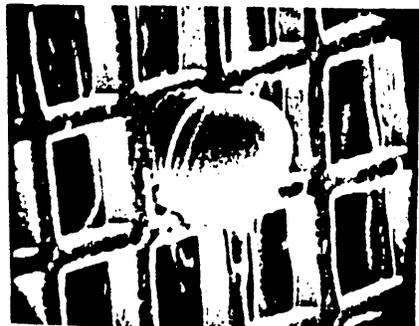
2. Metal ball causing reflections. One metal was aluminum. It comes from the evaporation of aluminum onto the mesh. The second metal was stainless steel coming from laser rework splashing stainless onto the mesh.

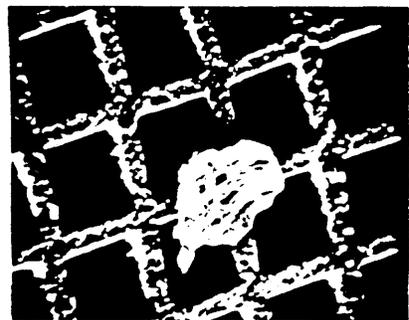
3. Shiny particle causing star pattern spot. It has been identified as being stainless steel. But the source is not known.

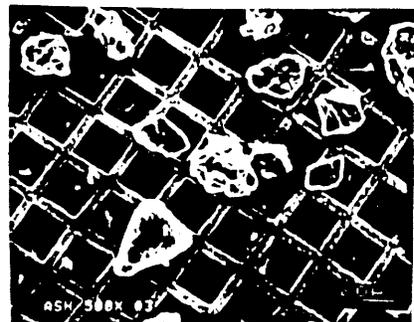
4. One particle which has not been found in scrap tubes is volcanic ash. If it were to be present, it is expected to produce a bright spot because ash is glass.

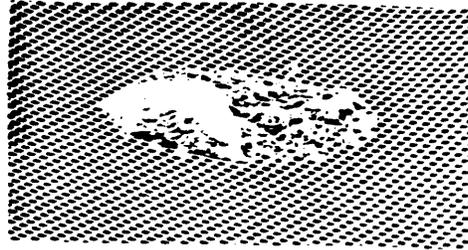
MgO SPOT

This is a gross blockage of the mesh by a film of MgO. Early spots were identified as being caused by spit from people talking over the mesh. Later spots were found forming after sealing. Moisture dissolves the MgO, redistributes it, and dries out during pumping.
