GRID CURRENT BALANCE CIRCUITRY
REMOVED AND INPUT SELECTOR
SWITCHES CHANGED TO REDUCE INPUT
HOOK AND TRACE SHIFT RESPECTIVELY

M9709

Type 10A1 Plug-in Unit

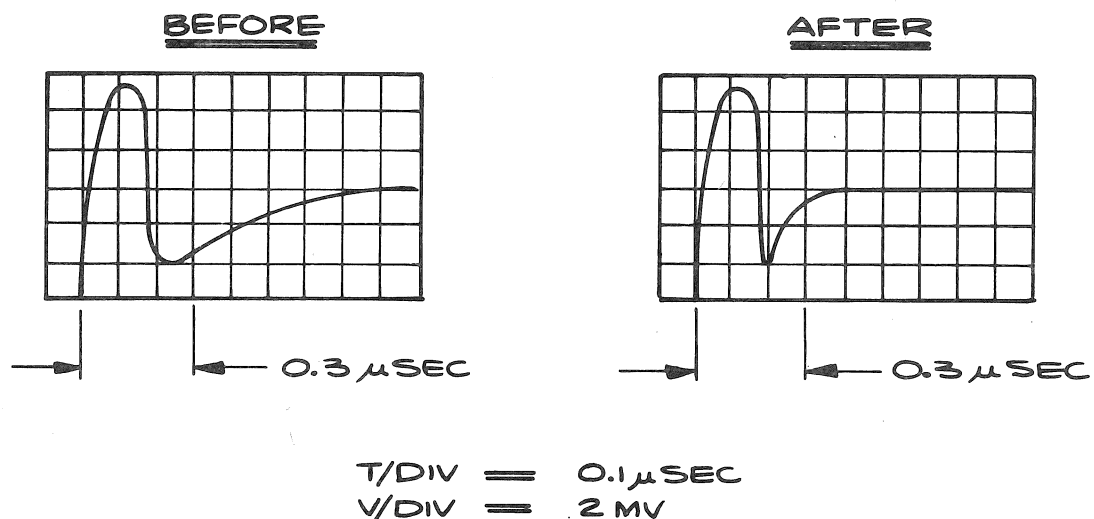
PROBLEM: Test found it necessary to select Q153 and Q353 to meet the overload recovery test limit. The recovery time after differential offset must be less than $0.3\mu\text{s}$ for a return to within $\pm 2\text{mV}$.

Replace Q153 and Q353 with 151-0199-00 transistors.

NOTE: If Q153 is replaced, then Q353 must also be replaced and vice versa.

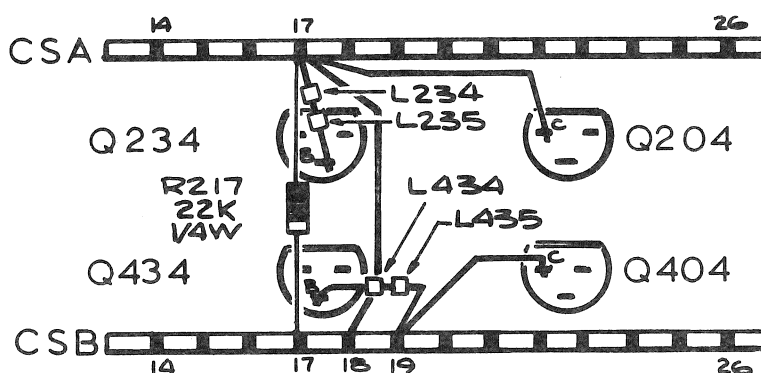
INPUT AMPLIFIER 10A1 (PARTIAL)

FRONT PANEL SYMPTOM: 200 MHz oscillations in limited bandwidth mode usually with
10A1 in RM647, sometimes in 647.

PROBLEM: 20 MHz oscillation in operational amplifiers Q204, Q404, Q234 and Q434.

- a) Remove R217 (22k 1/4 W 5%) between base pin of Q234 and CSB-17.
- b) Replace the #22 bare wire between base pin of Q234 and collector pin of Q204 with a new wire, between CSA-17 and collector pin of Q204.
- c) Replace the #22 bare wire, between collector pin Q404 and base pin Q434, with a new wire, between collector pin Q404 and CSB-19.
- d) Remove the #22 bare wire, between base pin of Q234 and CSB-18.
- e) Solder a #22 bare wire to base pin of Q234. Add ferramic cores L234 and L235 to the wire, soldering the free end to CSA-17.

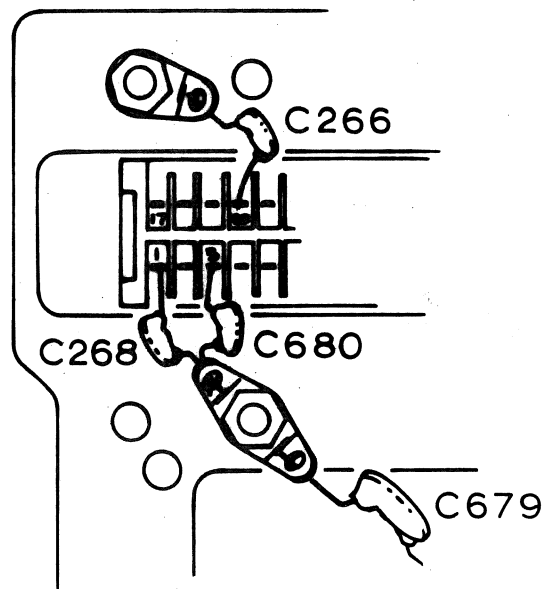
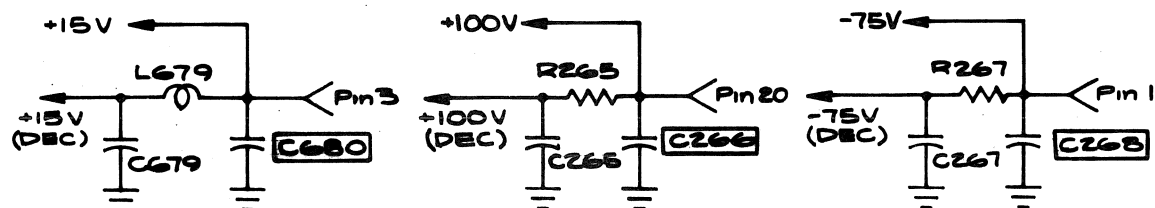
Additional power supply decoupling is provided by this modification to reduce the amount of sweep start transients being coupled into the vertical circuitry. These transients can cause objectionable vertical aberrations to appear on the trace, particularly at 1 mV/CM vertical sensitivity and fast sweep speeds.

- 1) Unsolder the lead of C679 going to ground solder lug near pin 1 of the amphenol connector.
- 2) Remove the ground solder lug and relocate it near pin 17 of the amphenol connector, as shown in the illustration.
- 3) Install a double-end ground solder lug (210-0204-00) in the location shown in the illustration, using a 6-32 x 1/4 PHS screw and a 6-32 x 5/16 Keps nut.
- 4) Install C266, C268, C680, and the lead of C679 removed in step 1, as indicated in the illustration.
