SERVICETEKNOTES

TABLE OF CONTENTS

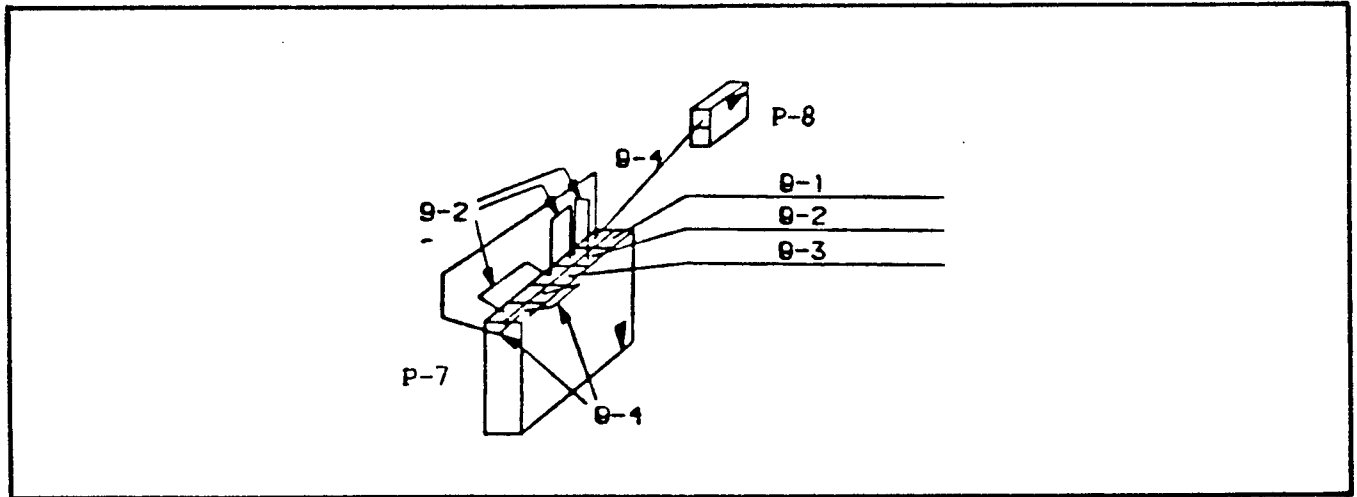
Figure 1a.
Wire Harness for 118-0358-01, -02 and 118-1004-01

The wire harness shown in Figure 1a is currently used for both versions of the non-LSI boards. Following is the procedure for connection of this wire harness.

- 1) Place P-7 of this wire harness (shown in Figure 1a) on the board so connector pins 1 through 5 go over the square pins which connect to edge connector pins 2 through 10.
- 2) Place P-8 of the wire harness on pin set D of the board so the wire of P-8 is connected to the square pin which is toward the inside of the board.
- 3) Solder the 9-1 wire to the through hole connections to pin 3 of IC 2F.
- 4) Solder the 9-2 wire to the middle square pin of the NP/WP pin set.
- 5) Solder the 9-3 wire to the through hole located between ICs 3C and 3D (see Figure 4).

- 1) Place P-7 of the wire harness (shown in Figure 1a) on the board so connector pins 1 through 5 go over the square pins as shown in Figure 5.
- 2) Place P-8 of the wire harness on pin set D of the board so the wire of P-8 is connected to the square pin which is toward the inside of the board.
- 3) Solder the 9-1 wire to the through hole connecting to pin 13 of IC 4B.
- 4) Solder the 9-2 wire to the WP square pin of the WP/NP pin set.
