Wizards Workshop

Published by Service Admin Support
56-037 Ext. 8939 Merlo

September 19, 1980
Issue 10-19

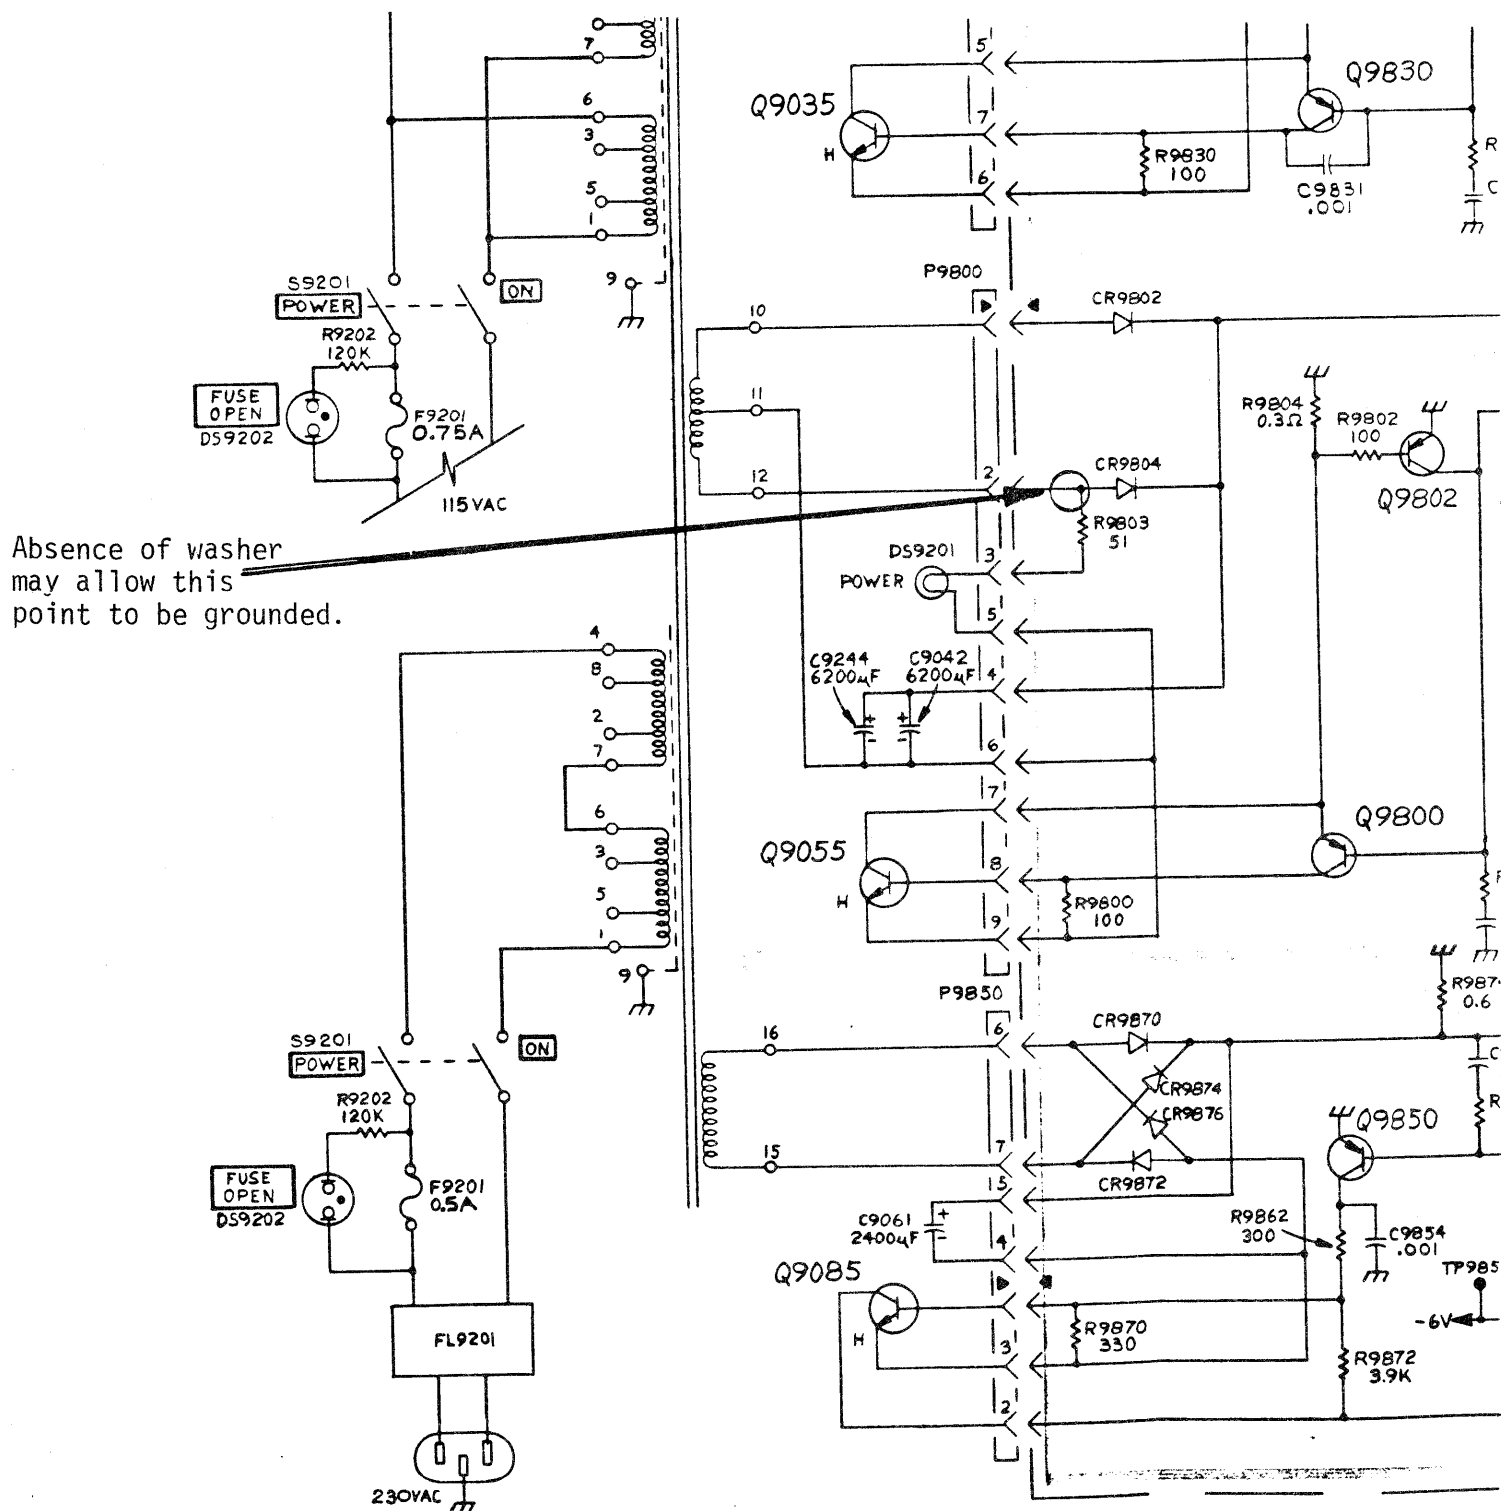
1430, 1440, 1441, 1460, 1461 - MISSING WASHER ON POWER SUPPLY BOARD
PART NUMBER CORRECTION (CONTINUED)

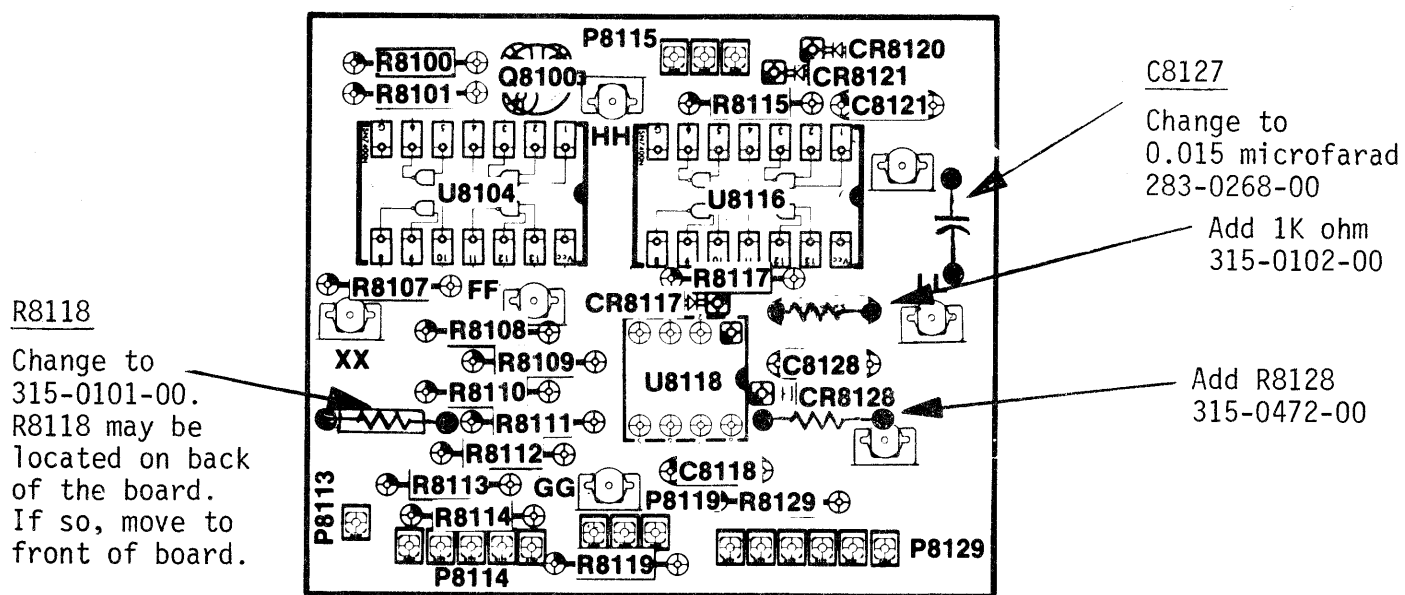
A16 SECAM FIELD RECOGNITION

1481/1485 OPTION 8

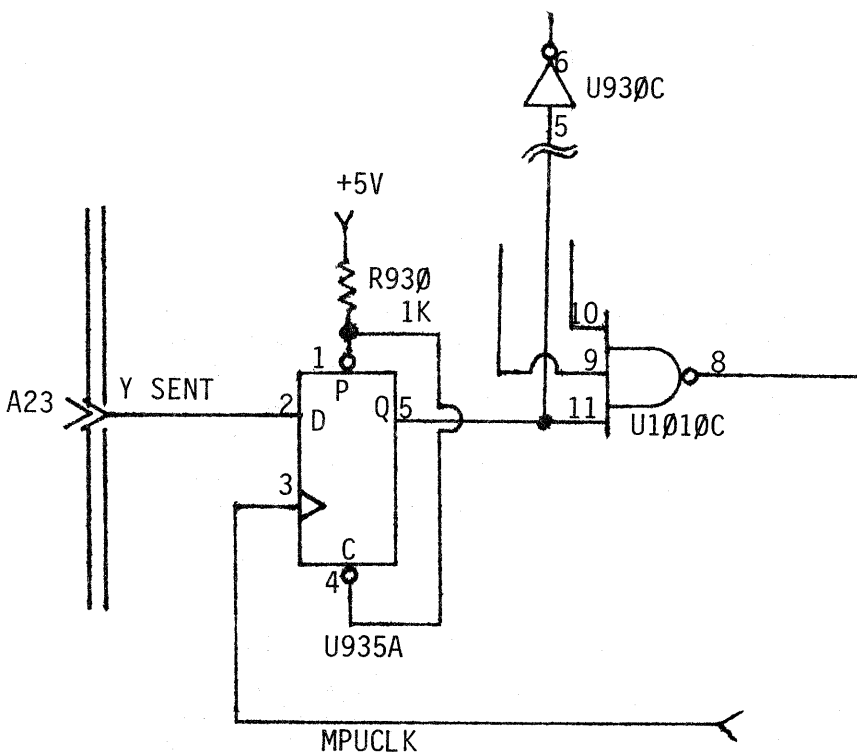
DIAGRAM 'C'

7612D: INCORRECT NUMBER OF DATA BYTES, CAUSING CKSUM ERRORS (CONTINUED)

PARTIAL VIEW OF TIMEBASE CONTROL 5

CUT RUN BETWEEN
PIN 5 OF U930
AND FEEDTHROUGH
HOLE ADJACENT TO
PIN 6 OF U930.

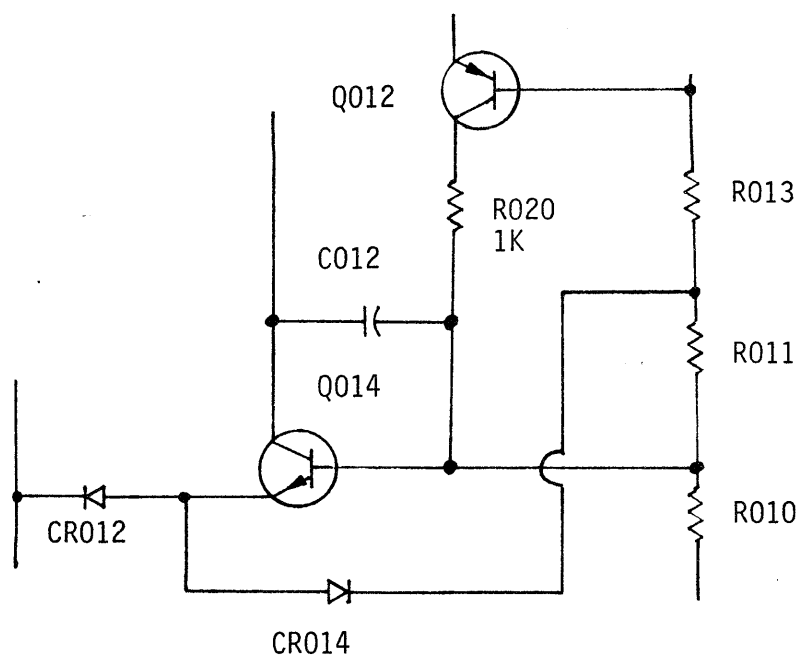
DIAGRAM 'B'

7912AD: ADDED PROTECTION FOR THE CRT AND IMPROVED RELIABILITY

PARTIAL VIEW OF THE Z-AXIS/HIGH VOLTAGE CIRCUIT SCHEMATIC 7

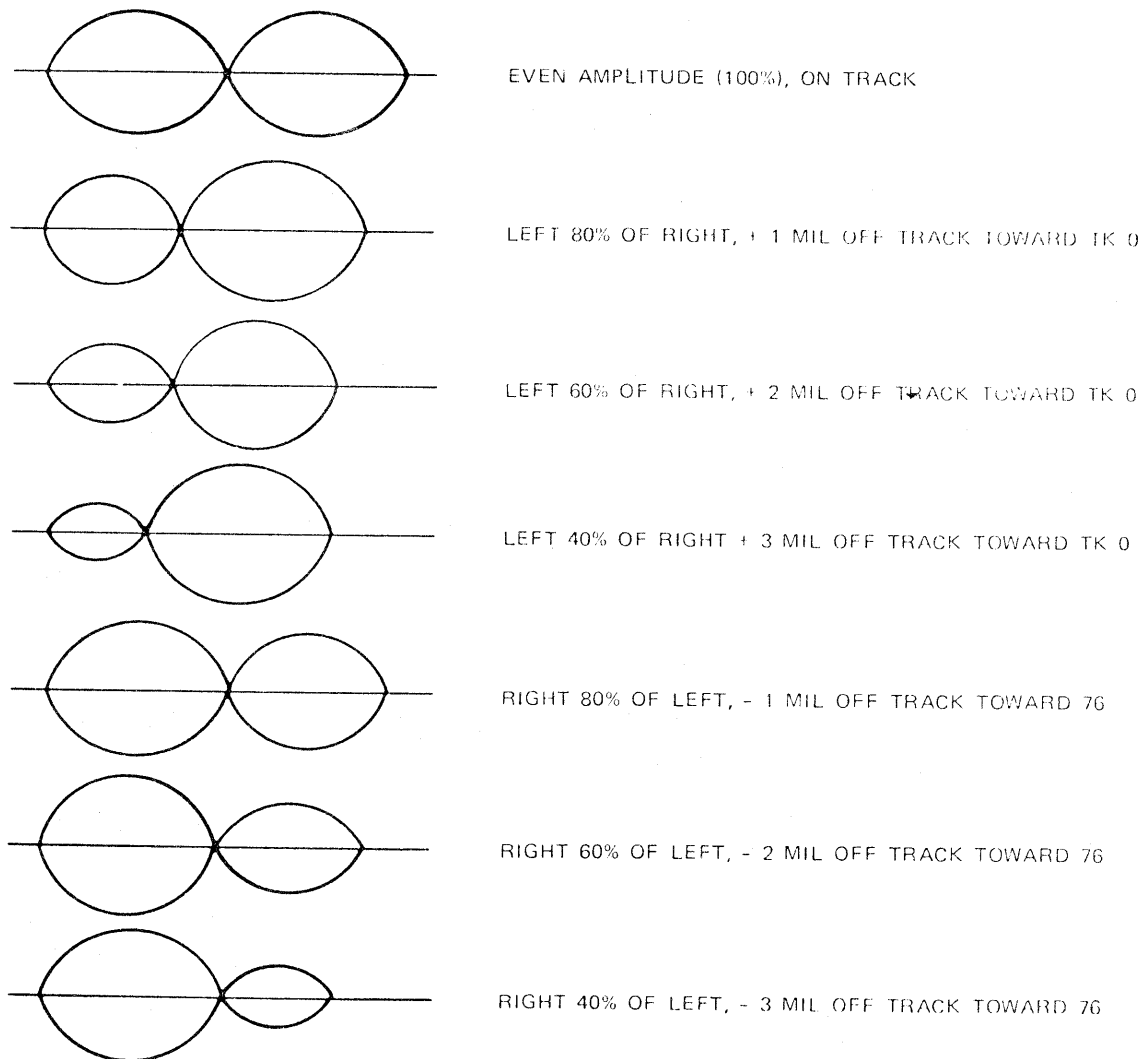
FIGURE 1 Head Radial Adjustment

- Display - 1-2
- c. Step to track 38 (UDK #6)
- d. Two cat eyes will be displayed on the scope, they should be within 70% amplitude of each other. (figure 1)

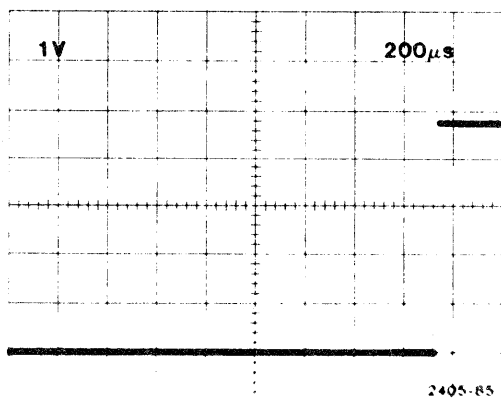
FIGURE 2 INDEX PULSE ADJUSTMENT

- a. Insert the alignment disk into the drive.
- b. Set scope as follows:
 - CHAN 1: DC 2 v/div Probe on TP12
 - TRIGGER: Auto internal negative .2 ms/div
 - DISPLAY: Chan 1
- c. The index pulse will be displayed on the scope, it should have a pulse width of $1.7 \text{ ms} \pm .5 \text{ ms}$. (Figure 2)
- d. If the index pulse is not within tolerance adjust the index sector potentiometer for a pulse width of $1.7 \text{ ms} \pm .5 \text{ ms}$.
- e. Put glyptol or equivalent coating (loctite, enamel) on the index sector potentiometer.

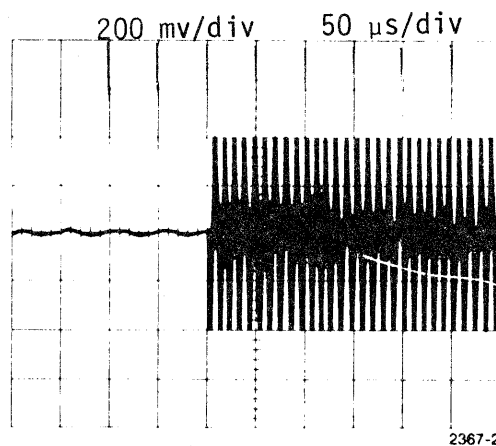
FIGURE 3 Index to Data Timing

d. Observe the timing from the start of the sweep to the beginning of the data burst; it should be 200 μ s \pm 50 μ s. (Figure 3)

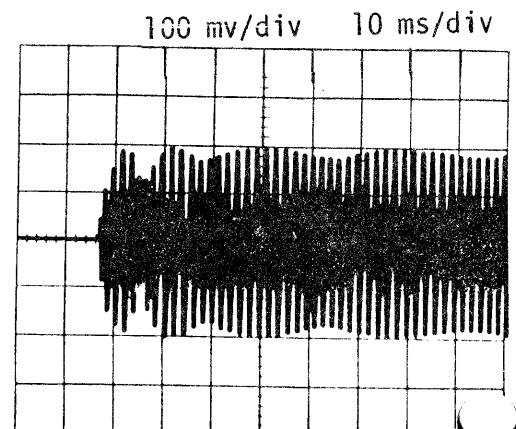
FIGURE 4 Head Load Activator Timing

d. When the head loads, the signal on the scope should be 50% of full amplitude within 35 ms (Figure 4). Trigger slope must be adjusted carefully to obtain proper timing.
