COMBINATION WIZARDS

Tektronix®
 COMMITTED TO EXCELLENCE

October 3, 1980
 Issue 10-20

TABLE OF CONTENTS

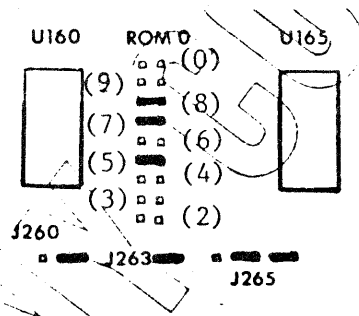
Example:

ROM straps to select the appropriate ROM's

NOTE: ROM numbers are in parentheses. The straps, as shown, select ROMs 5, 7, & 8. These are the ROMs used in V-3 & 4 F/W.

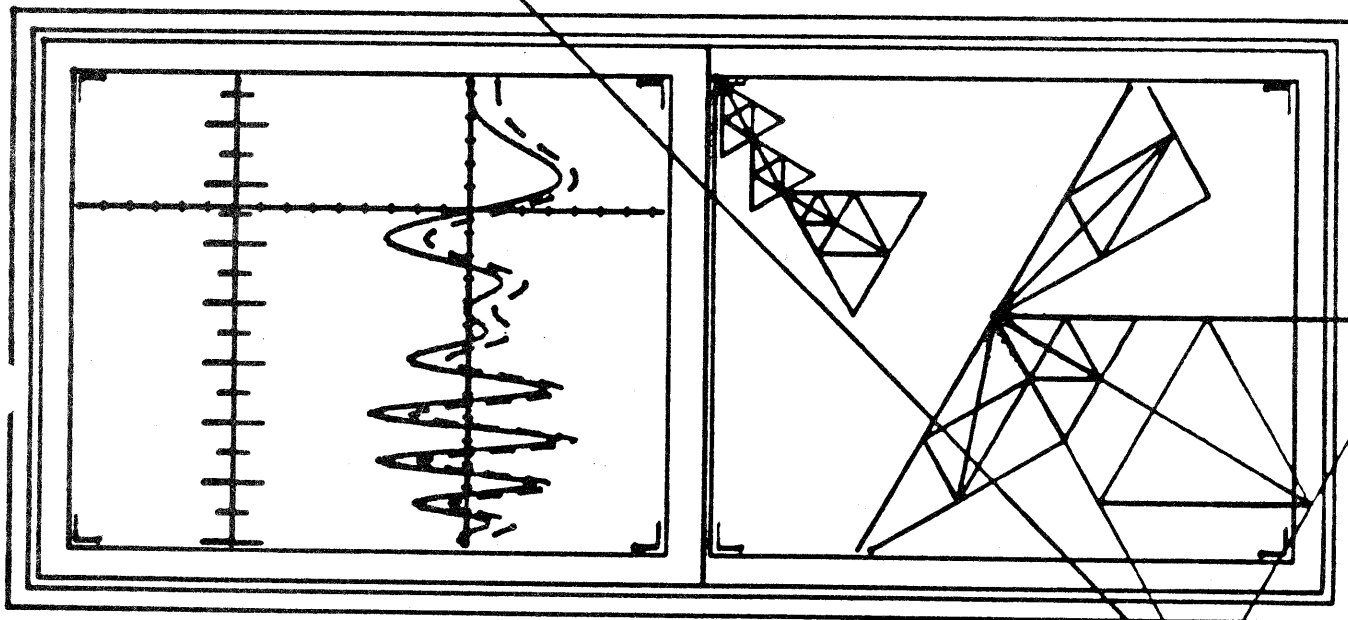
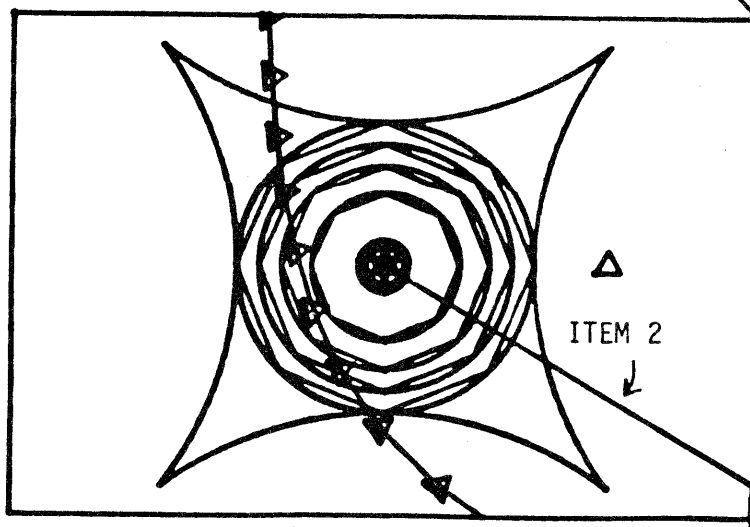
ITEM 2

- 2) A line is drawn from the top of the page to the center of the Option 31 verification plot (see item 2 on the next page).
The cause of the line draw is the code at line #2250 of file #8.
