# SERVICETEKNOTES

## TABLE OF CONTENTS

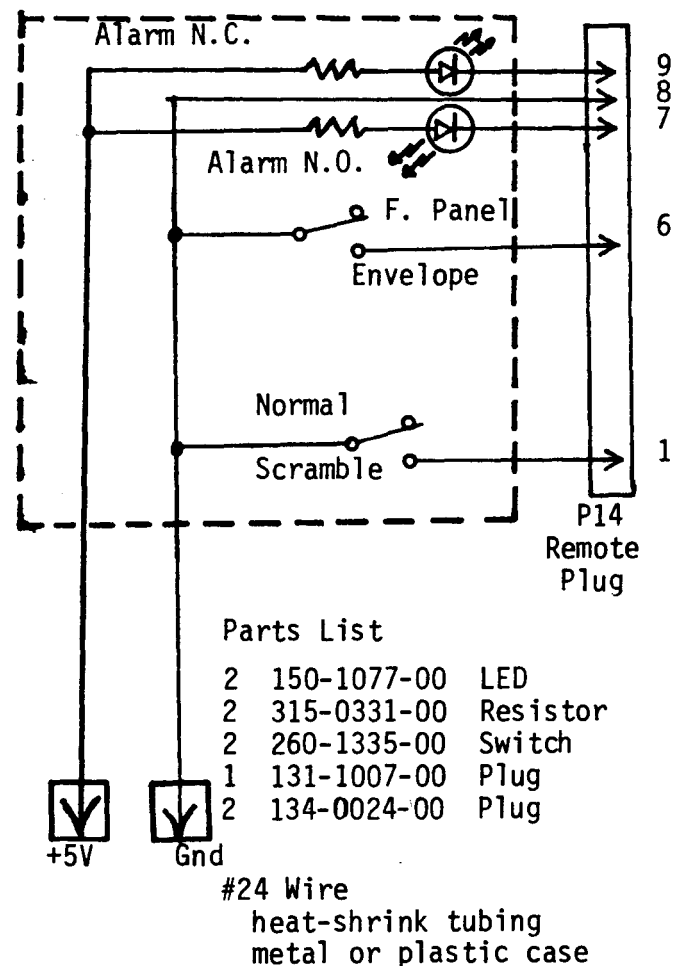
Figure 1

Remote Test Fixture

An additional service aid can be constructed locally to allow ease of actuation of the option circuitry. It consists of a male plug (131-1007-00), with a SPST switch wired to pin 1. A ground clip is wired to the other side of the switch and can be connected to any convenient ground point. A more "delux" test fixture can be made up to test the remote connector functions of any 1450. See Figure 1.

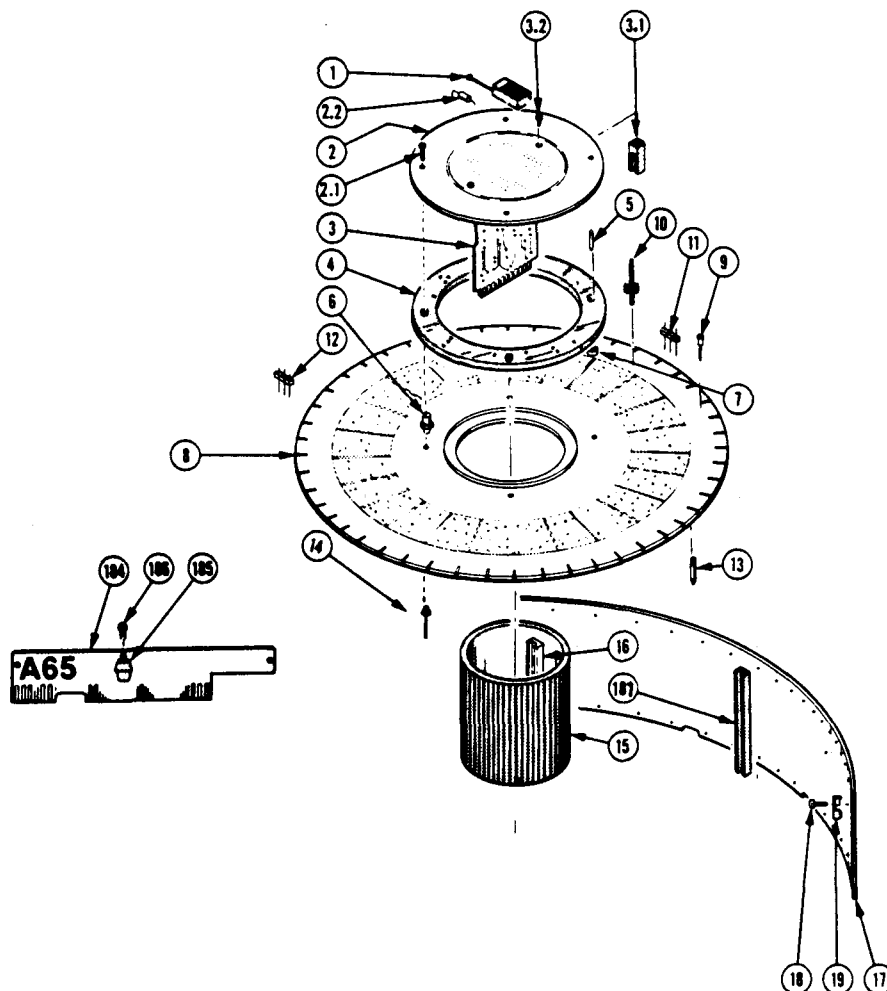
## 1807 FIGURE 2 MANUAL CORRECTION (cont.)

In the 1807 manual, Volume 2, 070-4134-00, page 6-77 there are errors. The load board and hardware Fig. 2 index numbers 3 through 14 are incorrect. Shown below is the correct mechanical view of the load board and hardware plus the corrected part number listing.

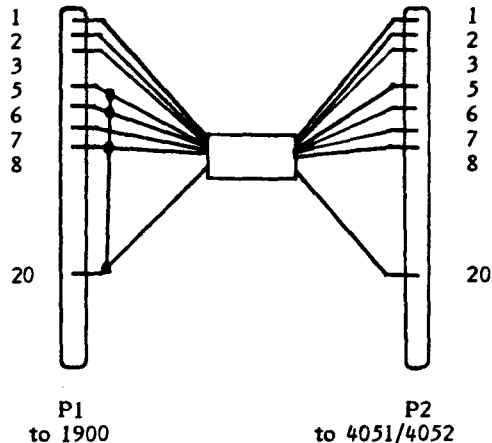
FIGURE 1

The 1900 RS-232 Remote Interface was designed to exercise a basic 3-wire handshake with the controlling terminal. To use a 4051/4052, several functions of the RS-232 must be "by-passed" to compensate for the 4050 series' more complex implementation of the RS-232 standard.

To allow a service tech, equipped with a 4051/4052, the ability to exercise the RS-232 functions, a small adapter must be built for interfacing between the 1900 RS-232 connector and the cable normally supplied with the 4051/4052 Data Communication Interface (Option 1). Construct this cable similar to Figure 1.
