SERVICETEKNOTES

TABLE OF CONTENTS

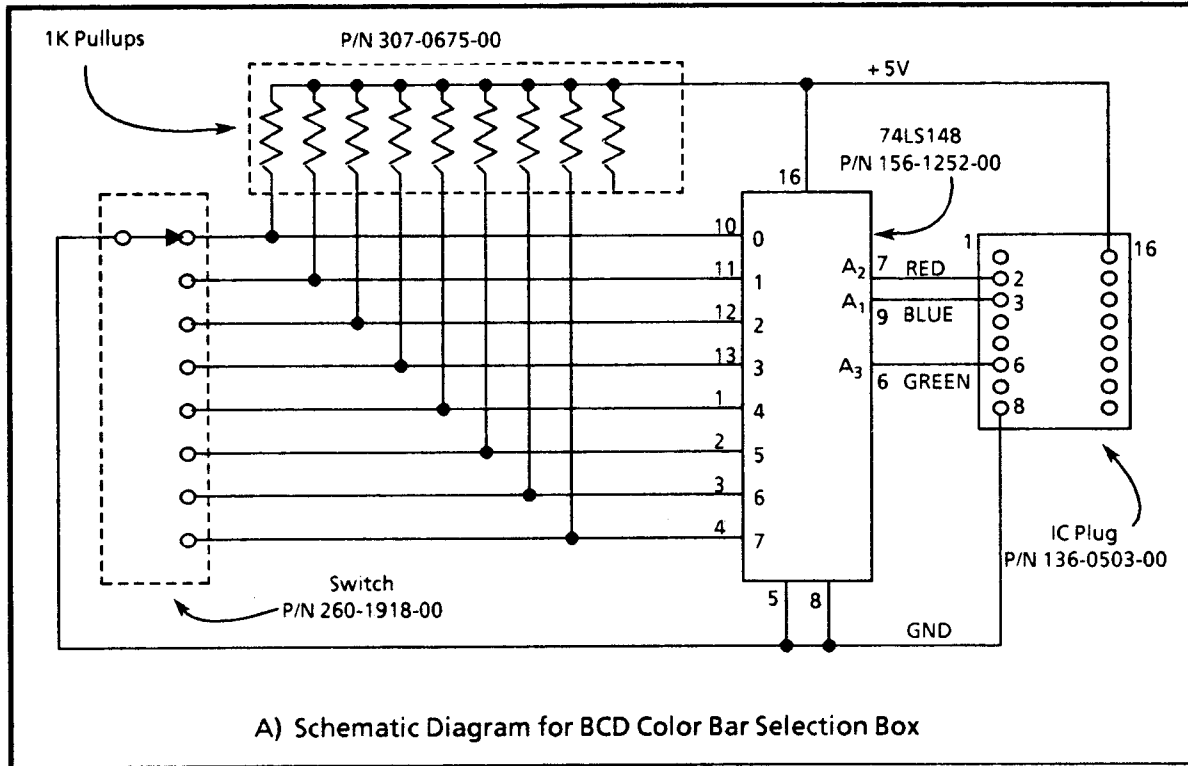
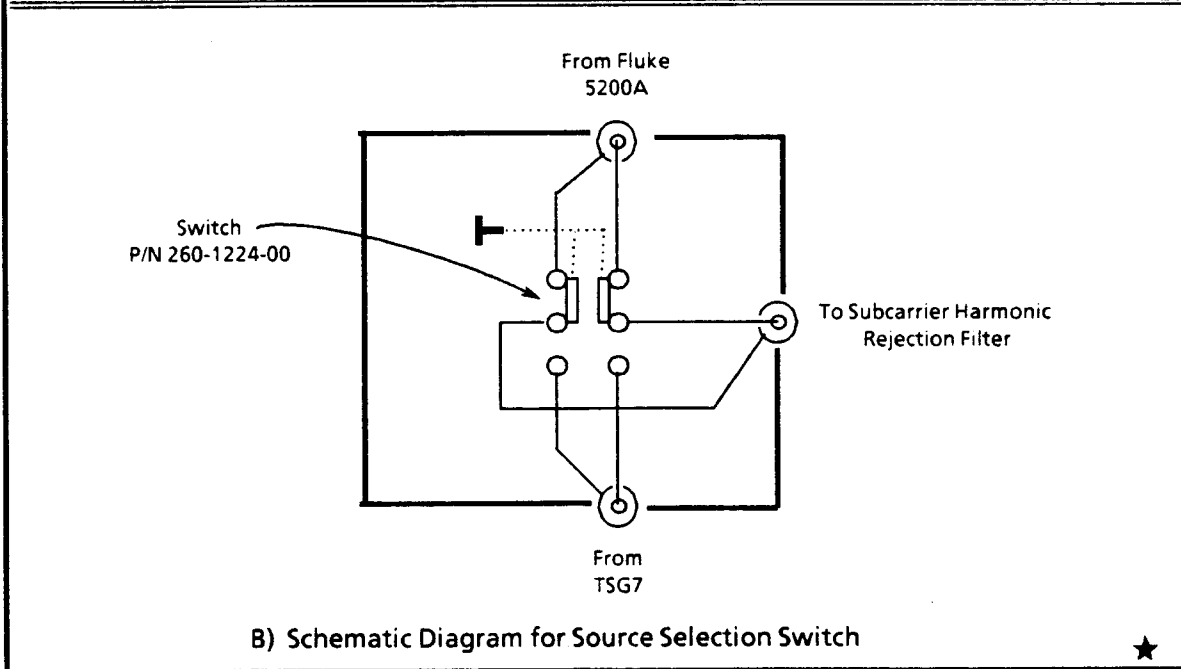
Fig. 1. Schematics for locally constructed test equipment

21. Locally constructed BCD color bar selection box.
(See Fig. 1a for schematic and part numbers)

22. Locally constructed source selection switch box.
(See Fig. 1b for schematic and part numbers)

CHANGE Fig. 1 AS FOLLOWS:

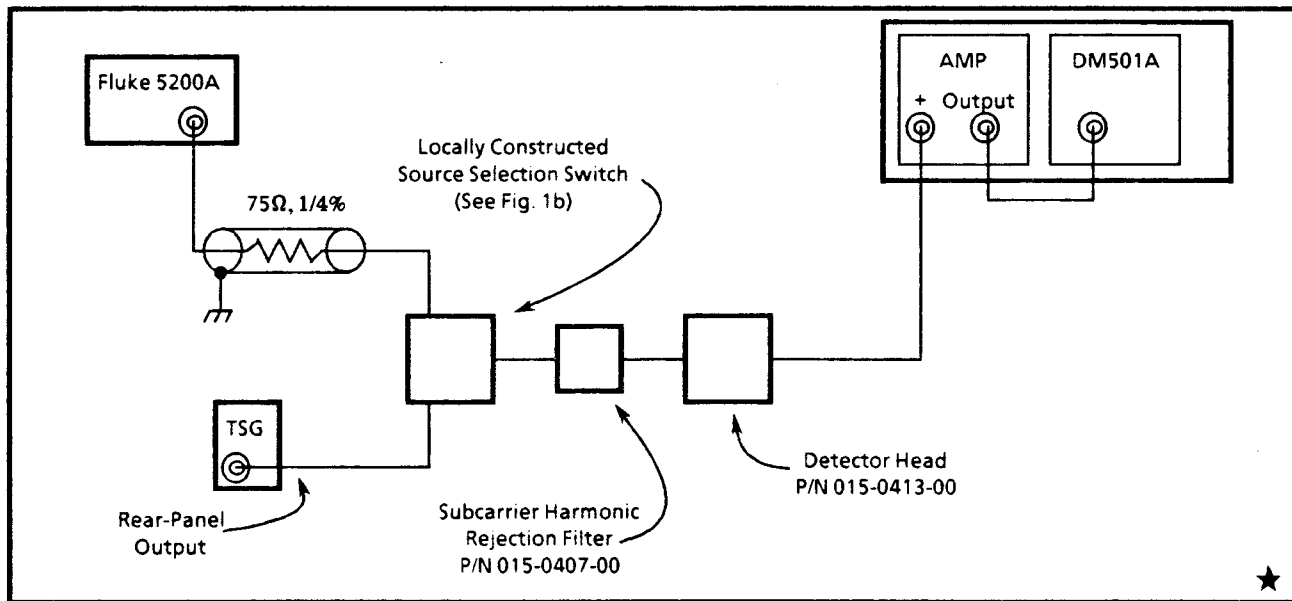
Fig. 2. Equipment Connections for Chrominance Amplitude Measurement.

- d. Connect the Fluke 5200A with 75 ohm series resistor, the TSG7, and the source switch as shown in Fig. 2. Select the Fluke 5200A with the source switch box.

g. Select the TSG7 with the source switch (see Fig. 2). Do not readjust the p-p detector level control. Set the BCD switch to the appropriate bar (Red, Green, or Blue).

k. Select the TSG7 with the source switch (see Fig. 2). Set the BCD switch to the appropriate bar (Red, Green, or Blue).

CHANGE Figs. 2 and 3 AS FOLLOWS:

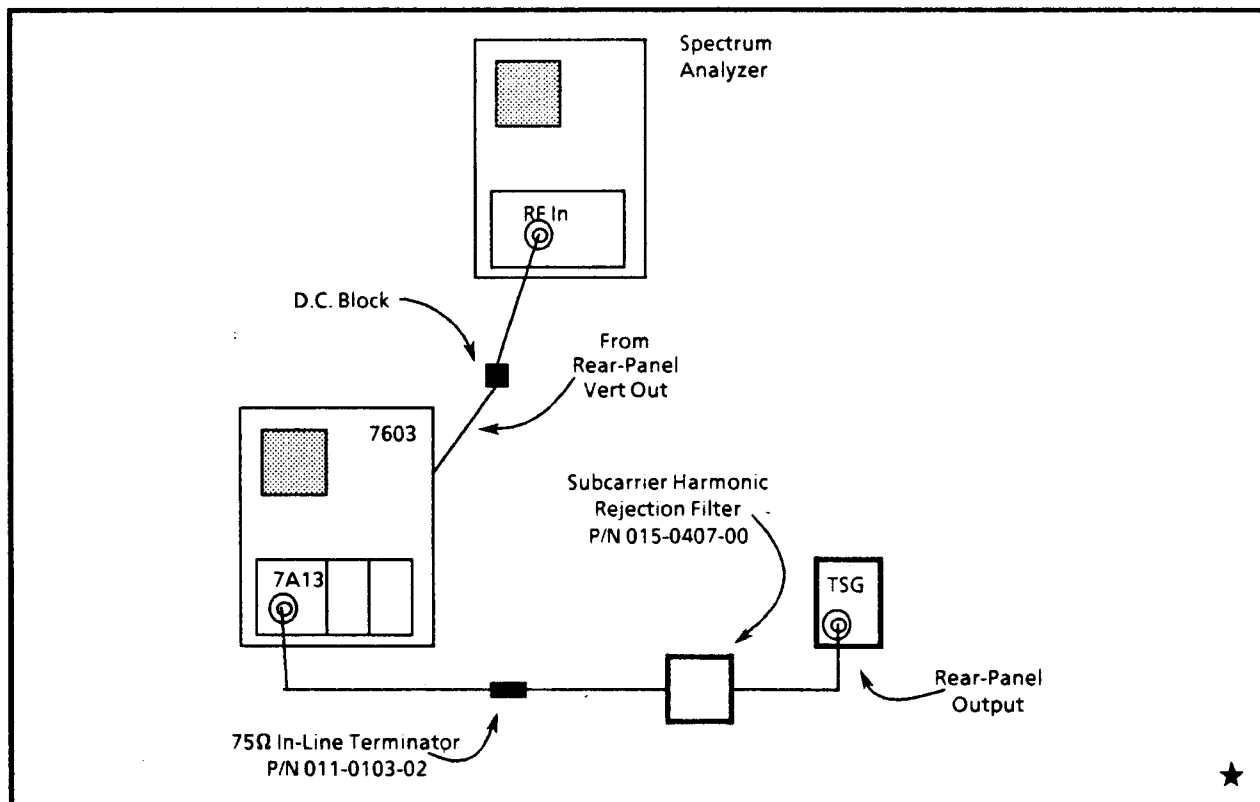
Fig. 3. Equipment Connections for Residual Chrominance Measurement.

i. CHECK/ADJUST - for less than 0.5 mV subcarrier on the white bar (See Fig. 3 for equipment connection diagram; oscilloscope at 1 mV, full bandwidth, trigger source - left). Adjust R249 to set the subcarrier amplitude to read 5 mV on the oscilloscope, and note the residual subcarrier level on the spectrum analyzer. Adjust R249 for minimum residual amplitude, and check that it is at least 20 dB down from the original level.
