Wizards Workshop

Published by Service Admin Support
56-037

February 20, 1981
Issue 11-3

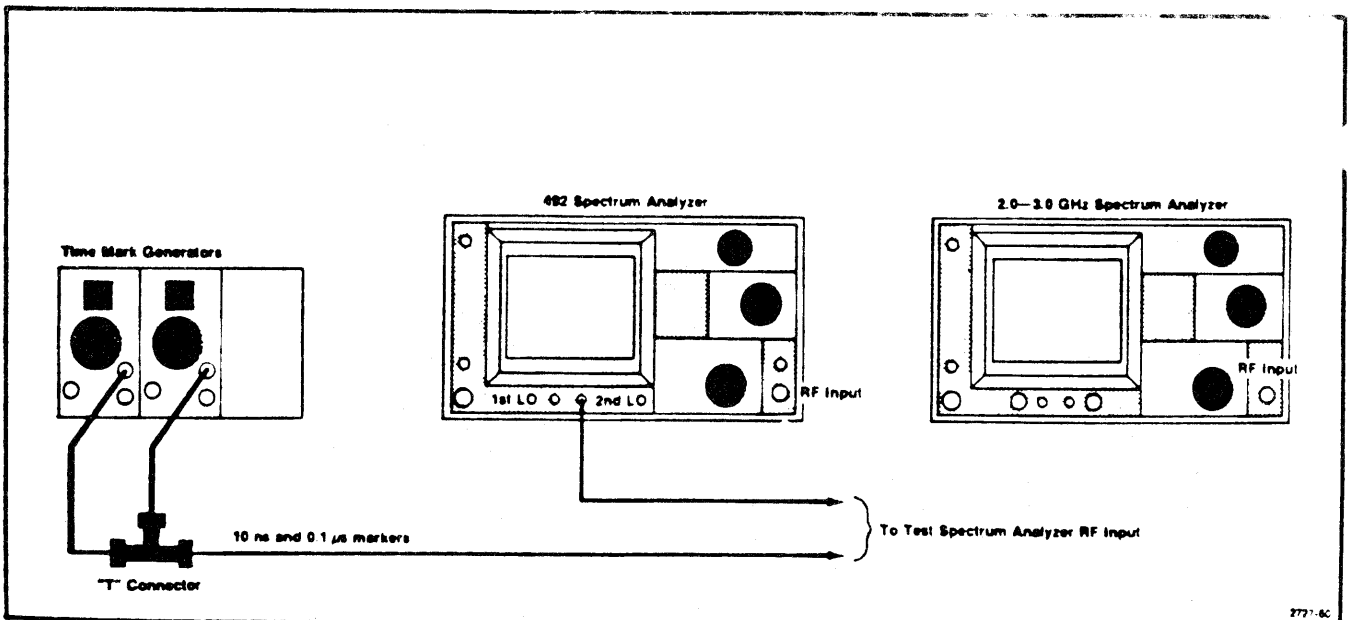
Fig. 3-32. Test equipment setup for check and adjustment of 1st and 2nd LO frequency.

- A. Test equipment setup is shown in Fig. 3-32. Apply 10ns and 0.1 μ s markers from the time mark generator to the Input of the test spectrum analyzer (frequency range 2.0GHz to 3.0GHz). This should produce accurate frequency markers every 10MHz around a center frequency of 2.2GHz.

- F. Using a 5/16-inch open-end wrench and a 5/64-inch Allen wrench, loosen the lock nut and adjust the Fine Tune slug in the cavity for a counter reading of 2182.0 MHz \pm 1.0 MHz.
- G. Tighten the lock nut, check the oscillator frequency and, if it is not correct, go back to Step F.
- H. Refer to page 3-43, Step 6 for "2nd L.O. Frequency and Tuning Range Adjustments" in the 492/P Service, Volume 1 (P/N 070-2727-02).
