WIZARDS WORKSHOP

TEKTRONIX INTERNAL USE ONLY

Published by Service Administration Support,
d.s. 56-037, ext. 642-8940

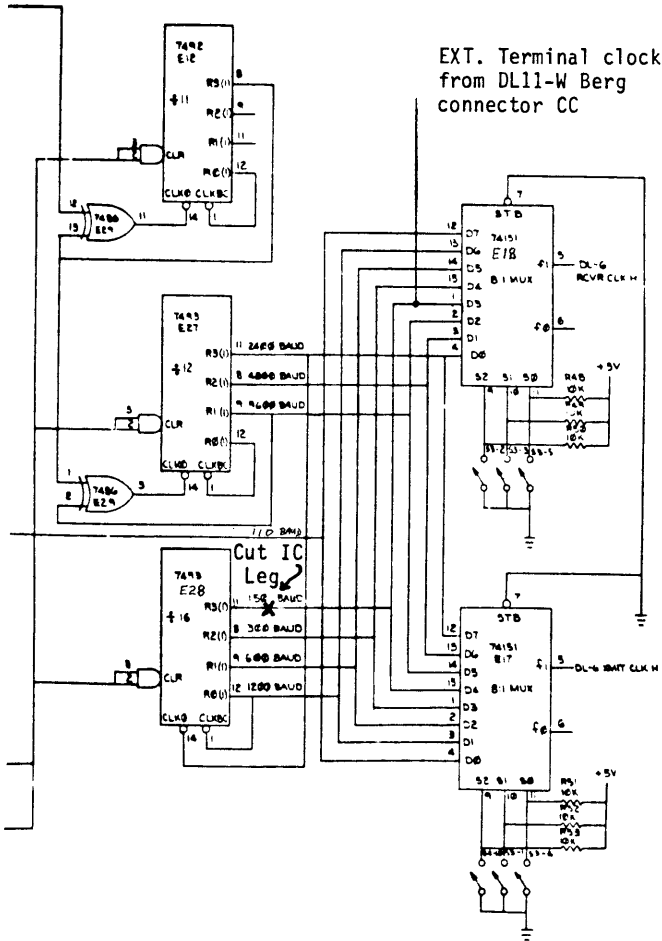
FIGURE #4

1. Cut pin 11 of E28.
2. Install a wire from the DL11-W berg connector pin CC to pin 1 of E18. Install the wire on the back of the board. See Figure #4.
