## WIZARD WORKSHOP ARTICLES

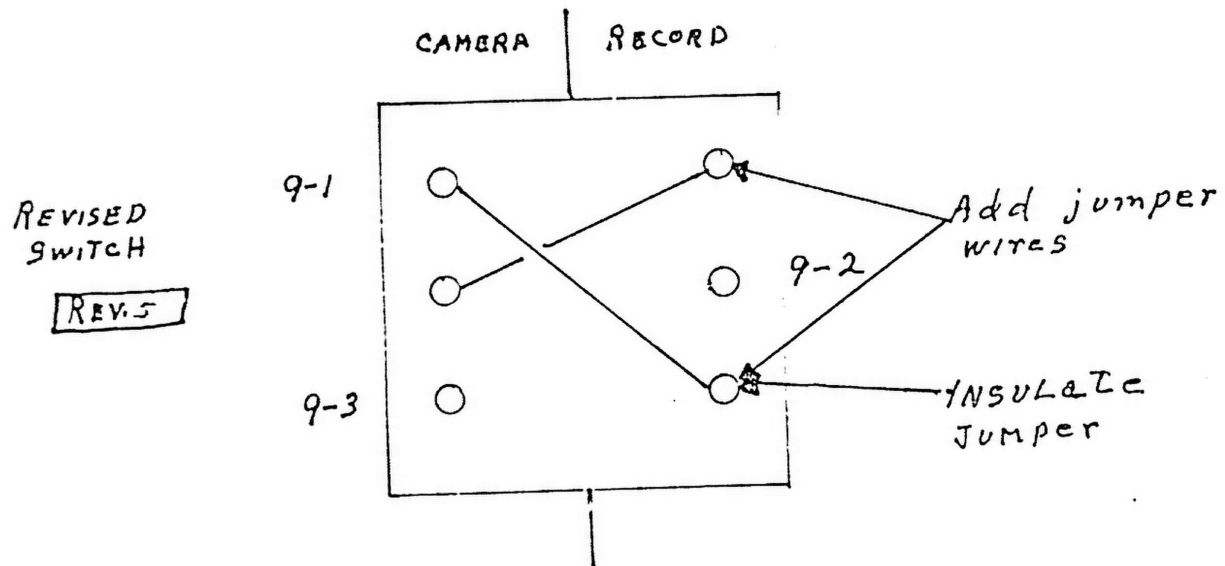
1502-1503 CAMERA FUNCTION (continued)

Now that the dust has settled, further explanation is in order. The camera function has been deleted from the 1502 and 1503 due to low usage and a patent problem in Japan. The incorporation of this deletion has caused some misunderstanding and inconvenience. There are ~120 1502's and 220 1503's in which the function was deleted, but not the word "camera" from the front panel. Some have new front panels with "Camera", some have "Camera" covered with a sticky back tag.

CAMERA FUNCTION DELETED

If the customer brings in a unit because the camera function is inoperative and it says "camera" on the front panel. Rewire the unit so the camera function is again operative, and inform the FE immediately. Repair will be performed under warranty.

If the customer brings in a unit because the camera function is inoperative and the front panel does not say camera (or is covered up), contact the FE and let him determine the next course of action. If repaired, it will be customer accommodation.

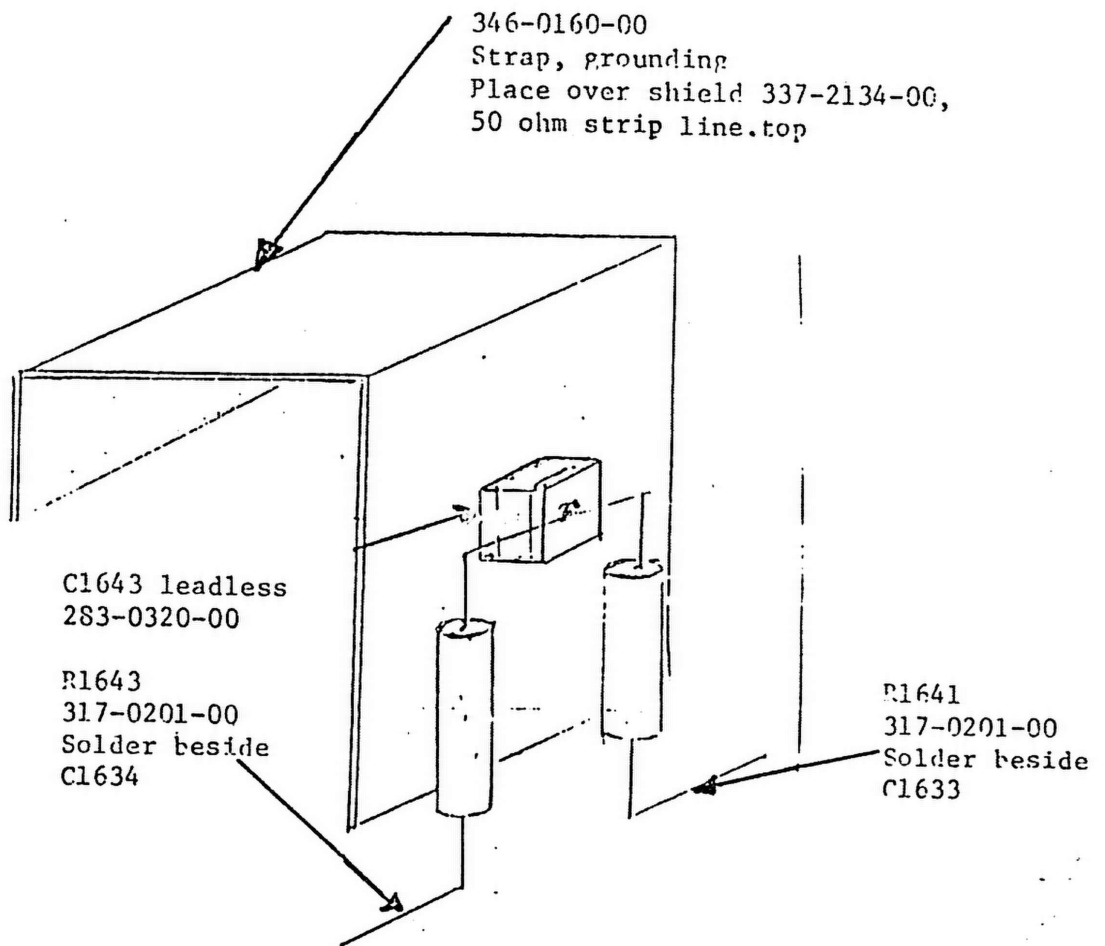
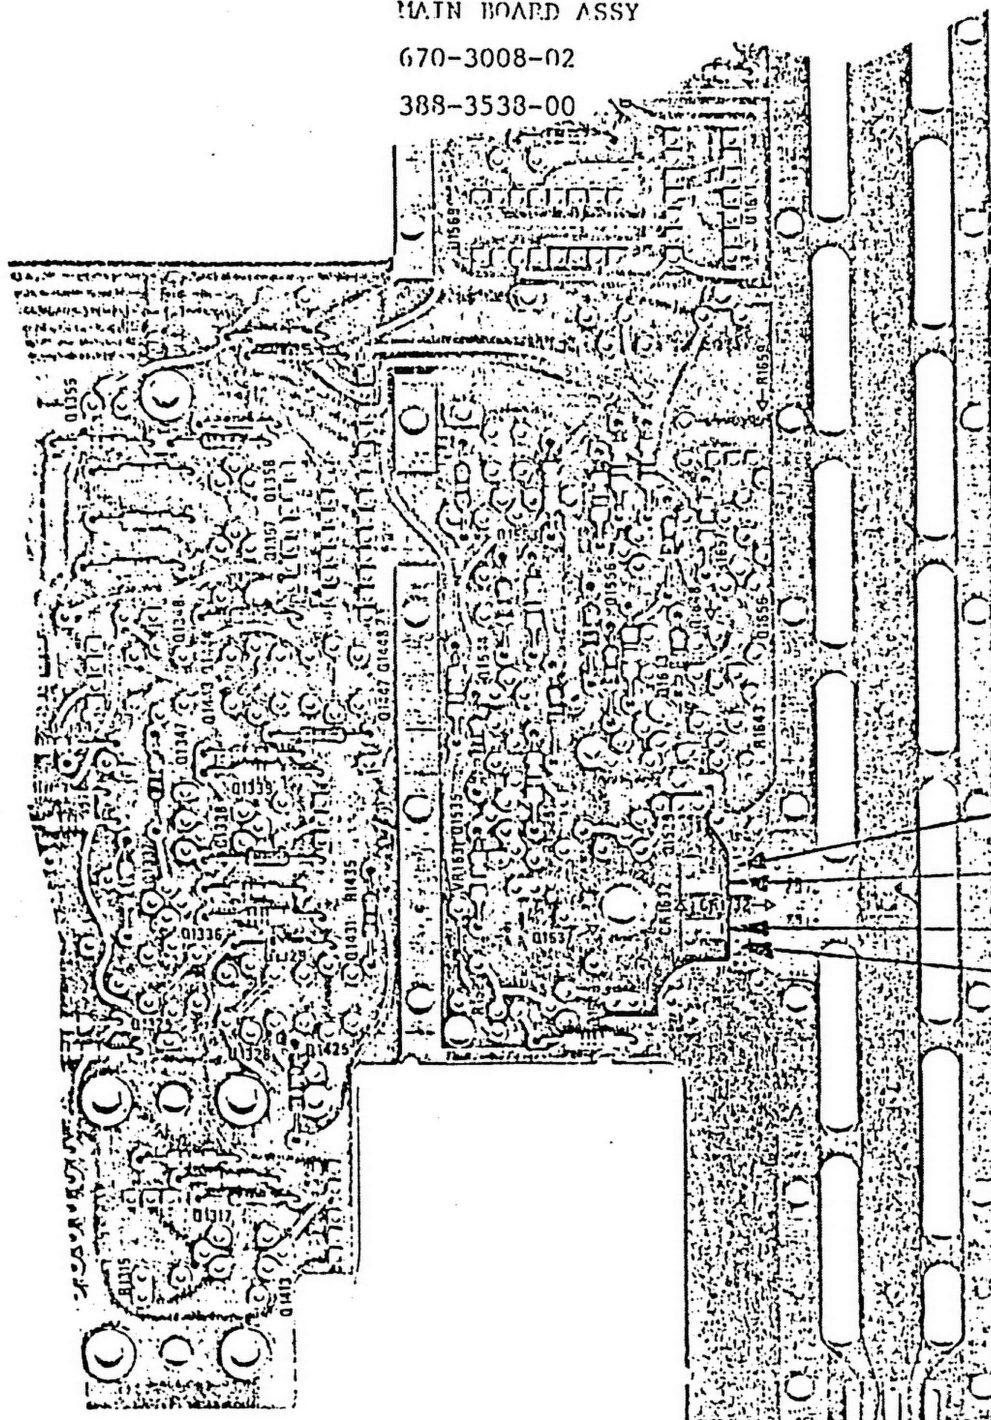
## DAMPENER COMBO

1502 ABERRATIONS (continued)

~~Add P1641~~  
317-0201-00
