# SERVICETEKNOTES

TABLE OF CONTENTS

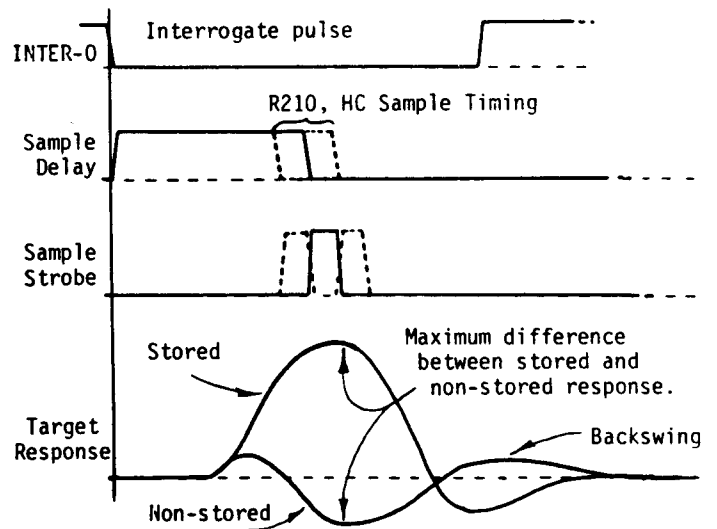
Fig. 1: Strobed Hard Copy Board Timing Diagram

The new board "reads" the CRT target only when a target response is most expected. This reduces the noise produced in the hard copy, especially with CRT targets exhibiting substantial backswing (see the timing diagram). The strobe window can be adjusted with R210, hard copy sample timing. Typically, R210 can be set to midrange and forgotten. Noisy copies may be improved by straying from midrange either clockwise or counterclockwise.

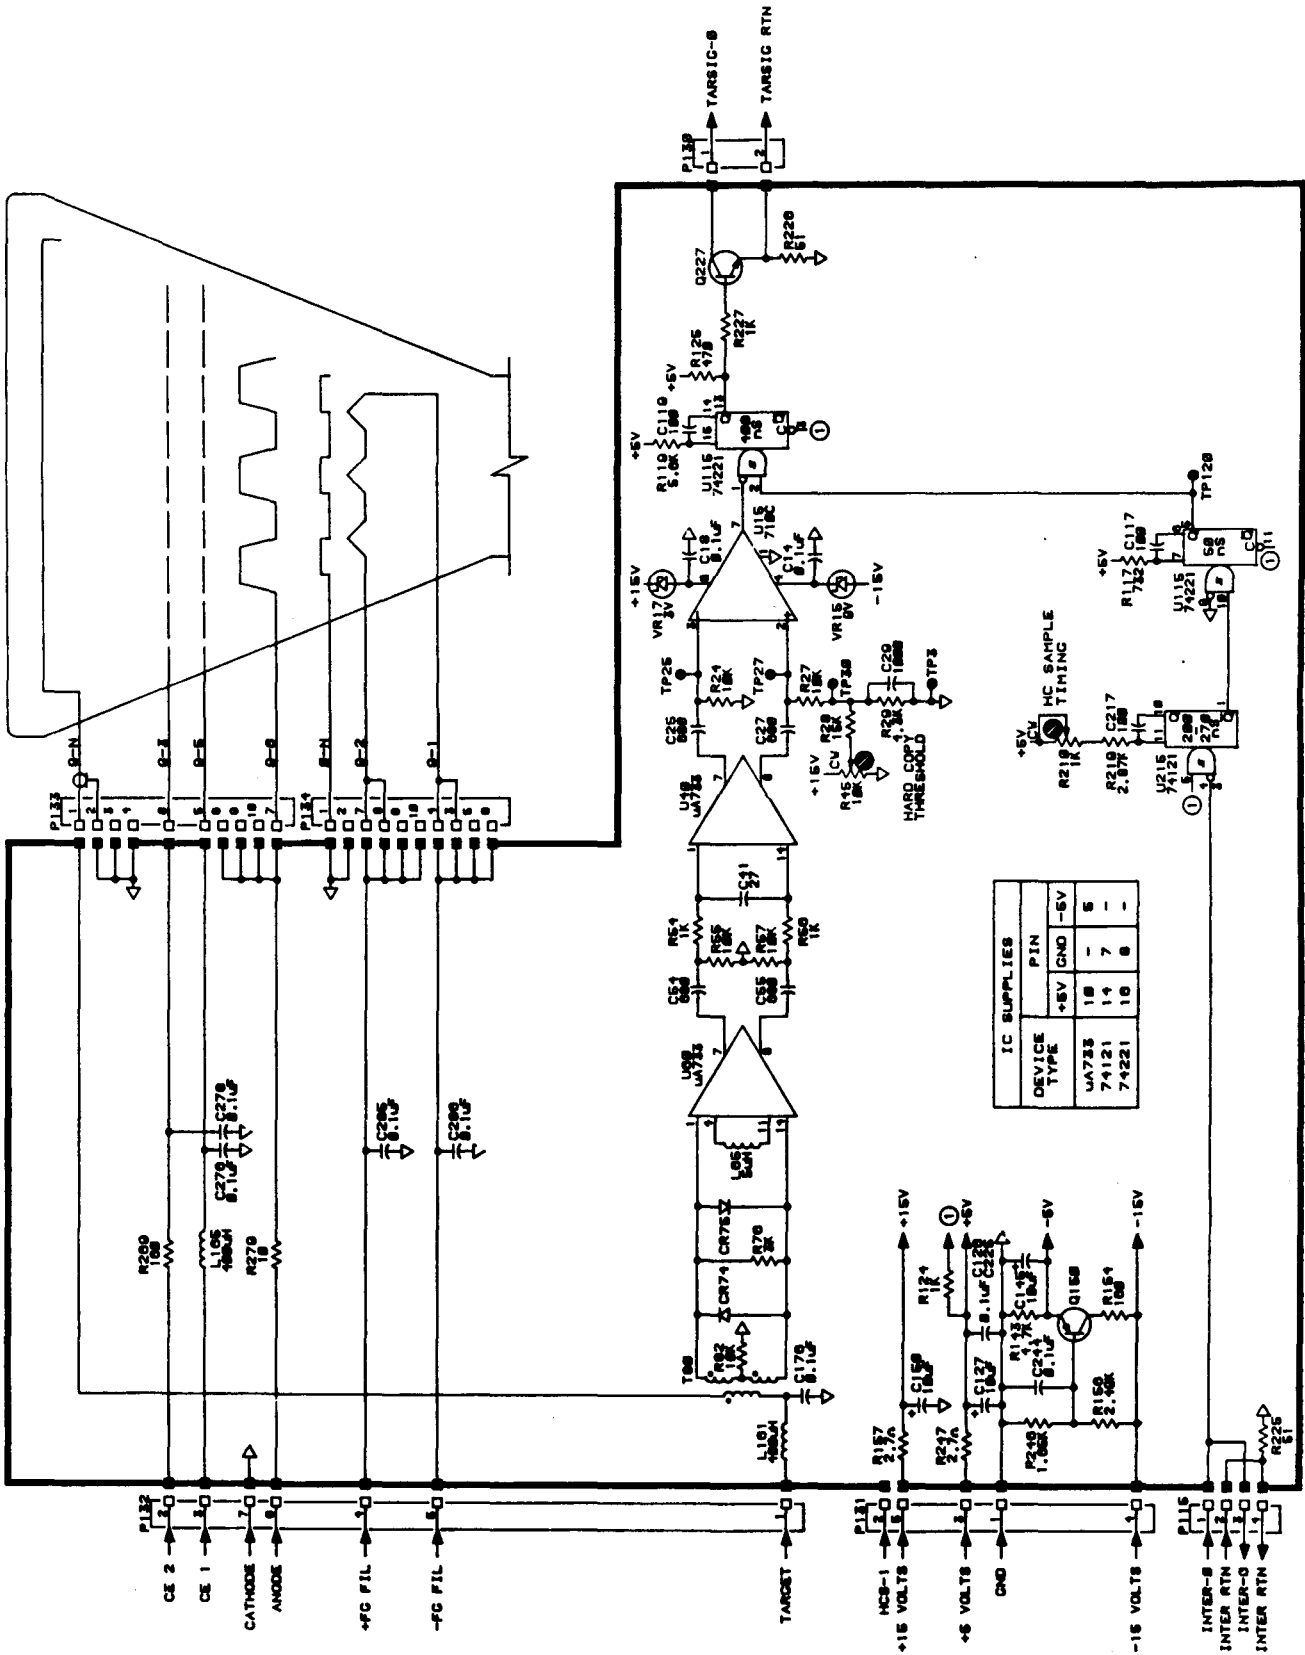
Figure 2

Schematics of the new board and hard copy cable assemblies are given in Figures 2 and 3. Note that the added circuits around U215 (sample timing delay) and U115 (sample strobe) distinguish this board from the earlier 670-3097-XX hard copy board. Note also that the INTER-0 signal produced by the hard copy unit is routed directly to the hard copy board to trigger the strobe. The HCS-1 signal produced on the storage board and necessary with the earlier 670-3097-0X is no longer used.

Schematic of 670-7550-00 strobed hard copy board.

A new hard copy amplifier board is being used in the GMA101A, GMA102A, 618, 4054, and 4114. This new board, part number 670-7550-00, is identical to that now used in the GMA103, 4054 Option 31, and 4114 Option 31 products. It requires the use of the INTER-0 signal present at the backpanel hard copy connector, therefore the hard copy connector cable assembly is also changed. The addition of a potentiometer (R210, sample timing) requires that the plastic hard copy amplifier cover be changed as well.

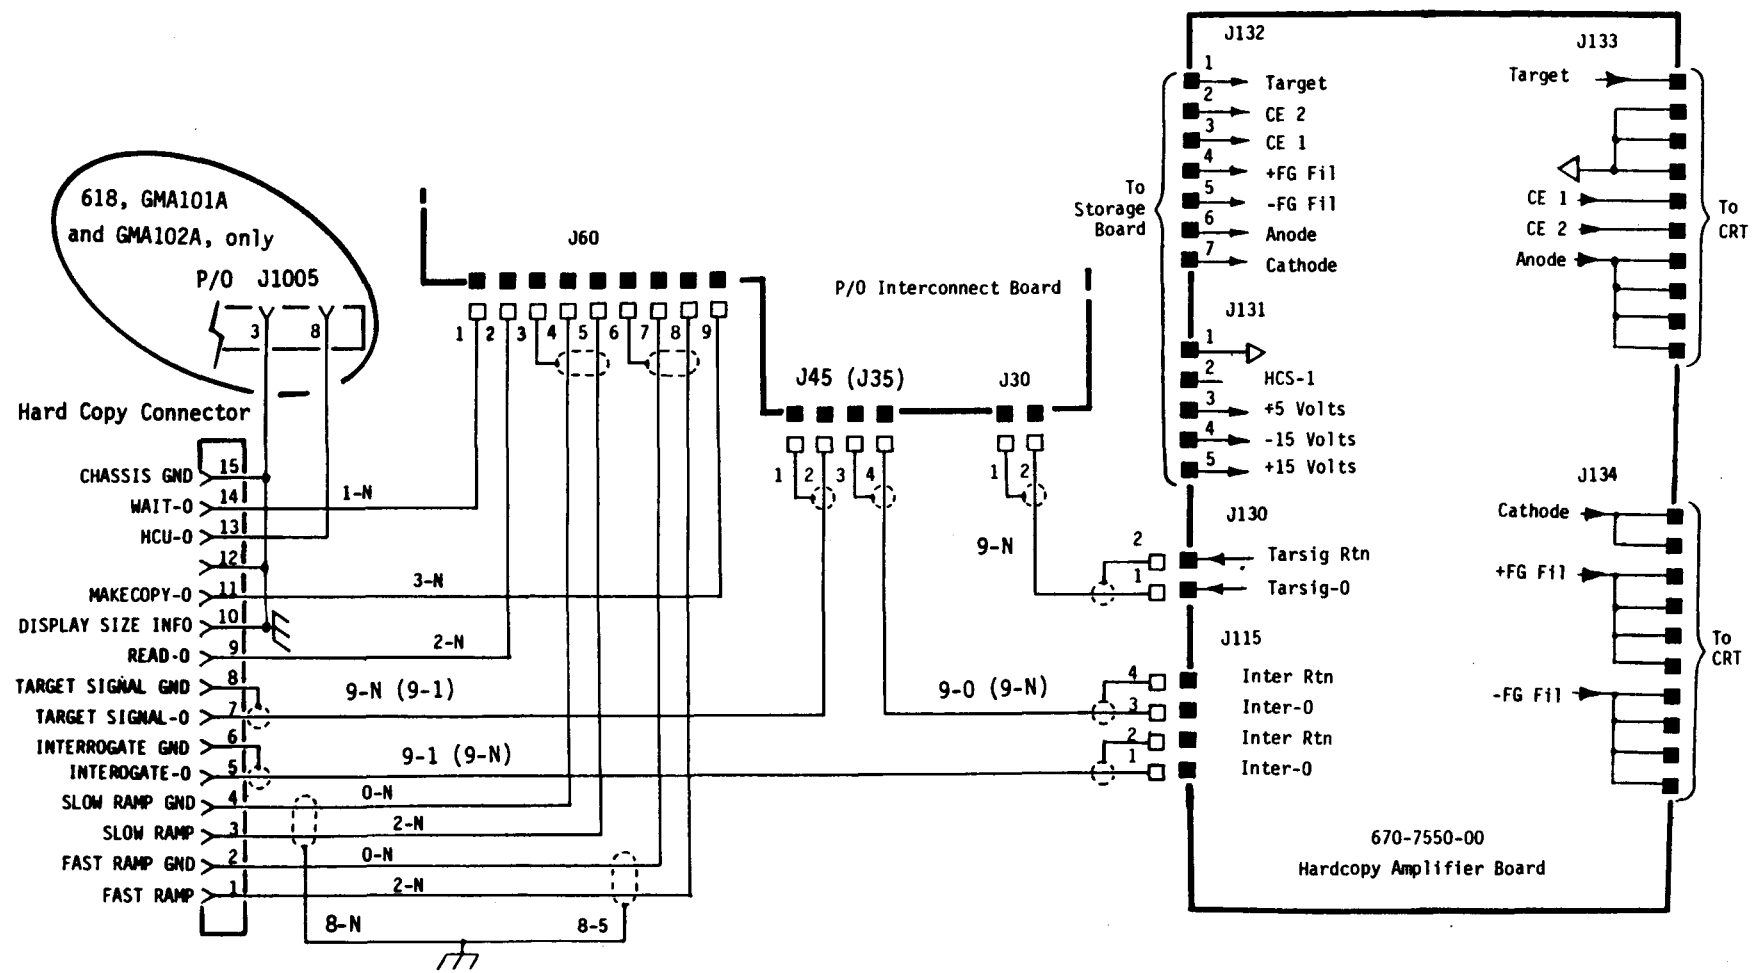
Figure 3

Schematic of the 179-2876-00, 179-2877-00, 179-2879-00 and CM179-2880-00 cable assemblies used with the 670-7550-00 strobed hard copy board. Numbers in parens apply to some 4054 products only.
