COMBINATION EDITION

Wizards Workshop

TEKTRONIX INTERNAL USE ONLY

November 21, 1980
Issue 10-23

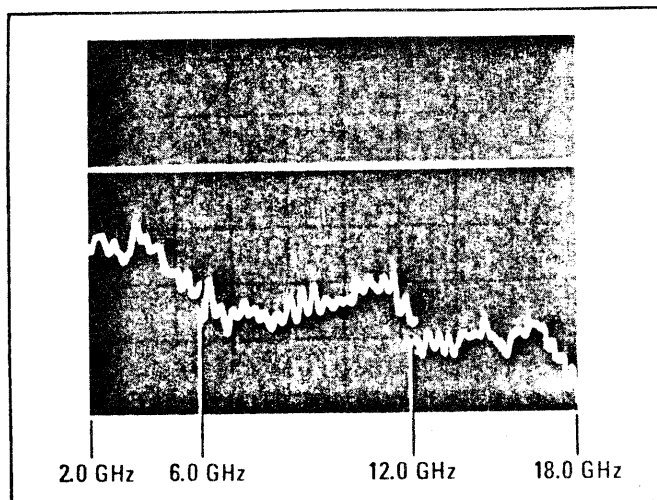
Figure 3-5. Unleveled Rf Power Output for Sequential Sweep

4. Adjust ALC GAIN and POWER LEVEL controls fully clockwise for maximum RF power OUTPUT and maximum ALC Loop gain. Adjust PEAK control for maximum RF power. One of the conditions shown in Figures 3-5 through 3-9 should be displayed on oscilloscope. If trace is unleveled as shown in Figures 3-5 or 3-7 (or partially leveled) and UNLEVELED lamp is on, turn POWER LEVEL control counterclockwise until trace is level. (See Figures 3-6 and 3-8). If ALC loop gain is too high, oscillations may occur as shown in Figure 3-9. To remove oscillations, reduce ALC loop gain by turning ALC GAIN control counterclockwise.

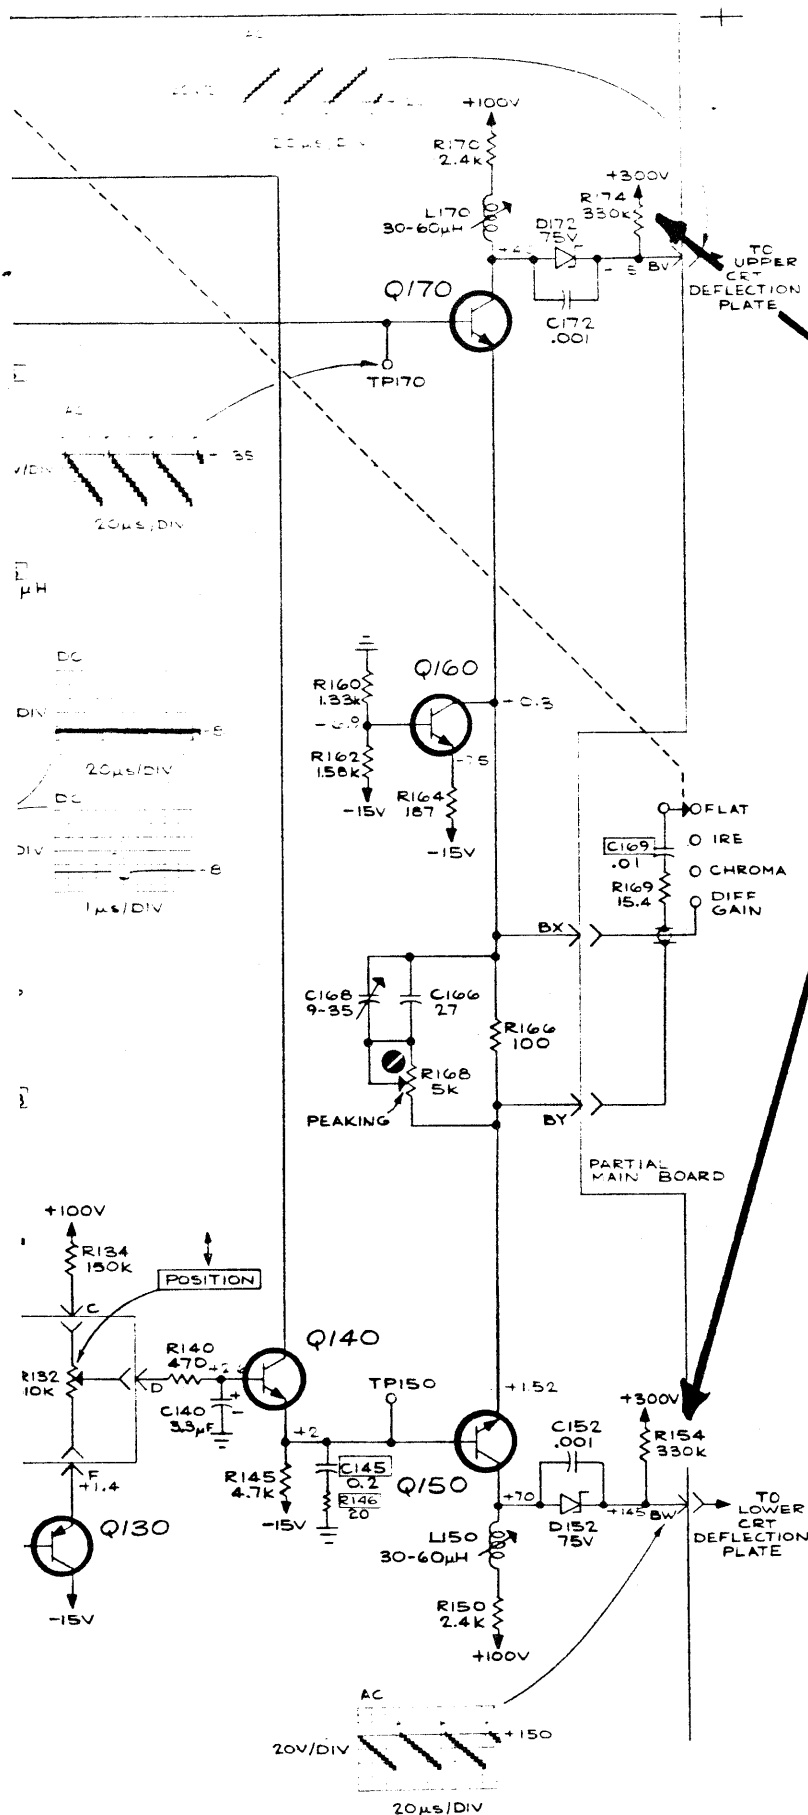
670-0588-06

528 VERTICAL, NOISE ON TRACE (CONTINUED)

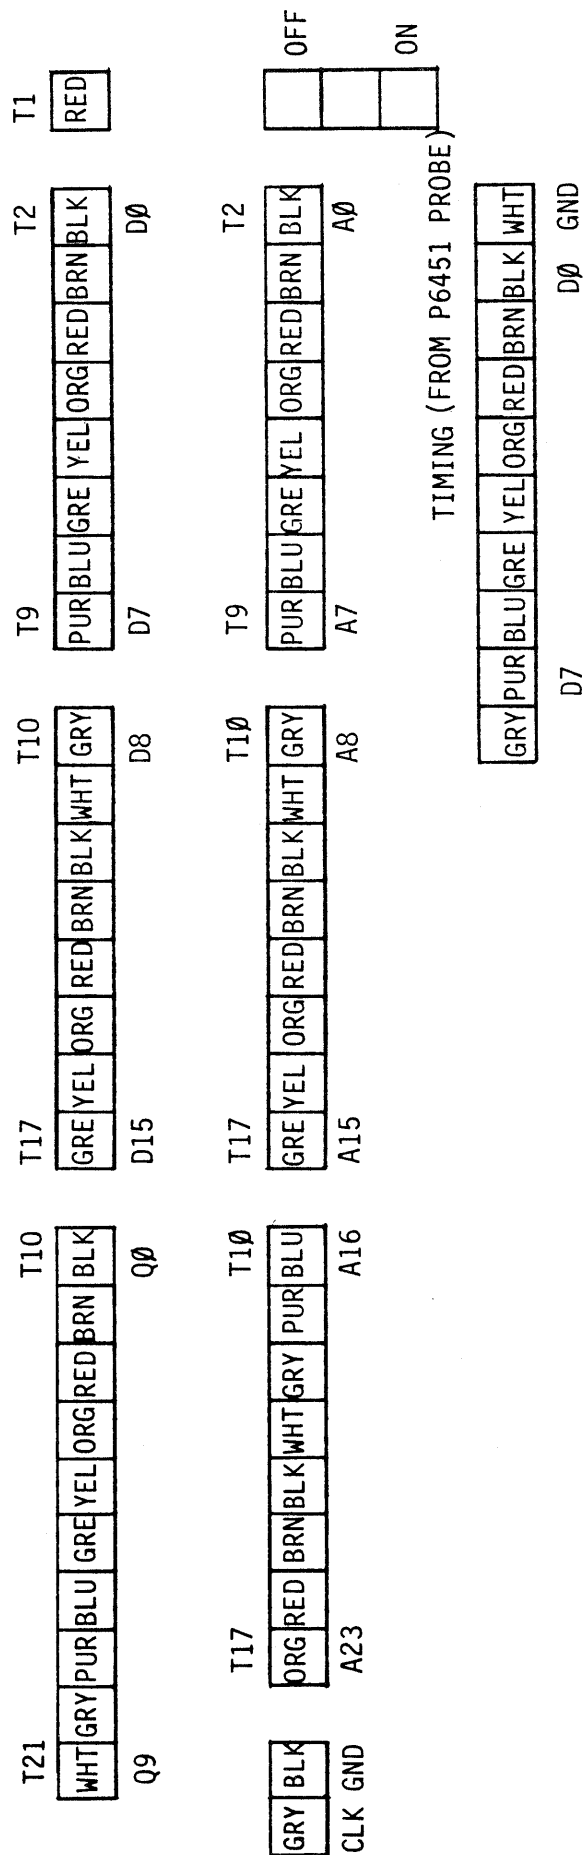
FIGURE 1

When making the 7D02 self-test stimulus connections on the PM101 personality module, it is important that all loopback connections be in the correct positions. If any signal lines are not connected or on wrong pins, failures will result in the personality module diagnostic tests.

Figure 1 shows the colors of all the PM101 signal and ground pins. Note that the address and data lines start with black through white, then start over with black. The second black being line ten. Be sure to connect the P6451 probe when running the extended diagnostics. Without the P6451, Timing Option Test will fail test 3 with a 2E807-7 error (no trigger error).
