SERVICETEKNOTES

TABLE OF CONTENTS

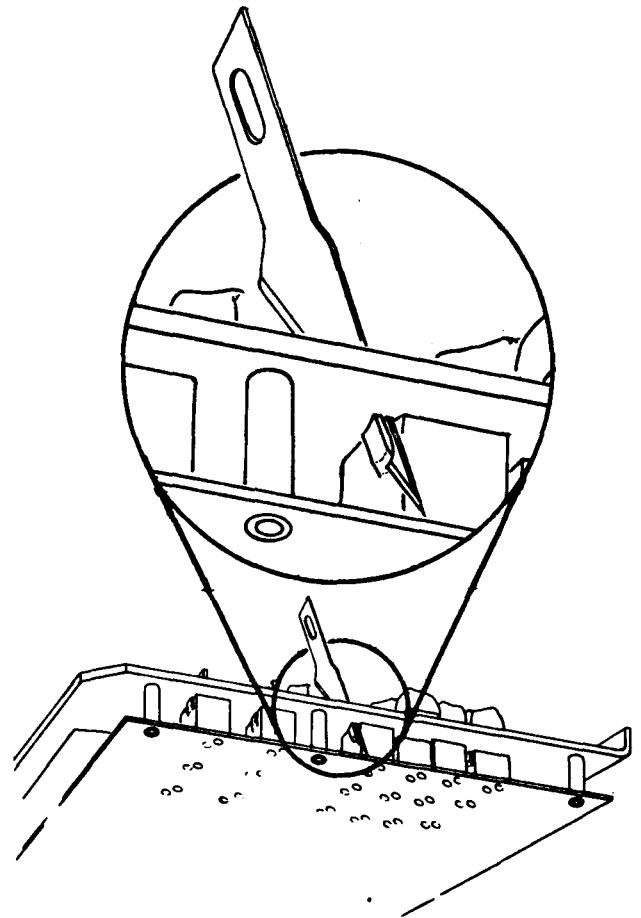
4006/4010/402X/405X CHERRY KEYSWITCH
REPLACEMENT

The late style cherry keyswitch, with the expanding mounting tabs, is difficult to remove from the keyboard without first cutting the mounting tabs off.

It has been found that the X-acto blade #11, 002-1040-00, with the long straight edge, works quite well in cutting the cherry keyswitch tabs. Insert blade in keyboard as pictured and cut off tab.
