# SERVICETEKNOTES

## TABLE OF CONTENTS

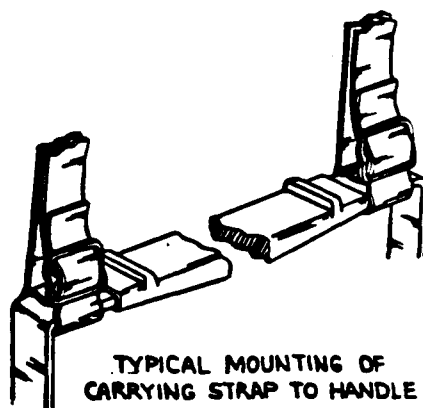
TYPICAL MOUNTING OF  
CARRYING STRAP TO HANDLE

A new style carrying strap is now available, P/N 346-0199-00. It was designed for use with the 2213/2215's, but can be used with any portable instrument having a standard adjustable carrying handle, such as the 400/300 series and 2300 series. The illustration below shows typical mounting and use.

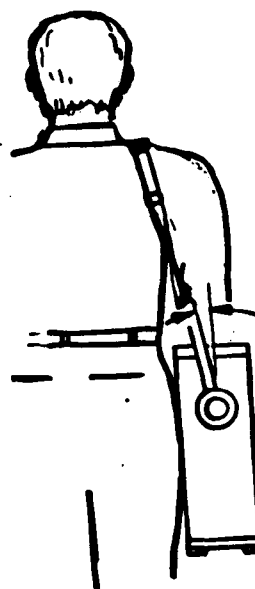
MOVE HANDLE OVER  
ONE POSITION FOR EASE  
WHEN CARRYING

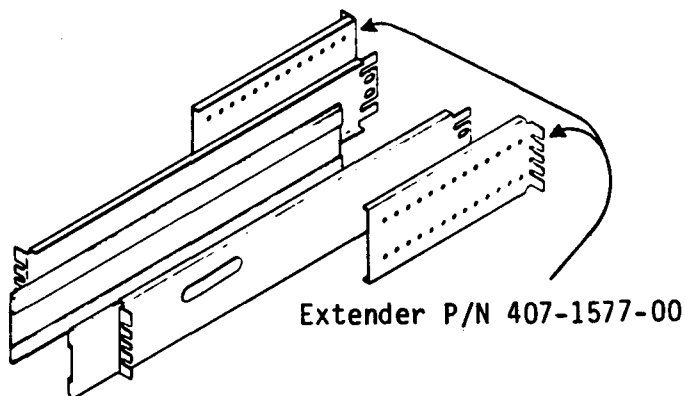
Slide Assembly 351-0085-00

The part number for the equipment slide assembly extender is 407-1577-00. The 407-1577-00 is for a pair of extenders, left and right side. These extenders are 3.56 inches wide and 6 inches long. The extenders are included as a sub part for the slide assembly 351-0085-00. Normally there should be no need to order the extender separately. The exception to this is when the extender is damaged or a rack mounted equipment is bought outside Tektronix, i.e. DEC RK05 disk drive. The extender may be needed because the slide assembly supplied with other vendor equipment is usually too short for the racks used in the S3200 series system.

Extender P/N 407-1577-00
