SERVICETEKNOTES

TABLE OF CONTENTS

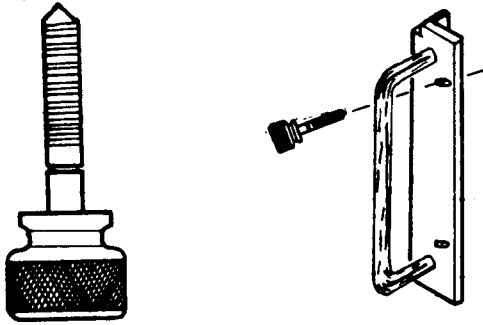
S-3200 RACK THUMBSCREW PART NUMBER

The thumb screw used to secure the different rack units to the rack is 213-0167-00. There is a teflon washer, 210-0894-00, that should accompany it. The figure below is an illustration of the thumb screw (the washer is not shown).

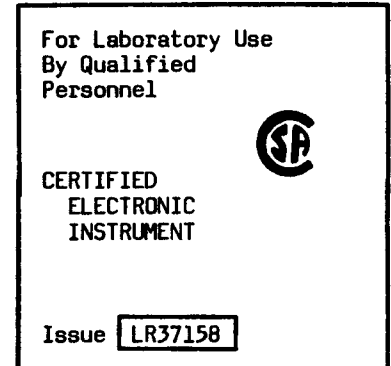
Figure 1
SAFETY LABELS

Starting at B010180 (690SR) or B010647 (6942) several labels have been added to the mainframe. Figure 1 illustrates the three safety certification labels that will be used. Labels 1A & C will be found on 690SR instruments in most applications, and labels 1B & C will be found on 6942 instruments and some 690SR options.
