TEKTRONIX INTERNAL USE ONLY

April 10, 1981
Issue 11-6

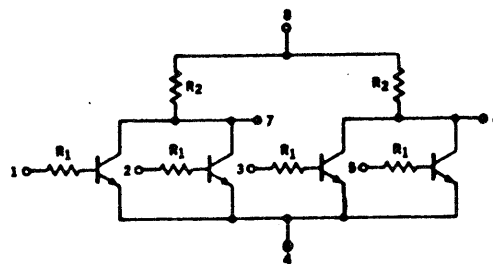
SCHEMATIC DIAGRAM

1. If a Line Timing board is ordered, be aware of the possibility of an ECB defect connecting pin 2 (input) to pin 4 (ground) on U635A. Stocks should be checked for any further problems in this area.
2. The instruction manual (070-0944-00), diagram 6b, U635A shows pin 1 as the input to the IC. Correct this to read pin 2. Manual changes have been requested.
3. The IC used in U635 (156-0011-00) is used quite extensively throughout the instrument in a variety of configurations. The error in #2 (above) is not necessarily true in other parts of the manual. As shown below, the 156-0011-00 is a Dual-NAND gate and as such can assume a variety of logic uses depending upon connections used.

4. If other discrepancies are found in the manual, we need to submit change requests, but verify the discrepancy carefully. Also, since the internal logic was not often published in older manuals, and information may be hard to come by on older IC's, let Service Support know when you need further documentation.
