# Wizards Workshop

TEKTRONIX INTERNAL USE ONLY

April 18, 1980  
Issue 10-8

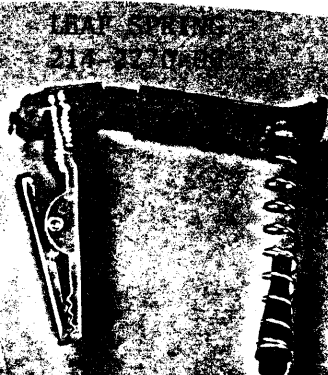
When constructed, this little jig looks to be straight out of a five-year-old's Tinker Toy box, but it works; and it saves a lot of aggravation and heat damaged sampling bridges (CR1732).

SCREW  
211-0504-00

CLIP  
344-0046-00

COIL SPRING  
214-1779-00

BUMPER  
348-0089-00
