SERVICETEKNOTES

TABLE OF CONTENTS

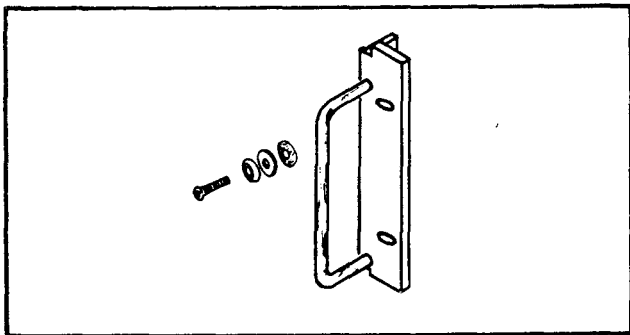
S-3200 SECURING INSTRUMENTS TO THE RACK (cont.)

There is also a kit available that contains four of each of the parts listed above. The kit part number is 016-0099-00.
