SERVICETEKNOTES

TABLE OF CONTENTS

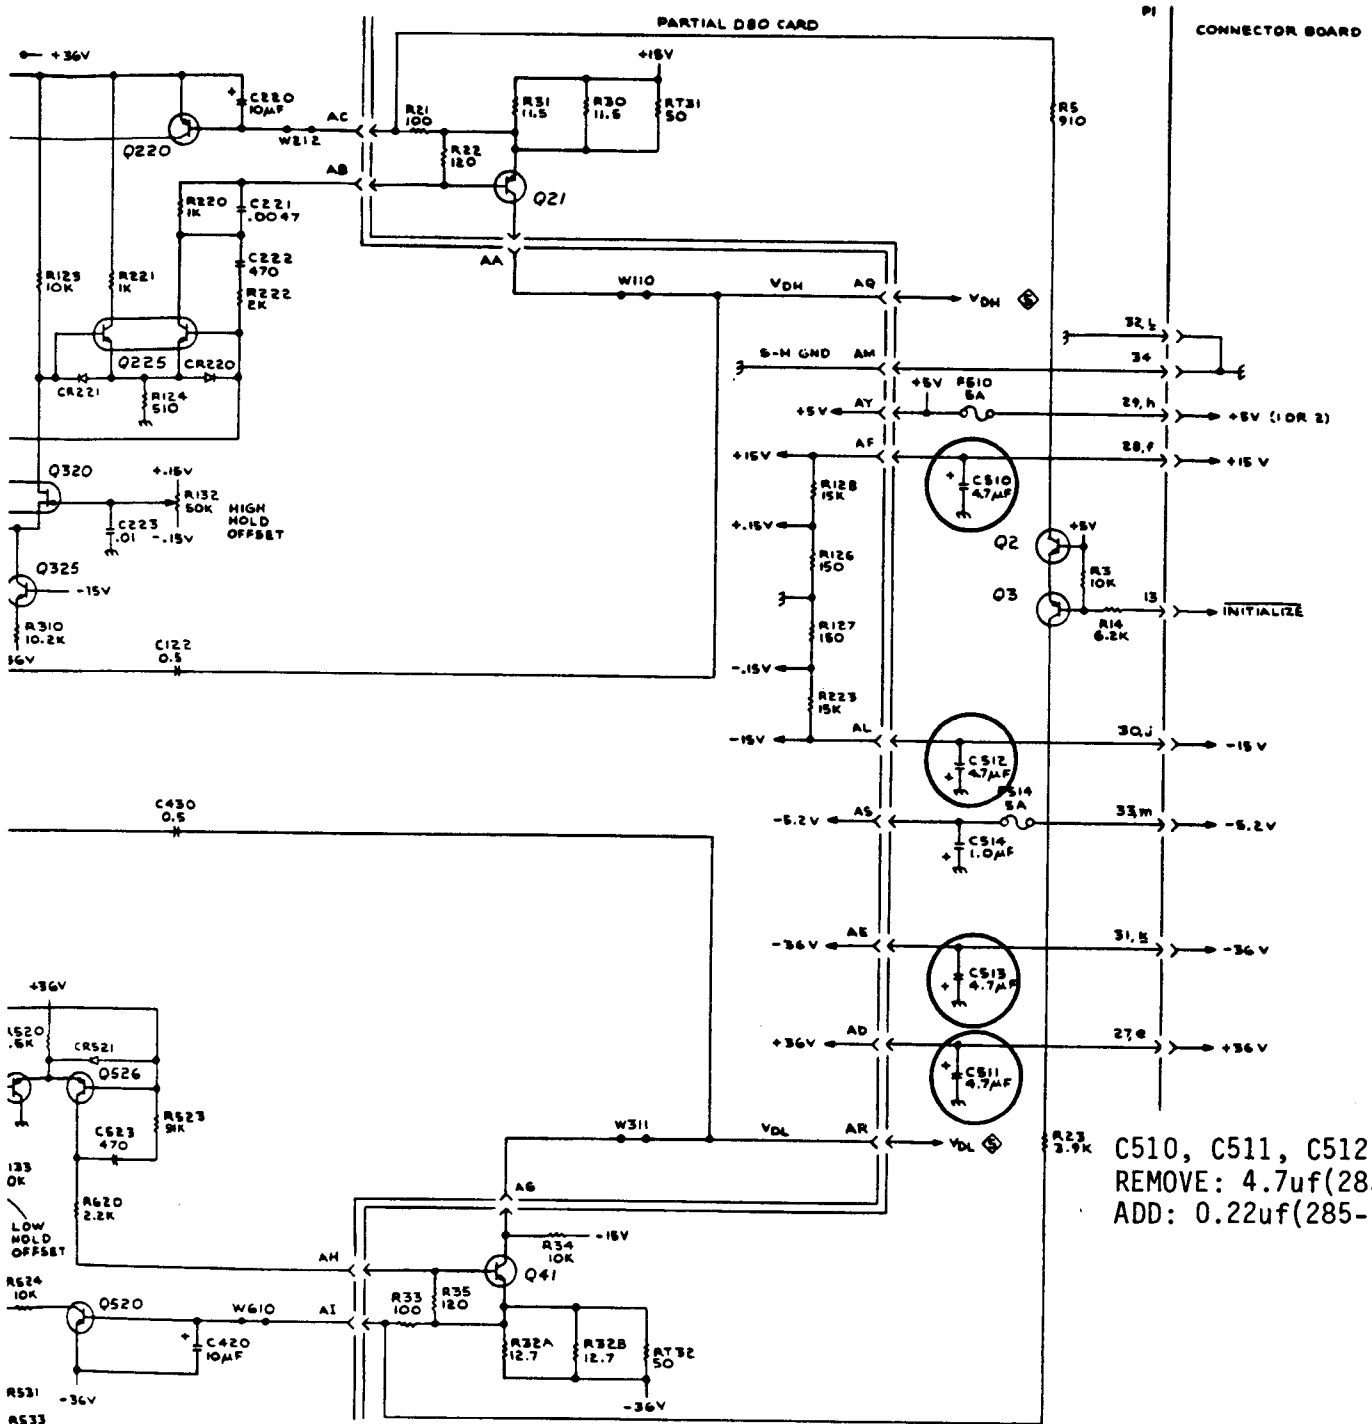
FIGURE 4

C510, C511, C512, and C513 with 4 each, Capacitor 0.22uf, 10%, 100V (285-1241-00). Replace 2 each, Capacitor 1uf, +80-20%, 25V (283-0177-03) located at C443 and C453 with 2 each, Capacitor 0.1uf, 20%, 50V (283-0111-00). The D70 Pin Electronics Card changes from 670-5347-03 to 670-5347-04. See Figures 1, 3, 4, and 6.

Replace 4 each, Capacitor 4.7uf, 20%, 50V (283-0194-00) located at

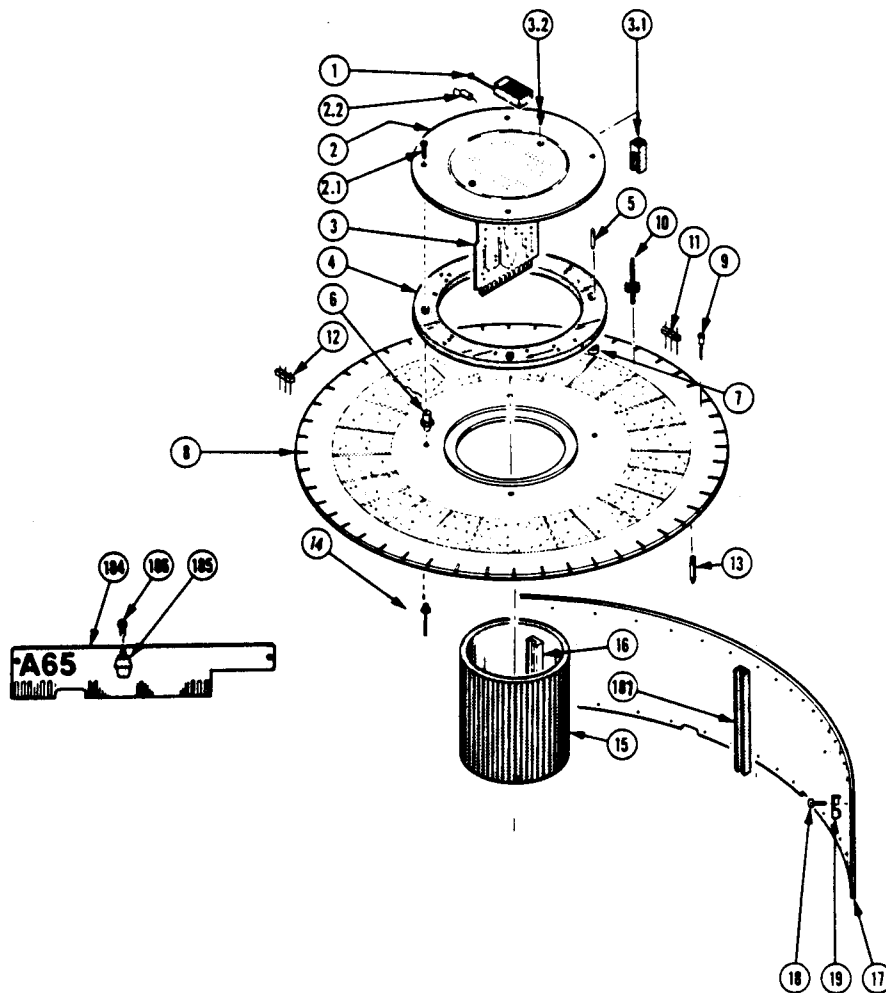
1807 FIGURE 2 MANUAL CORRECTION (cont.)

In the 1807 manual, Volume 2, 070-4134-00, page 6-77 there are errors. The load board and hardware Fig. 2 index numbers 3 through 14 are incorrect. Shown below is the correct mechanical view of the load board and hardware plus the corrected part number listing.
