SERVICETEKNOTES

TABLE OF CONTENTS

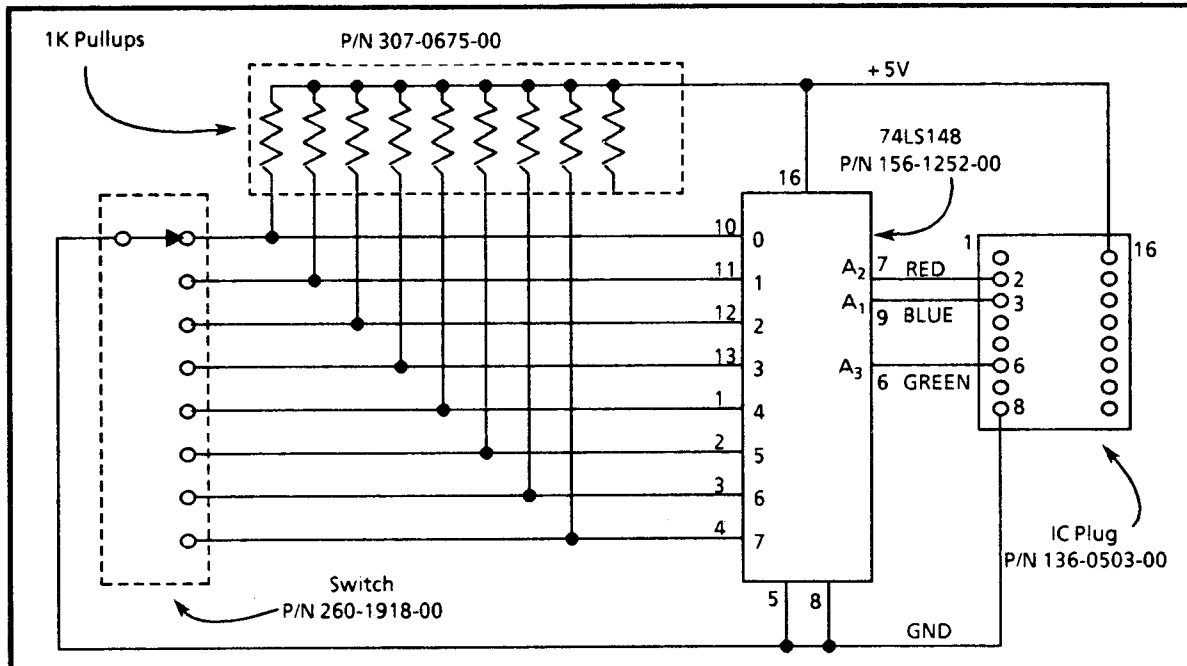
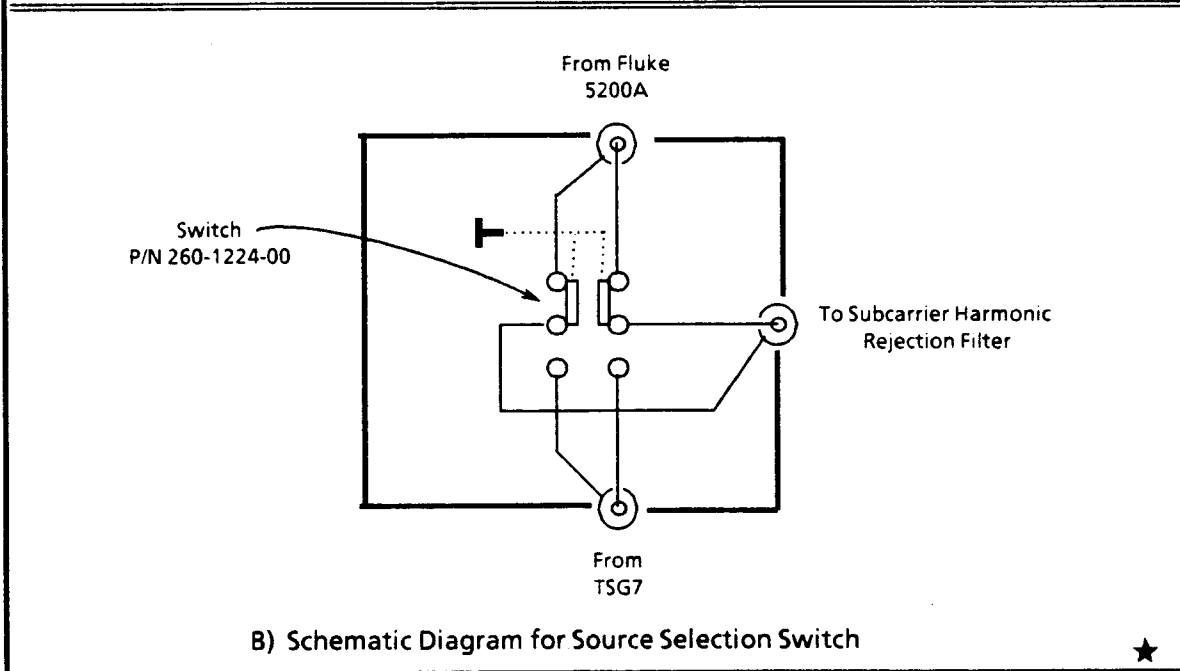
Fig. 1. Schematics for locally constructed test equipment

CHANGE Fig. 1 AS FOLLOWS:

A) Schematic Diagram for BCD Color Bar Selection Box

B) Schematic Diagram for Source Selection Switch

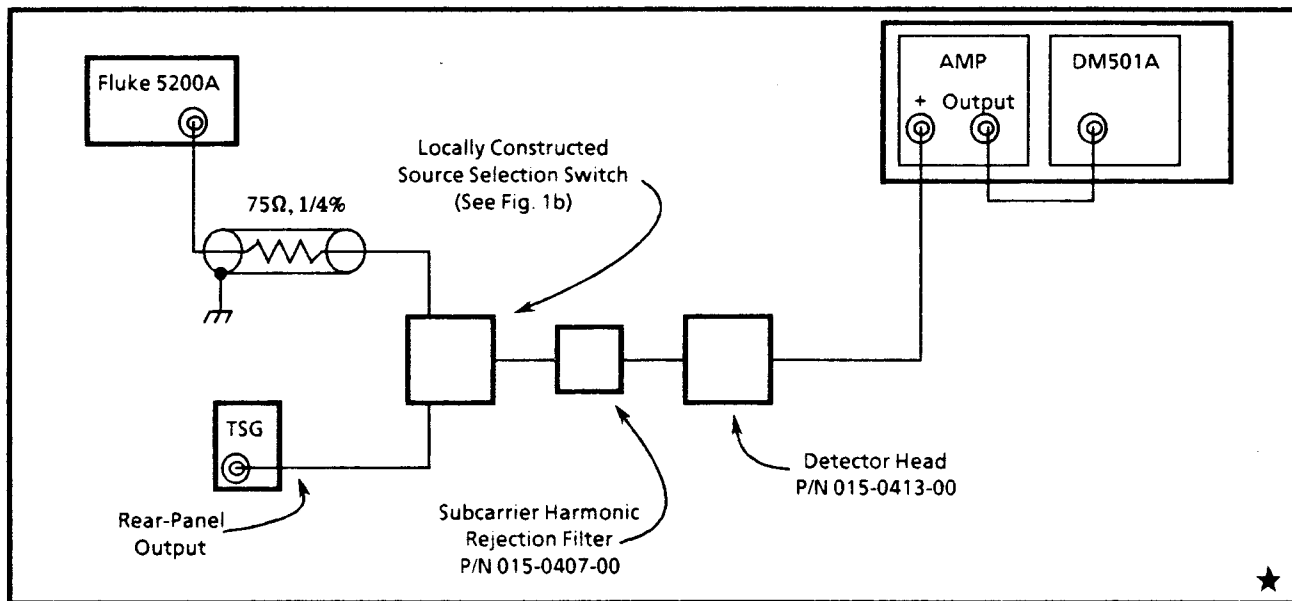
Fig. 2. Equipment Connections for Chrominance Amplitude Measurement.

CHANGE Figs. 2 and 3 AS FOLLOWS:
