# SERVICETEKNOTES

## TABLE OF CONTENTS

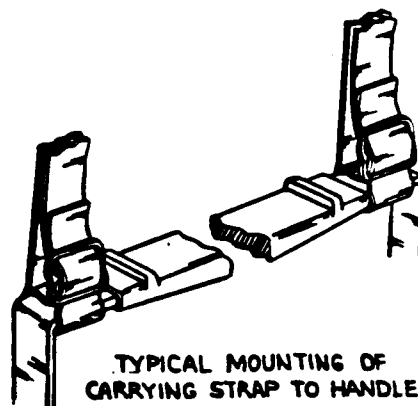
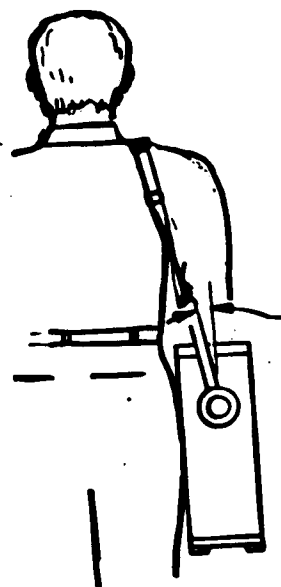
TYPICAL MOUNTING OF CARRYING STRAP TO HANDLE

MOVE HANDLE OVER ONE POSITION FOR EASE WHEN CARRYING

A new style carrying strap is now available, P/N 346-0199-00. It was designed for use with the 2213/2215's, but can be used with any portable instrument having a standard adjustable carrying handle, such as the 400/300 series and 2300 series. The illustration below shows typical mounting and use.
