465/475
492/P
2215

SERVICETEKNOTES

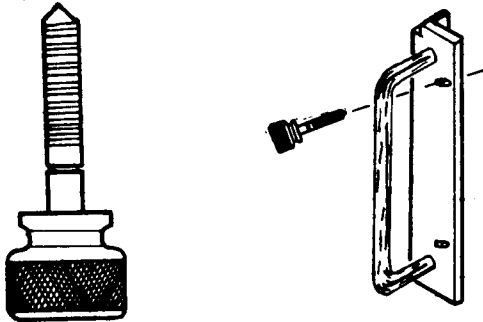
S-3200 RACK THUMBSCREW PART NUMBER

The thumb screw used to secure the different rack units to the rack is 213-0167-00. There is a teflon washer, 210-0894-00, that should accompany it. The figure below is an illustration of the thumb screw (the washer is not shown).
