TM 5000

# SERVICETEKNOTES

Published by Tektronix Service  
Administrative Support

## TABLE OF CONTENTS

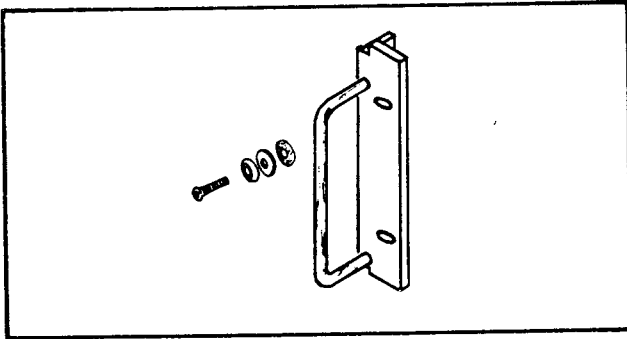
S-3200 SECURING INSTRUMENTS TO THE RACK (cont.)

There is also a kit available that contains four of each of the parts listed above. The kit part number is 016-0099-00.

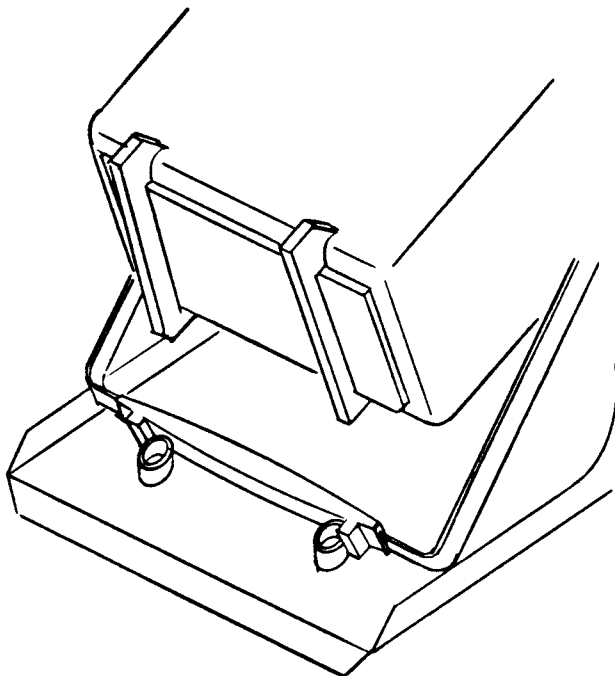
200C/PORTABLE INSTRUMENTS  
COMPATIBILITY AND CAUTIONS (cont.)

- 2nd - open the instrument flip-down cover to the fully open and locked position.
- 3rd - position the cushioned portion of the instrument handle against the 200C top tray, rear retaining feet (refer to sketch).
- 4th - and finally, secure the instrument by cinching down the tie-down strap over the instrument.
