# SERVICETEKNOTES

## TABLE OF CONTENTS

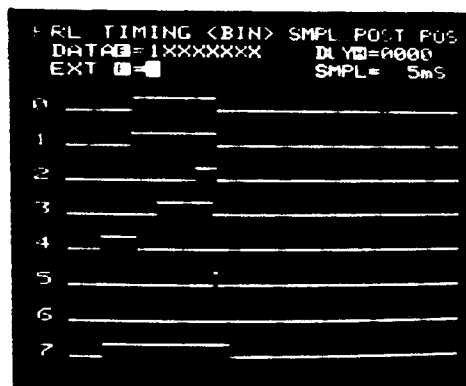
The 308 is triggered on channel 7 when 180X Power Status goes high, so finding any signal that goes high at the same time will indicate the Power supply circuit at fault.

Components external to the power supply are usually at fault (i.e. sector card). This procedure is only going to help narrow it down to a power supply circuit.

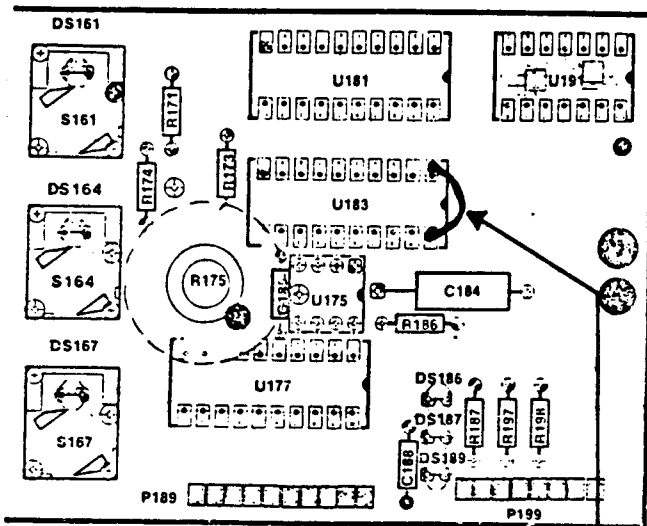
670-5863-00

1900 KEYSWITCH BOARD FAULT (cont.)PARTIAL VIEW OF KEYSWITCH BOARD

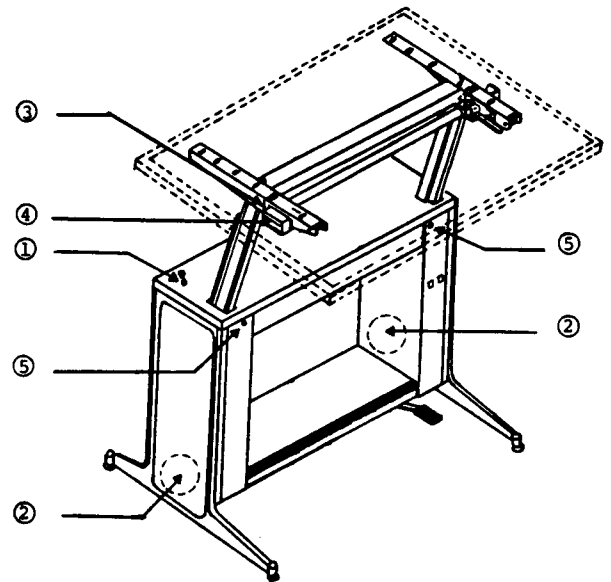
The 4954F32 Tablet pedestal has 5 adjustments which can be made, and should be checked, during every installation. They are: Elevation Counterbalance Adjustment, Elevation Brake Adjustment, Tablet Surface Tilt Locking Adjustment, "Dial-a-Torque" Settings and Adjustments, and Column Roller Adjustment. All adjustments should be made after tablet surface has been installed.

- ① Elevation Counterbalance Adjustment
- ② Elevation Brake Adjustment
- ③ Drawing Surface Tilt Locking Adjustment
- ④ "Dial-A-Torque" Settings and Adjustment
- ⑤ Column Roller Adjustment

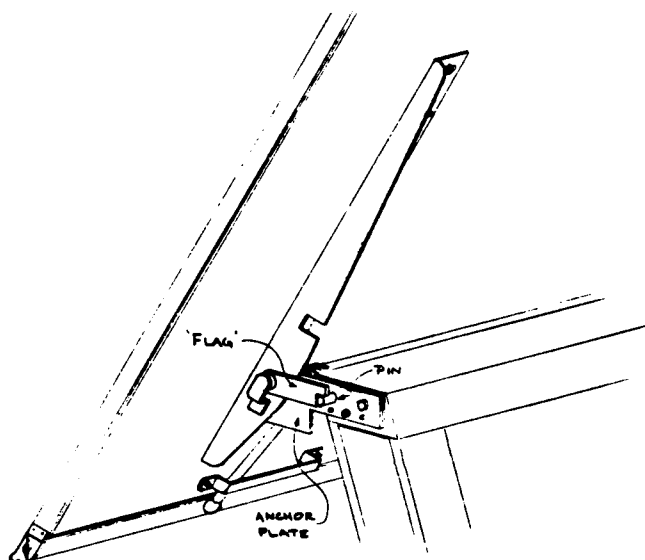
'Flag' and 'Pin' Illustration

"Dial-A-Torque" provides protection from damage to a tablet surface when tilting surface from the vertical to 'operating' position.
