Wizards Workshop

TEKTRONIX INTERNAL USE ONLY

July 11, 1980
Issue 10-14

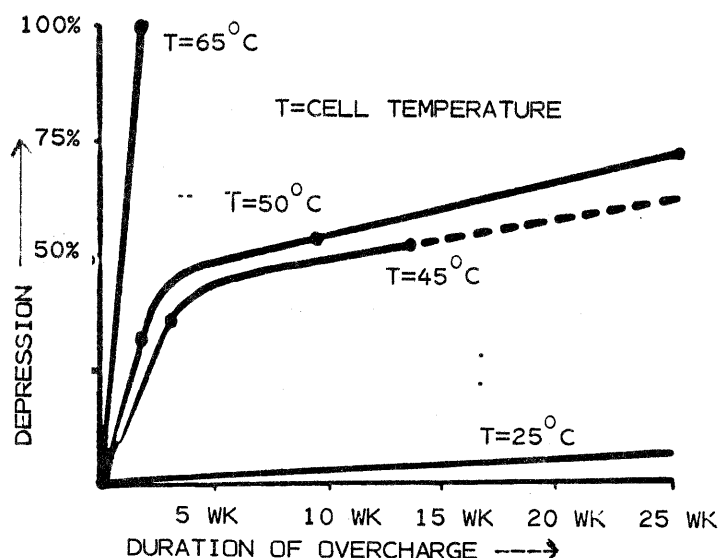
Figure 1 - Voltage-step depression as a function of overcharge time and cell temperature, T .

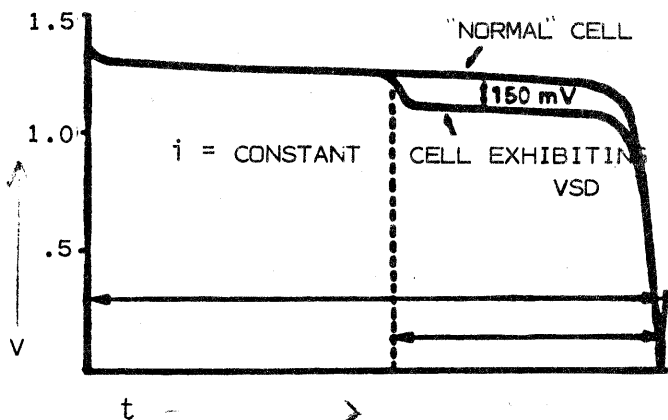
Figure 2 - Discharge curves for a "normal" NiCd cell and a cell exhibiting voltage-step depression.

Voltage-Step Depression is not a limiter to the charge level, rather VSD has an effect on the cells discharge characteristic. Cells have shown a VSD of 150 mV per cell, which could result in a 600 mV battery pack voltage drop in a 4 cell pack. The VSD occurs sometime during the discharge cycle, and the remaining discharge rate parallels the normal discharge curve, but at a lower voltage. (See Fig. 2) With either form of battery degradation the operating time is shortened, sometimes only allowing a few minutes of run time.

There are three alternatives for correction when an instrument is showing signs of battery degradation.

- 1) Replace battery pack.
- 2) Rejuvenate the batteries.
- 3) Do not use battery power with the instrument.

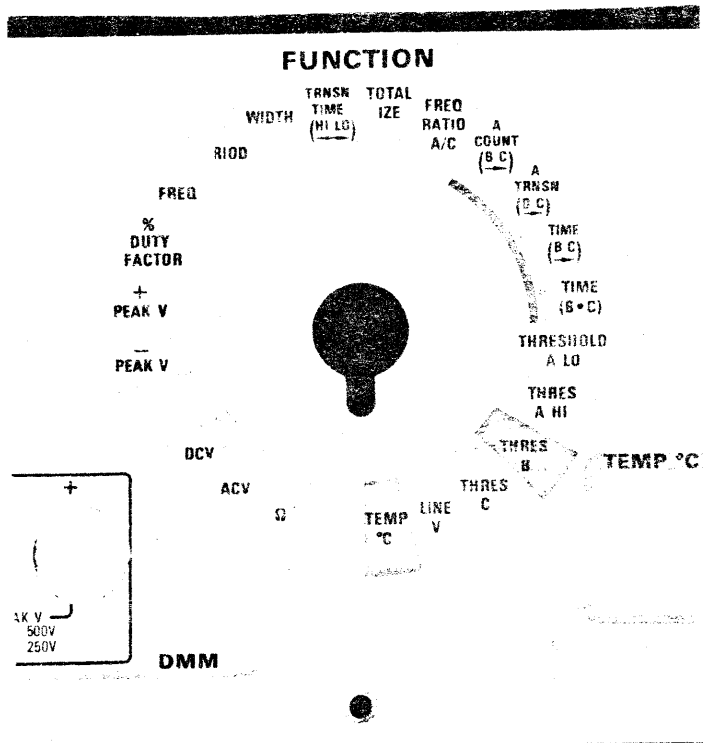
When calibrating the 851, the front panel assembly needs to be removed to gain access to test points and adjustments. The only problem with the removal of the front panel is that the Function switch no longer has a means for determining its position. To help alleviate this problem, Ted Milke from our Huntsville Service Center has suggested the following:

1. Glue Figure 1 to a stiff piece of cardboard.
2. Cut out Cal Aid and place over Function Switch.
