PG 507
492/P
2215

SERVICETEKNOTES

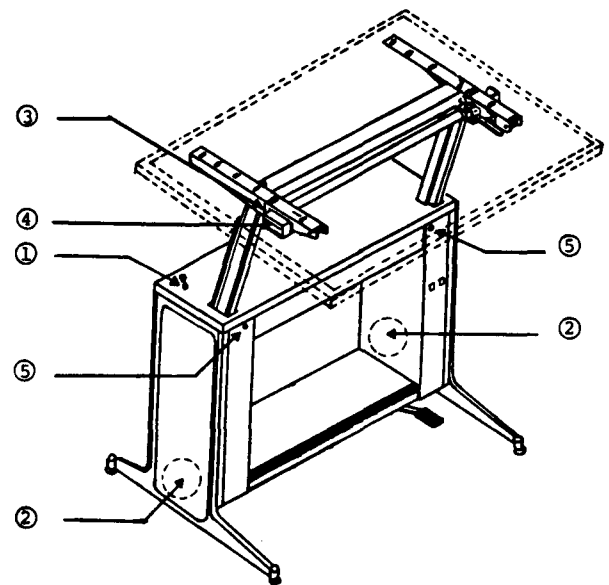
- ① Elevation Counterbalance Adjustment
- ② Elevation Brake Adjustment
- ③ Drawing Surface Tilt Locking Adjustment
- ④ "Dial-A-Torque" Settings and Adjustment
- ⑤ Column Roller Adjustment

The 4954F32 Tablet pedestal has 5 adjustments which can be made, and should be checked, during every installation. They are: Elevation Counterbalance Adjustment, Elevation Brake Adjustment, Tablet Surface Tilt Locking Adjustment, "Dial-a-Torque" Settings and Adjustments, and Column Roller Adjustment. All adjustments should be made after tablet surface has been installed.

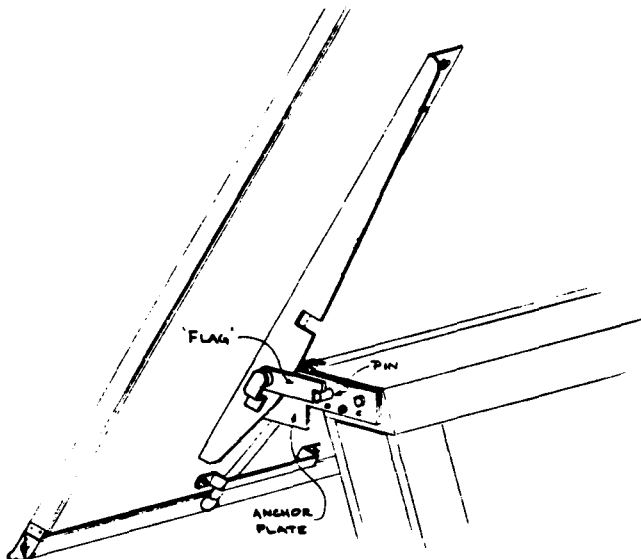
'Flag' and 'Pin' Illustration

"Dial-A-Torque" provides protection from damage to a tablet surface when tilting surface from the vertical to 'operating' position.
