Wizards Workshop

TEKTRONIX INTERNAL USE ONLY

Published by Service Admin Support

October 9, 1981
Issue 11-19

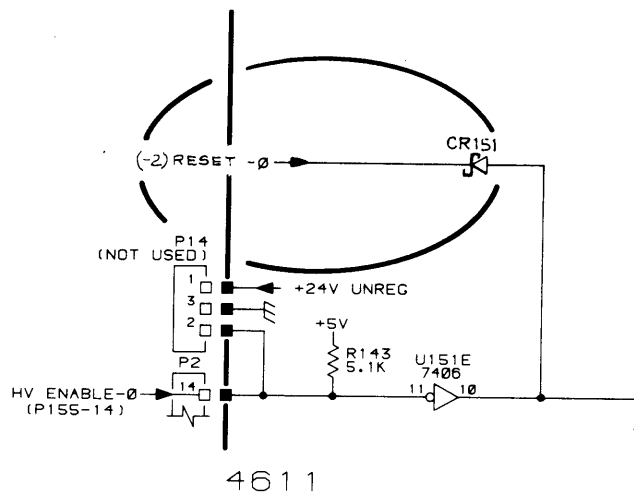
Figure 1. Power Supply Schematic, Sheet 1 (partial)

Schematic A2-1 Power Supply Board

CHANGE AS SHOWN:

1. R195 was changed to 150 ohm, p/n 315-0151-00; R193 was changed from a fixed resistor to a 2K pot, 311-1918-00, hand-add. See Figure 3.
2. New adjustment procedure for R193:
 - a. Turn on the hard copy unit and allow to warm up (copy light steady).
 - b. Connect a voltmeter between ground and the collector of Q191 (junction of R197 which is a 10K resistor, and C191 which is a 4700 pF capacitor).
