COMBINATION EDITION

Wizards Workshop

June 19, 1981 Issue 11-11

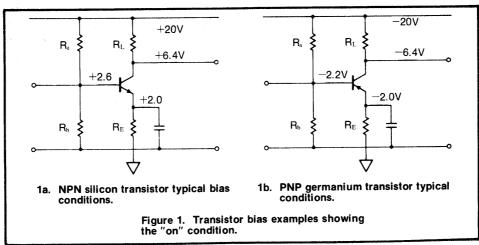
Conventional PNP or NPN transistors are basically "off" devices and must be biased "on" to their operating point. This is done by forward biasing the base-emitter diode to make the transistor conduct. Refer to Figure 1 for examples of forward bias on NPN/PNP silicon and germanium transistors.

As shown in Figure 1, an NPN transistor must have its base more positive than the emitter in order for current to flow.

In a PNP transistor, the base must be more negative than the emitter in order for current to flow.

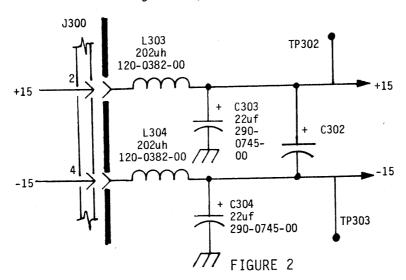
FIGURE 1

To improve geometry, an ORTHOGONALITY adjustment is added to both boards. However, the values of the added components differ between the two boards. Refer to Figure 1 for the values of the new parts. Those values in parentheses are for the Option 15 board. The new ORTHO control is best adjusted after step D5.h of the manual calibration procedure; that is, after the horizontal linearity adjustment.

The new standard yoke driver board includes the filtering components C303, C304, L303, and L304 needed for the Option 20 product. As a result, the 670-7004-00 will no longer be produced.

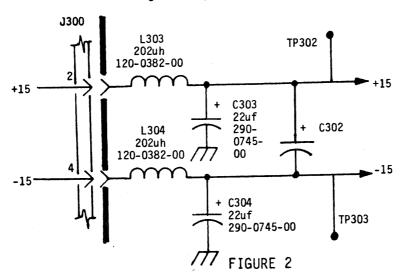
FIGURE 1'

To improve geometry, an ORTHOGONALITY adjustment is added to both boards. However, the values of the added components differ between the two boards. Refer to Figure 1 for the values of the new parts. Those values in parentheses are for the Option 15 board. The new ORTHO control is best adjusted after step D5.h of the manual calibration procedure; that is, after the horizontal linearity adjustment.

The new standard yoke driver board includes the filtering components C303, C304, L303, and L304 needed for the Option 20 product. As a result, the 670-7004-00 will no longer be produced.
