WIZARDS WORKSHOP

TEKTRONIX INTERNAL USE ONLY

TABLE OF CONTENTS

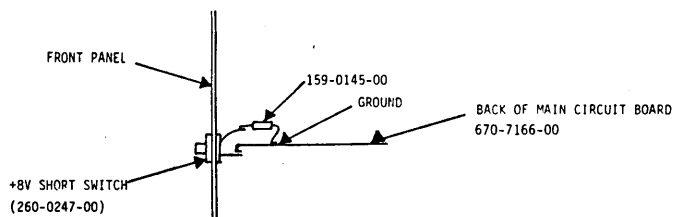
To prevent possible board damage when testing a defective +8V supply, a 15A fuse, P/N 159-0145-00, should be installed between the +8V short switch and ground on the back of the main circuit board. (See Figure 1). For future reference, make this correction on Schematic 1 of your manual.

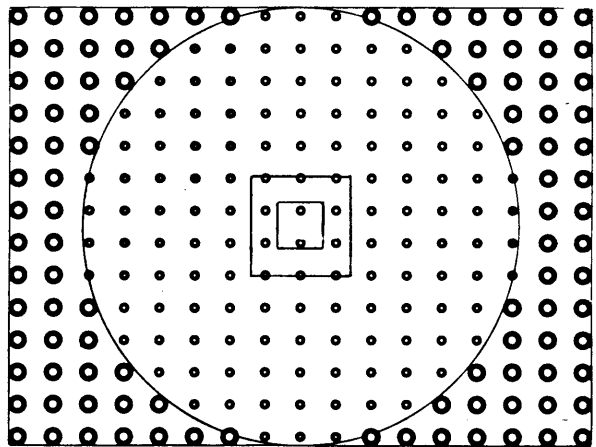
- "Paint" over the score marks with a black felt tip permanent marker. Immediately wipe off the excess ink with a tissue. A fine black line should now remain inside the scores. The completed scale should appear as shown below.

This procedure makes possible several thousandths inches of error. In addition, local magnetic fields may displace the "undeflected" spot on a CRT faceplate several millimeters. Therefore, considerable discretion should be used before declaring a given CRT to be in or out of specification.

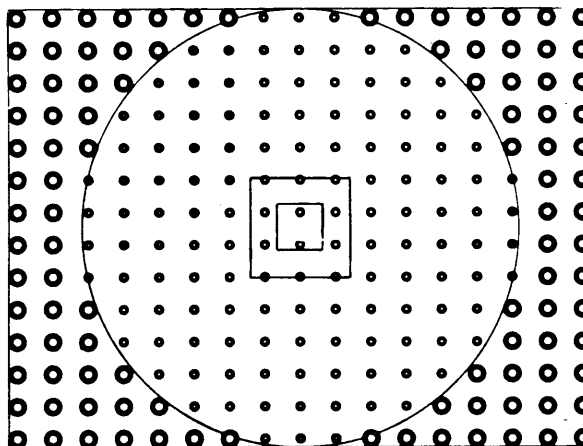
This procedure makes possible several thousandths inches of error. In addition, local magnetic fields may displace the "undeflected" spot on a CRT faceplate several millimeters. Therefore, considerable discretion

should be used before declaring a given CRT to be in or out of specification.
