**INTFAC. RUN
1340 TO PDP-11
MULTI-INTERRUPT
INTERFACE
VERIFICATION PROGRAM
062-4816-00**

INSTRUCTION MANUAL

070-3647-00
Product Group 70

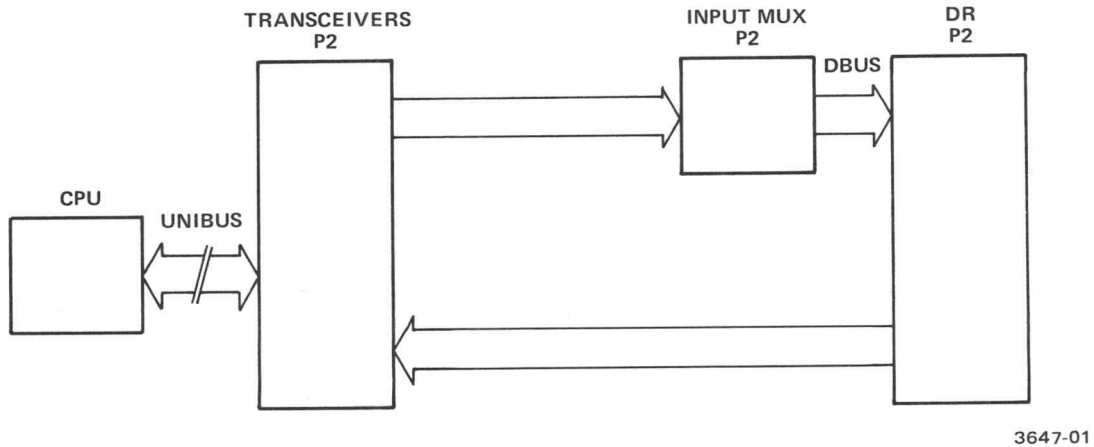
Figure 3-1. Data Path for BASE+124 (DR)

The state diagram for the PM shows when the crucial control signals should happen (see Figure 3-1).

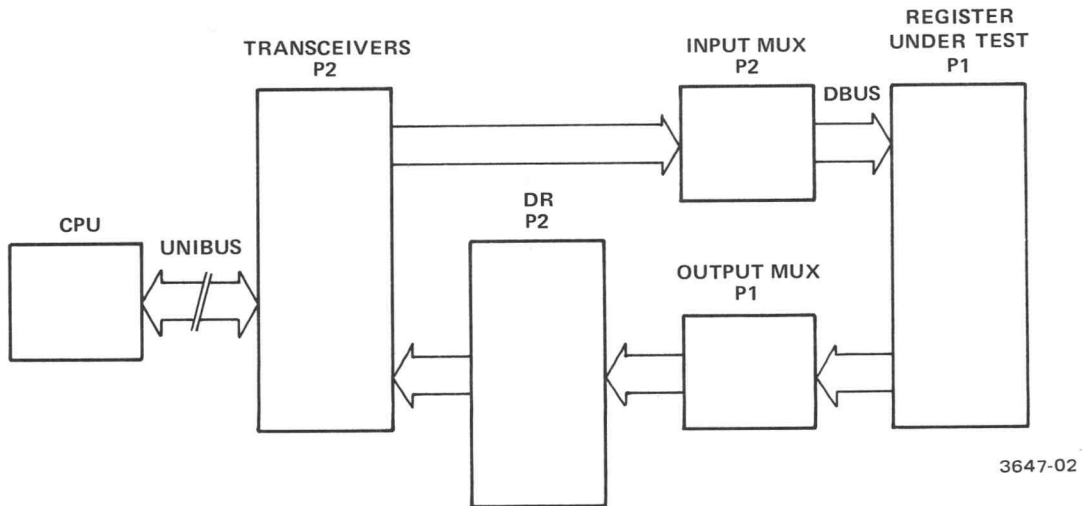
Strategy:

1. Check for the correct SELECT.
2. If <write> = 177777, check control lines.
3. Follow a wrong bit through the path.

Figure 3-2. Data Path for BASE+130 (LIER), BASE+134 (UIER), BASE+160 (LTAR) and BASE+164 (UTAR)

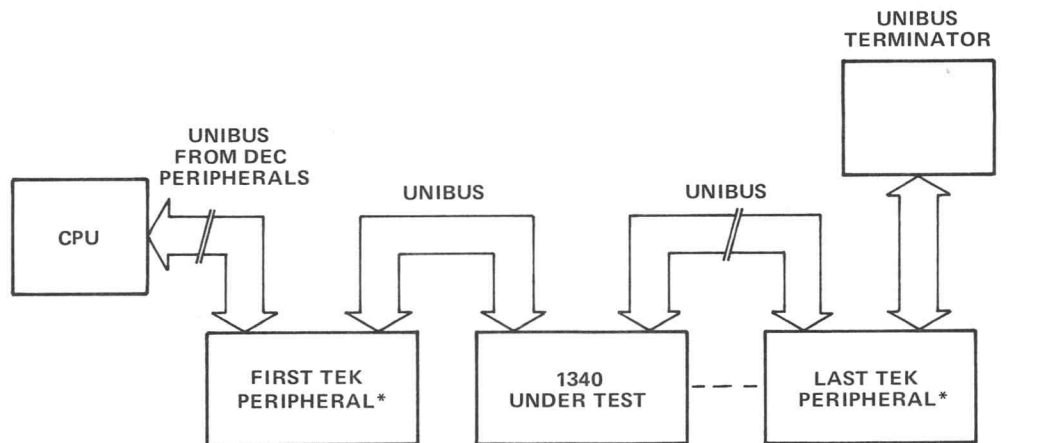
3647-06

*TEK peripherals refer to TEK instruments connected directly to the UNIBUS (i.e., 1340, R2943)

Figure 3-6. Normal UNIBUS Connections

Restart the program. If the program stops at the same point, disconnect any other TEK peripherals from the UNIBUS. Install a UNIBUS terminator after the 1340 under test (see Figures 3-6 and 3-7).

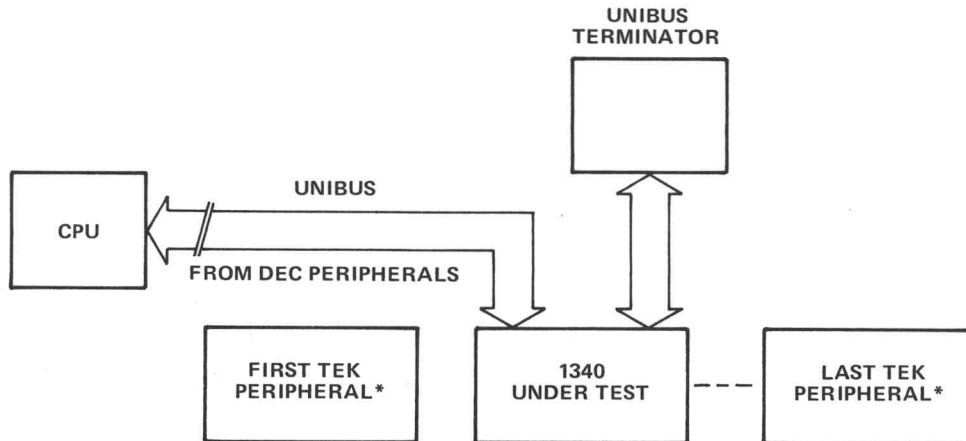
3647-07

*TEK peripherals refer to TEK instruments connected directly to the UNIBUS (i.e., 1340, R2943)
